## Attachment A - Option Study

Stantec | Butlers Green Retaining Wall - Option Study | 23/02/2018

### Butlers Green Retaining Wall - Option Study

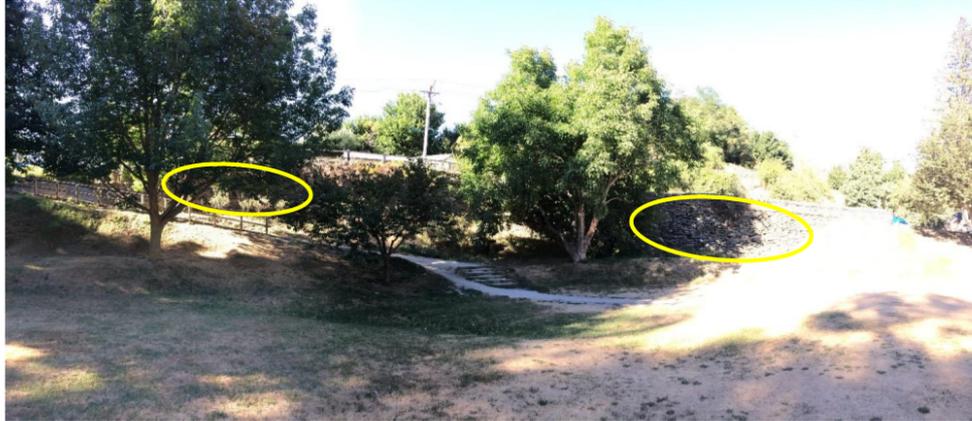
Two notable sections of the wall are bulging outward significantly with a deflection of approximately 600 mm. This deflection has resulted in cracking of some stones and loss of stones in some areas.

Figure 2 – The Retaining Wall viewed from Butlers Green, bulging areas marked in yellow

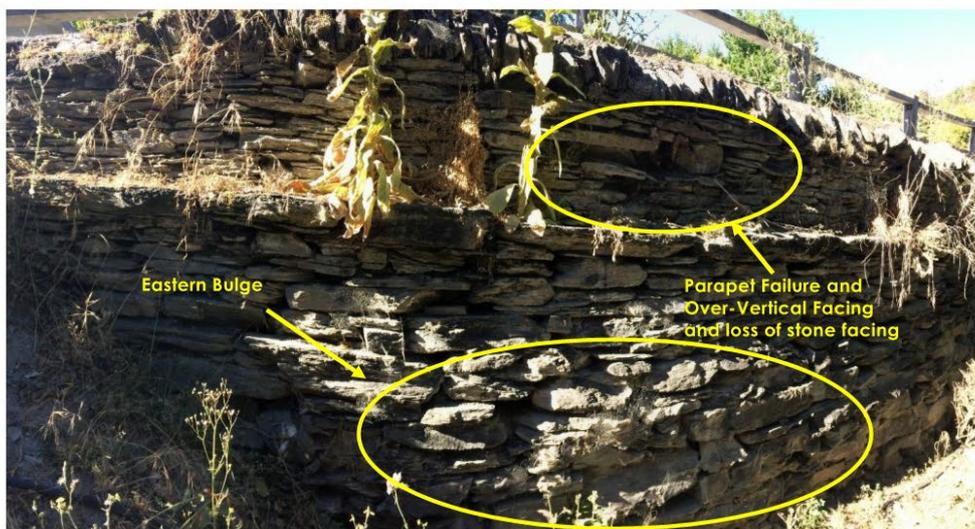
Figure 3 - Photograph of Eastern Wall Segment and Parapet Failure

The section of the wall above the walkway and adjacent to Berkshire Street is bulging by approximately 500mm. This movement appears to be ongoing and the condition of the wall is deteriorating. The top of the wall has deflected approximately 400 – 500mm and the wall in this area is over 2m high. The length of the bulge is approximately 10m. This segment is immediately above the existing pedestrian walkway. Action has been recommended by Stantec to place rock fall mesh to protect the walkway from the risk of the parapet falling.

The movement of the wall is resulting in fracturing of the stones and loss of some stones from the face.

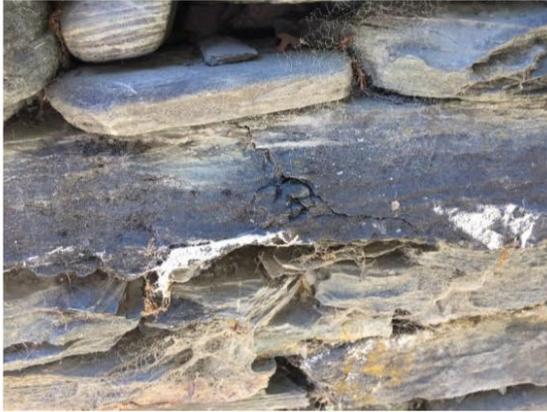
Figure 4 - Stones Cracking in Facing Near Eastern Bulge

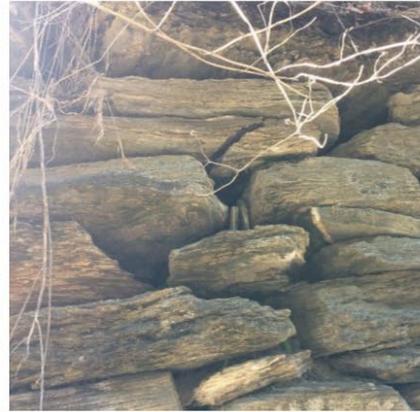
Figure 5 - Stones Cracking in Facing Near Eastern Bulge

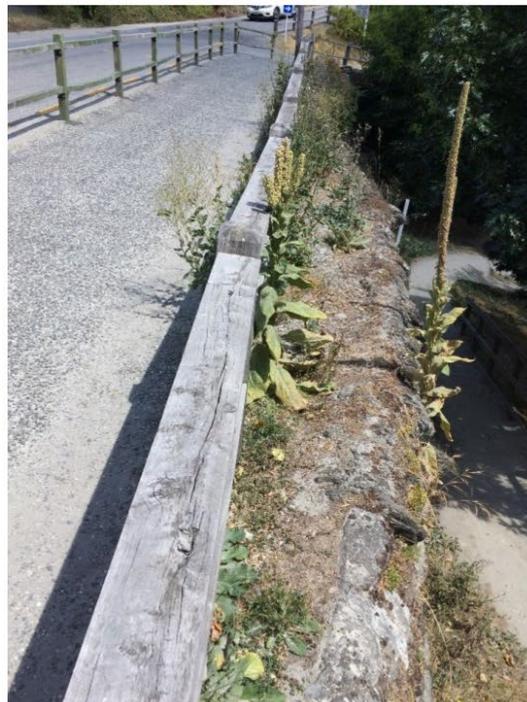
A section of the parapet on the eastern end of the wall is currently over-vertical and it appears that stones are starting to be lost from the wall face. The segment of wall that is over-vertical appears to have deflected up to 500 -600mm from its original position (refer Figure 6).

Figure 6 - Parapet and Wall Deflection As Seen From Above

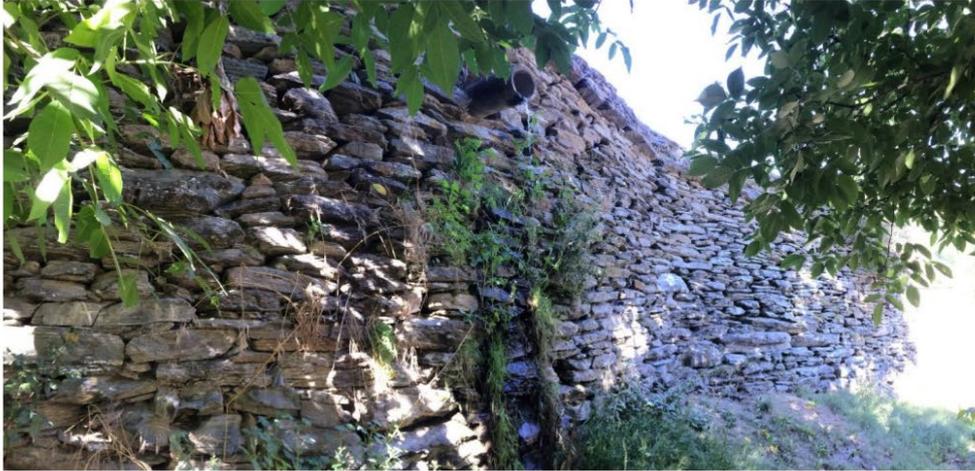
The western wall segment is along the section of Buckingham Street leading to Dudley's Cottage. There is a significant bulge and this area exhibits a general global wall failure. The wall in this location is nearly 4 metres high and the bulge spans most of the lower half of the wall (see below).

Figure 7 – Photograph of Western Wall failure area

There is a storm water drainage pipeline extending out of the face of the wall that was flowing at the time of inspection despite no prior rainfall. We believe that this water originates from a break in the water supply reticulation in private property in Villers Street.

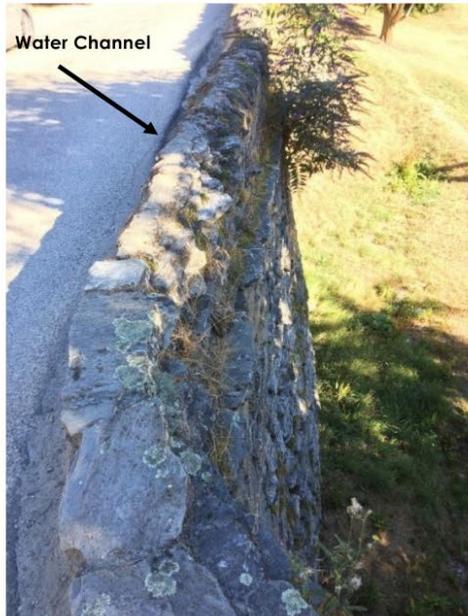
The road surface has been repaired above this area and an unsealed water channel has been formed which will direct surface water to the back of the wall and may allow direct ingress of water behind the wall facing. The presence of this unsealed water channel will reduce the factor of safety of the wall.

Figure 8 - Western Wall Failure From Above

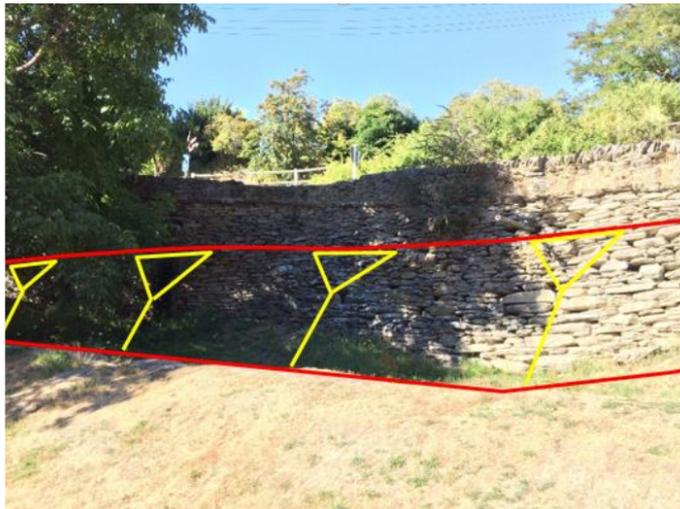
Figure 9 - Option 1 Indicative Passive Fill Location on the Western Failure

This option involves using bulk earthworks to fill part, or all, of the front of the wall to form a toe buttress of engineered fill to support part of the exposed face. This is shown in Figure 9 below;
