*Geotechnical Report No. 1184*  
*Mitchell Partnerships*

**Geotechnical/Natural Hazard  
Assessment  
Three Parks Land, Wanaka**

**March 2007**

Date: March 2007  
Reference: 6CWM03.46 006DD  
Status: FINAL

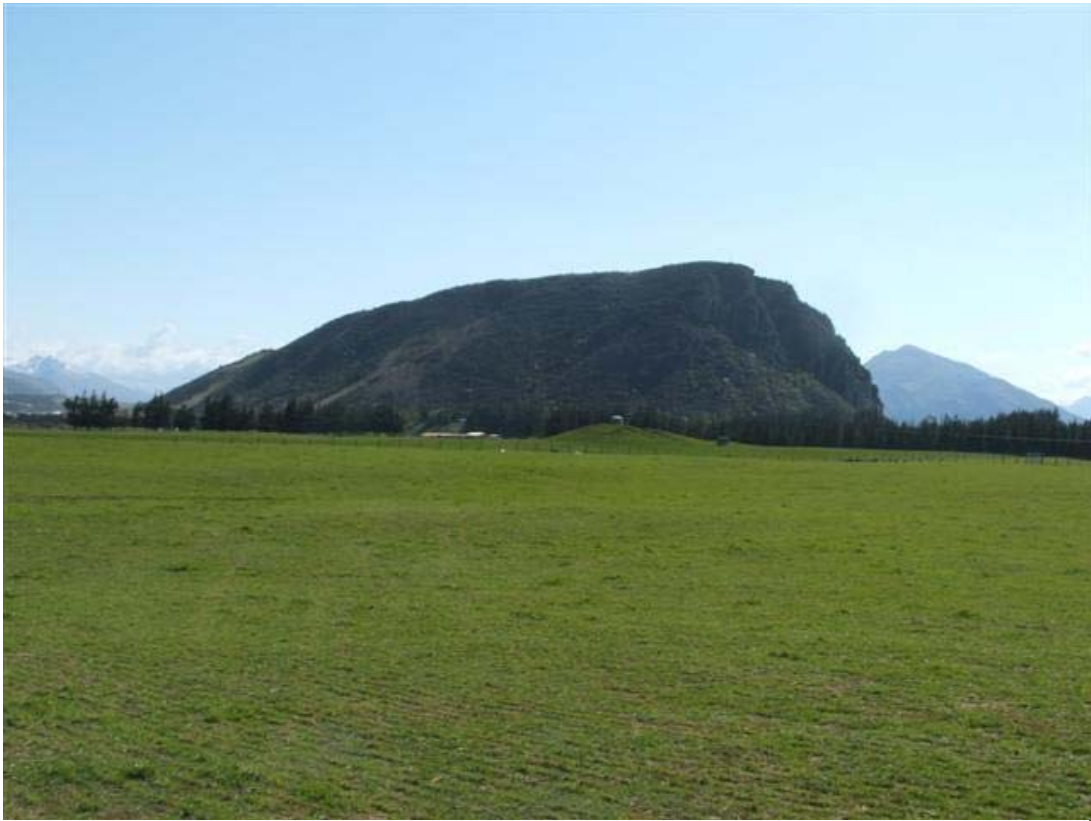
Due to the relatively flat topography, there are no landslide/rockslide/fall hazards on site. The Northern-most portion of the site, which is bounded by the State Highway, is located approximately 100m from Mt Iron (Photo 2).

An assessment of aerial photography and information gathered from the site visit was made to assess the landslide and/or rockfall/slide hazard posed to the development site from Mt Iron. The schist outcrop that makes up Mt Iron is well vegetated and historic aerial photographs do not show any evidence of instability of the slope. There is also no evidence of rock surrounding the slope on the side of the Wanaka State Highway. The whole schist outcrop is dipping away from the site 15° to the North-west. Landslide and/or rockfall/slide risk to the site from Mt Iron is very low.

Photo 2 - Mt Iron to the North of the proposed development site (October 2006).

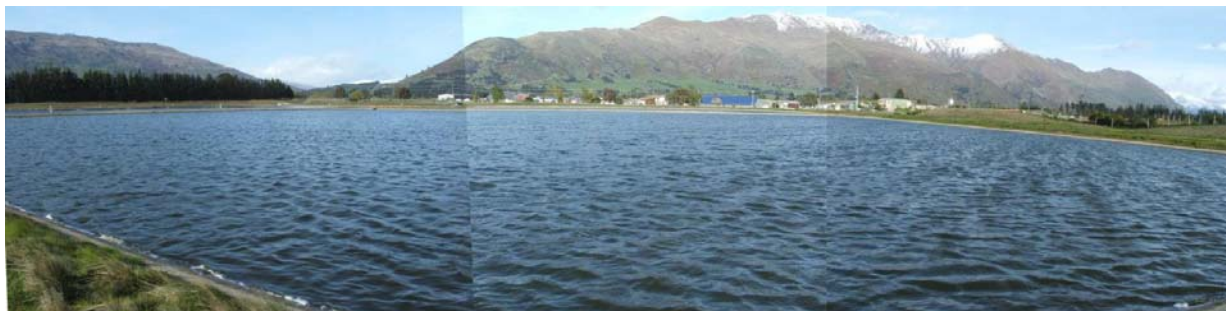
Photo 3 - Looking southwest over the largest of the oxidation ponds (October 2006).

It had been recognized that water quality at the discharge point does not always comply with consent conditions. Given this and other land development pressures at the current oxidation pond site, a Joint Working Party Group was formed in March 2003 to investigate alternative options and locations for Wanaka's waste treatment under an initiative entitled, "Project Pure". The final report by this working party indicated that the preferred option involves moving treatment elsewhere while the existing oxidation ponds are to be decommissioned and the site rehabilitated.

The sludge and clay layer would need to be removed to restore the natural drainage before development of the area could be undertaken. Further tests would be required to assess the suitability of the material beneath these ponds for foundations and pavements.

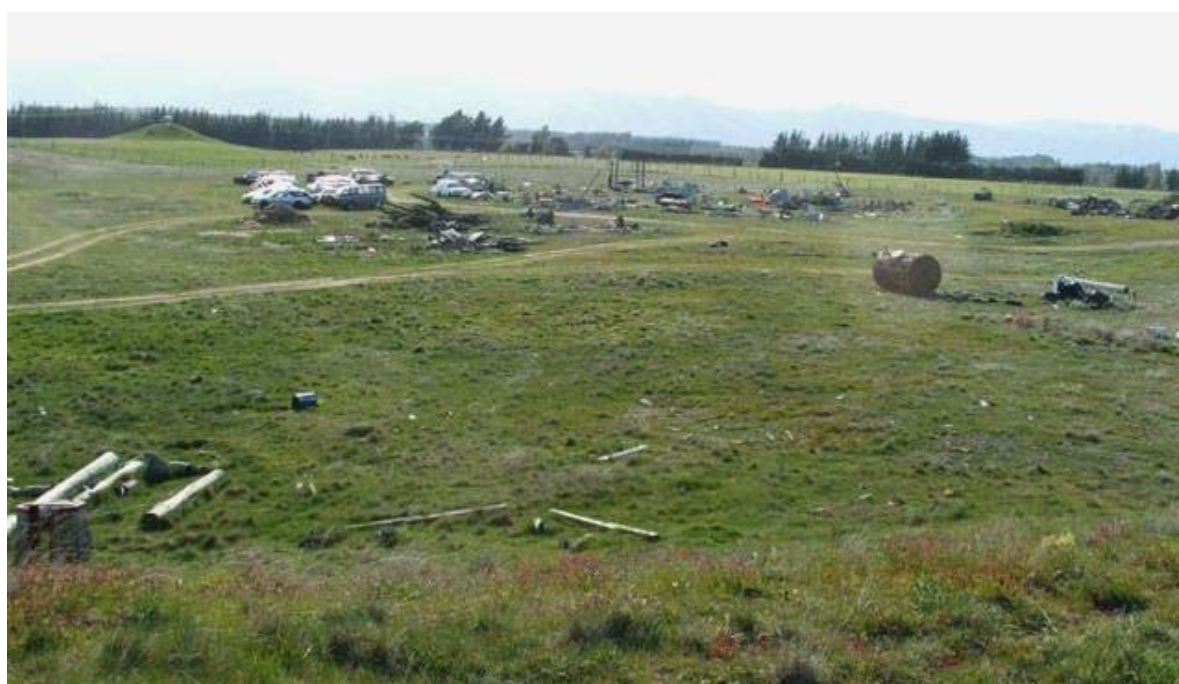
It has been observed that the area east of the oxidation ponds has historically contained a number of car wrecks, large drums/tanks, rubbish and other metal debris. The use of this area for storage of these types of materials continues today as observed during the site walkover inspection (Photo 4).

Photo 4 - Looking east over car wrecks, metal debris and other rubbish to the east of the oxidation ponds (October, 2006).
