**EVIDENCE OF PETER NICOLSON FOR**

Gertrude's Saddlery Limited (494) and Larchmont Developments Limited (527 and  
1281)

## 111 Atley Road, Arthurs Point, Queenstown Geotechnical Assessment for Proposed Plan Change

160771. SITE PLAN. 8/11/16. REVISED 7/5/17  
 111 ATLEY ROAD, ARTHURS POINT, QUEENSTOWN

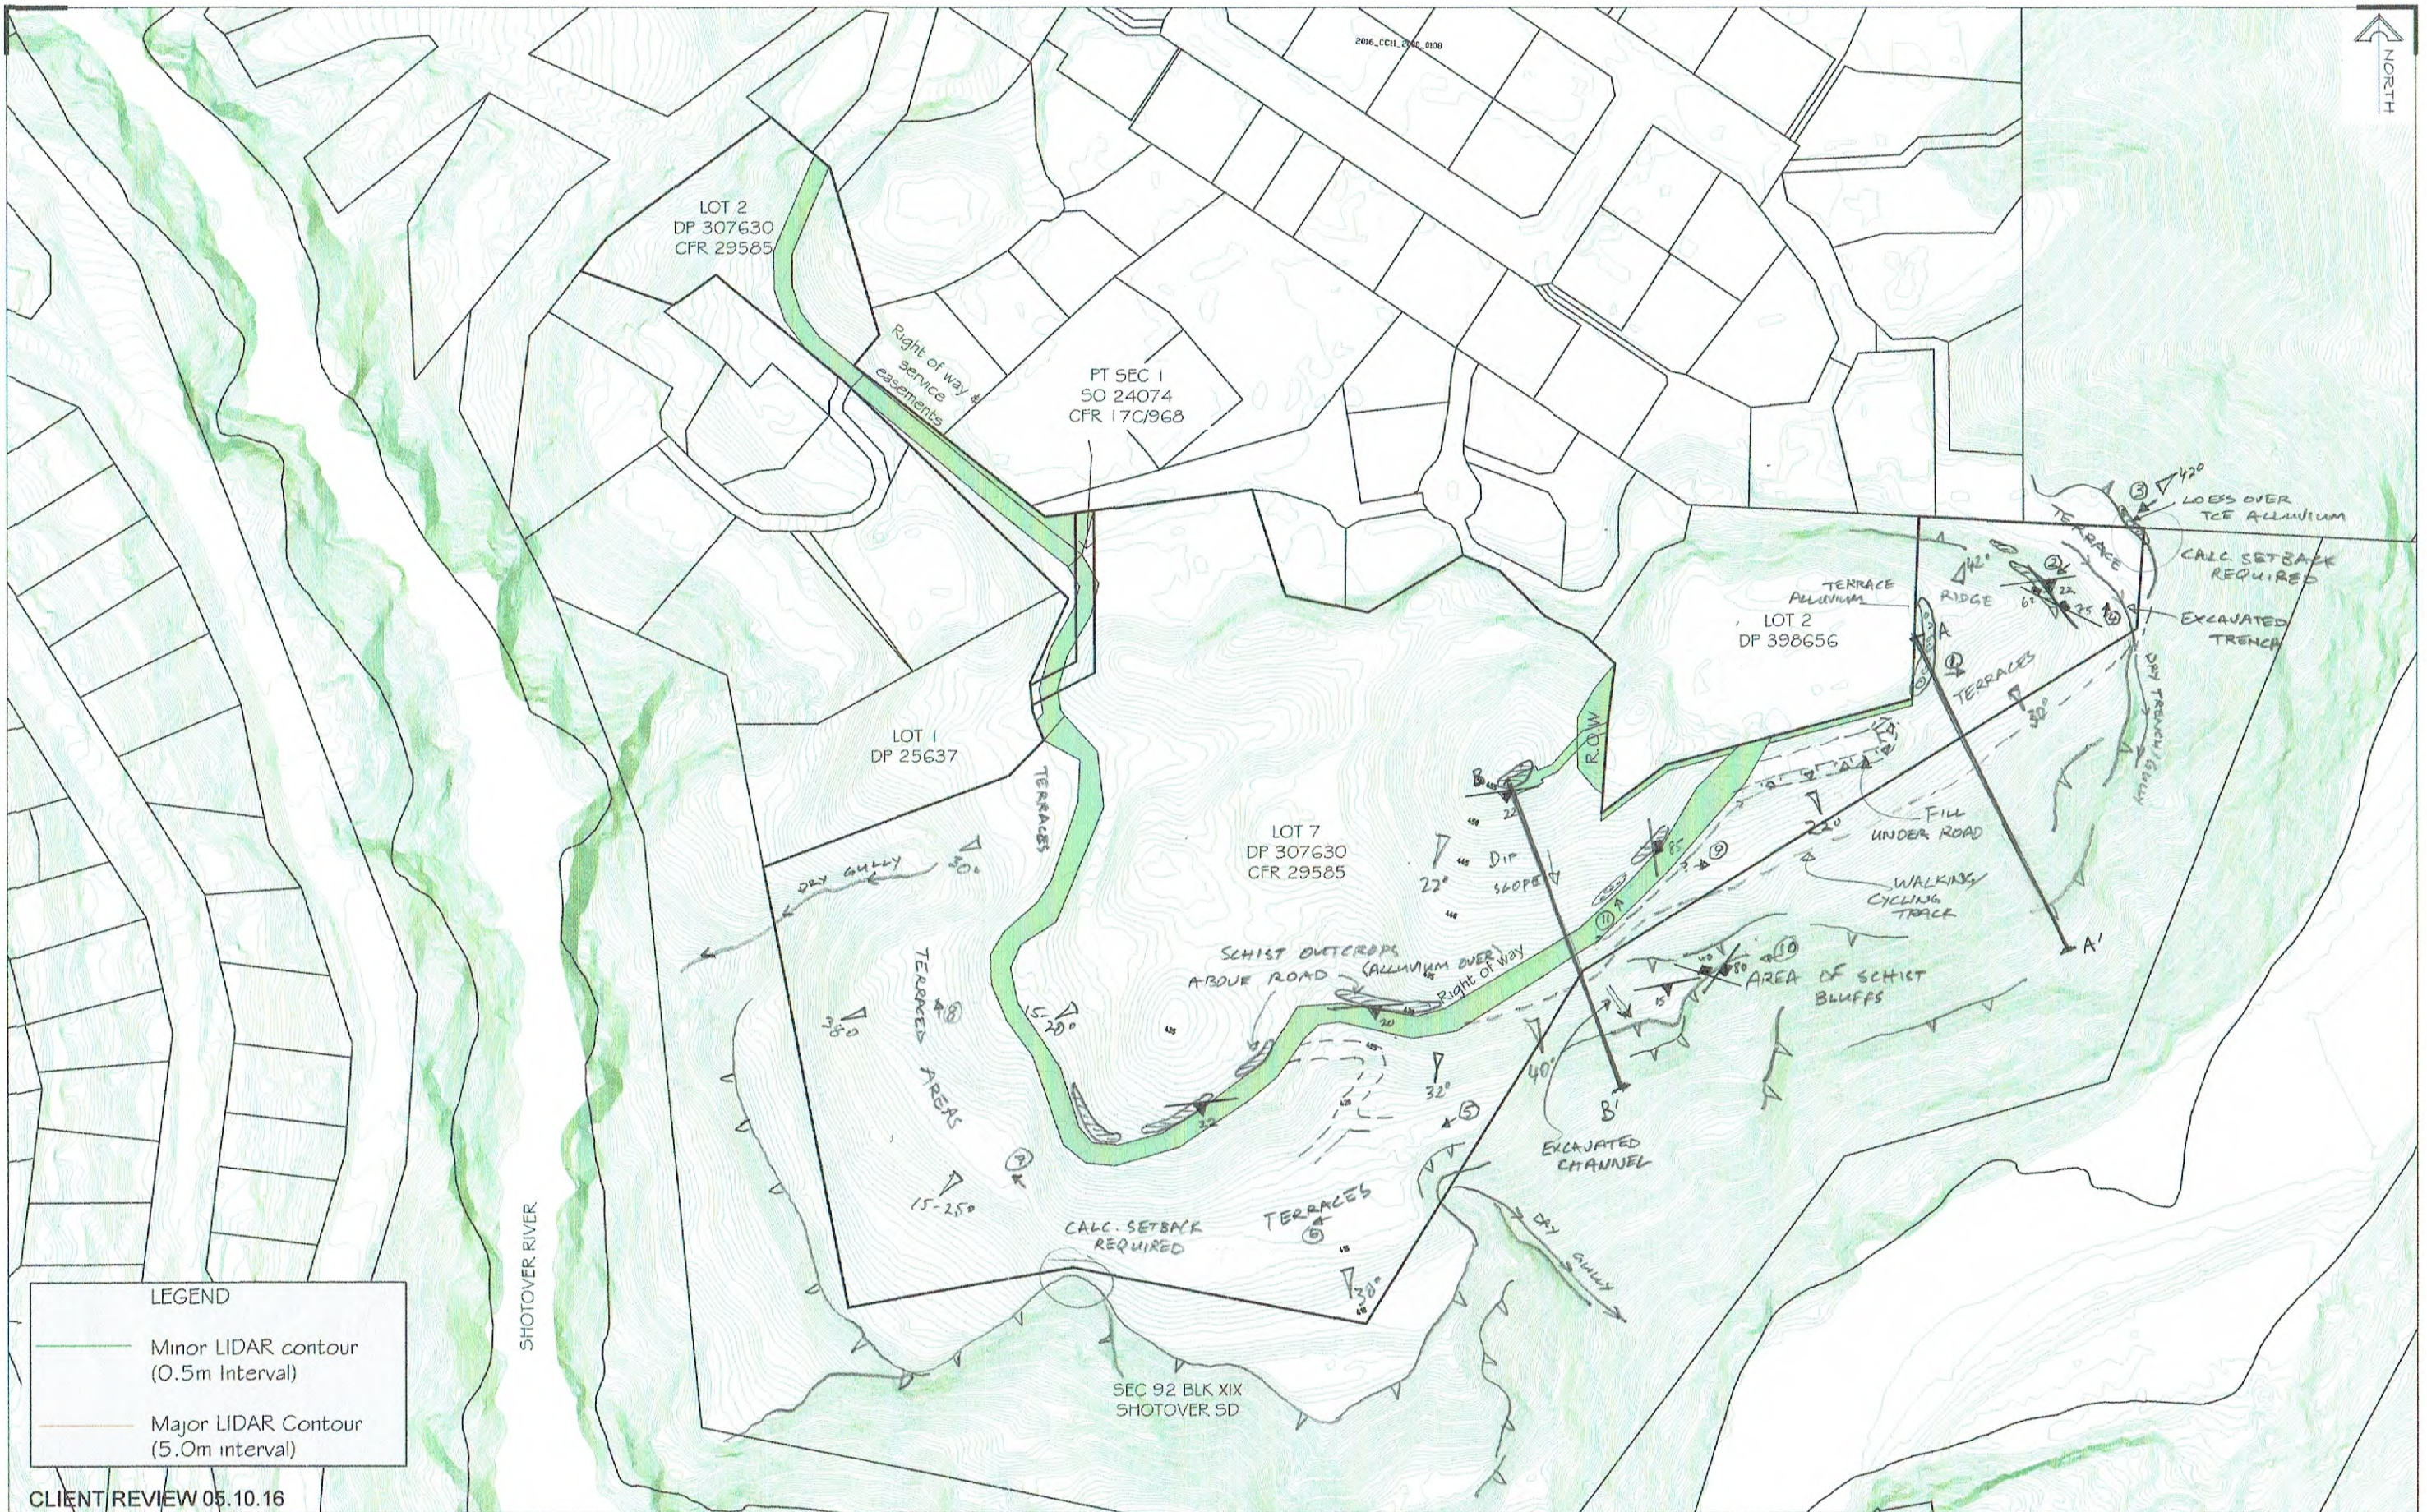
The topography of the proposed enlarged Low Density Residential development area comprises sub-horizontal to gently sloping river terraces, and an elevated schist hillock in the northeast of the site (see detailed LIDAR topography map Figure 1, Appendix A). The Shotover River is approximately 50-60 m in elevation below the main terrace levels. Slope angles vary from sub-horizontal to gently inclined (<5-12°) within the terraced areas, and between 40 and 60°+ within the bluff areas approaching the Shotover River, beyond the southern site boundary. Incipient and weakly incised dry

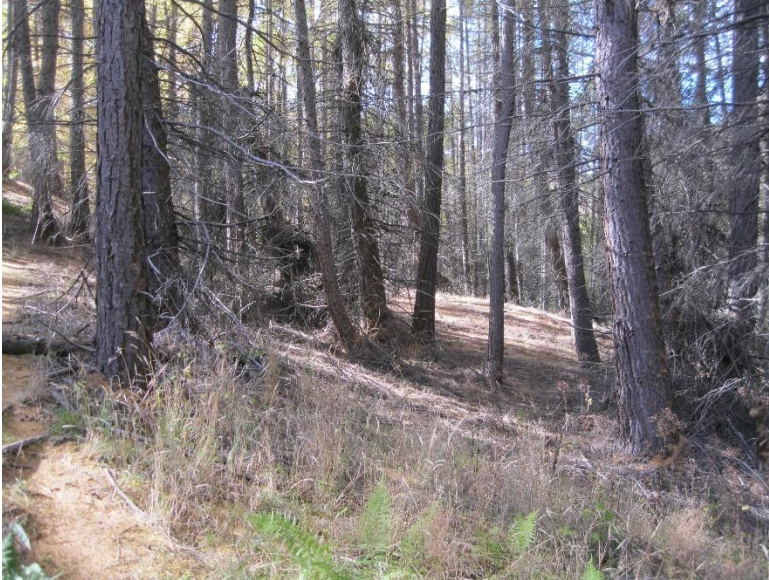
Photo 1: View east, northeast corner of site, buildable terrace, gently sloping.

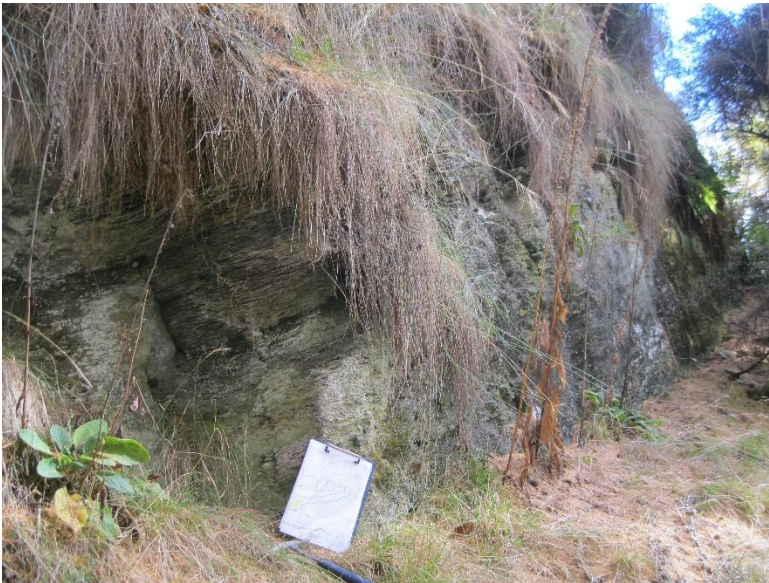
Photo 2: View SW, schist outcrop in northeast corner of site. South dipping foliation, main NW-trending joint set controls face profile.

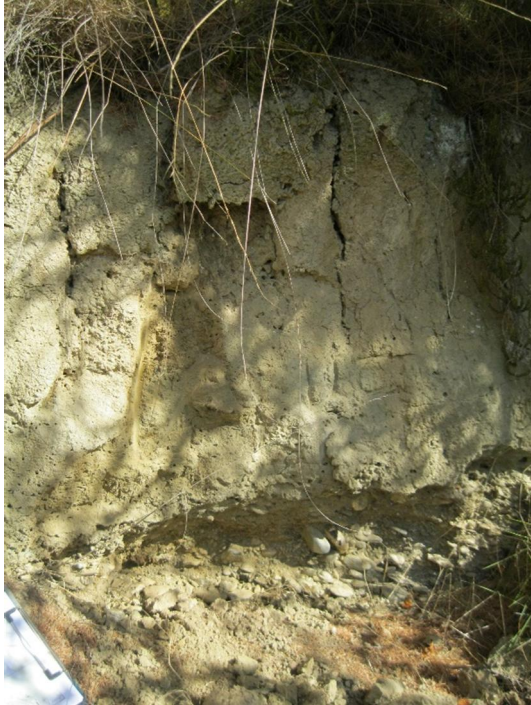
Photo 3: View SW, northeast corner of site. Loess (silt) over terrace alluvium. Loess is ca 0.5m thick.

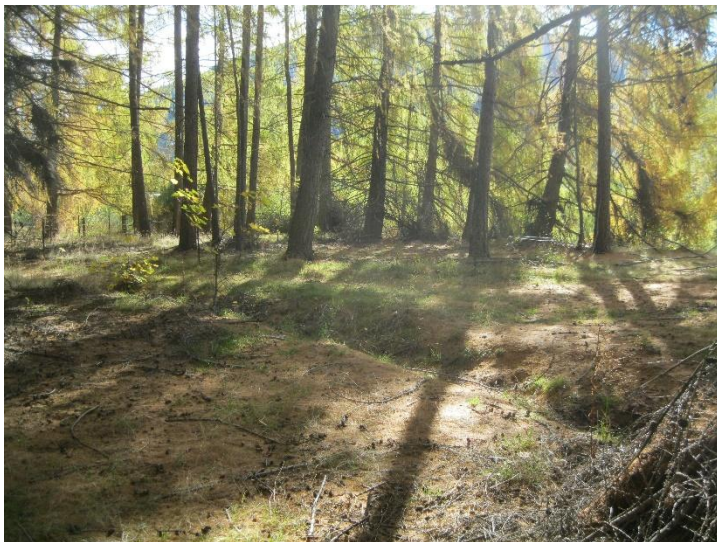
Photo 4: View north, northeast corner of site. Terrace, showing old trench draining to the right.

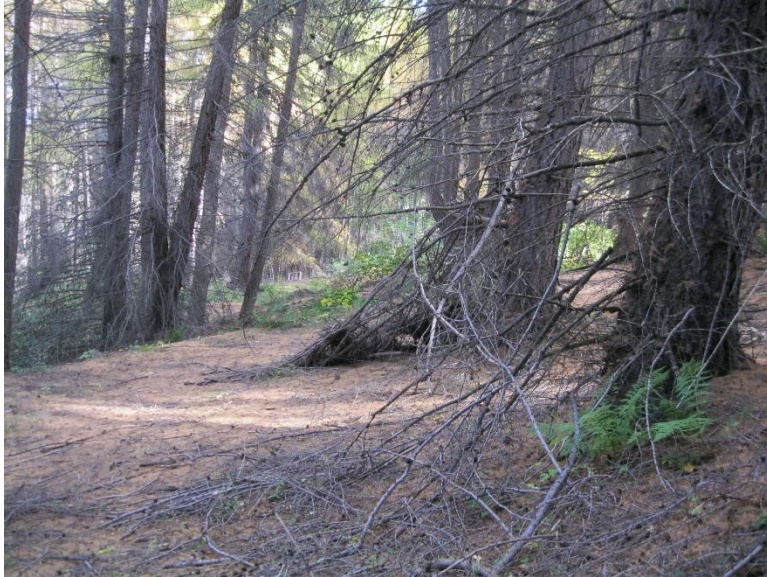
Photo 5: View SW, southern part of site. WSW-trending terrace.

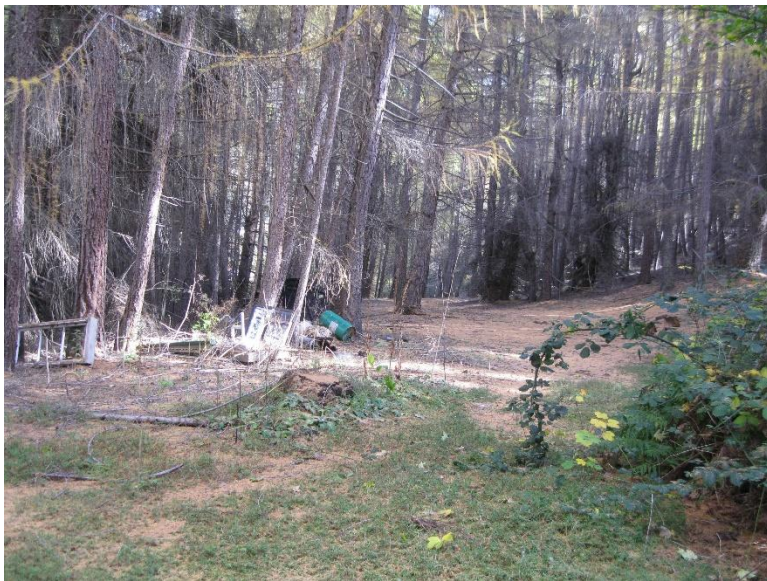
Photo 6: View west, main part of terrace shown in Photo 5.

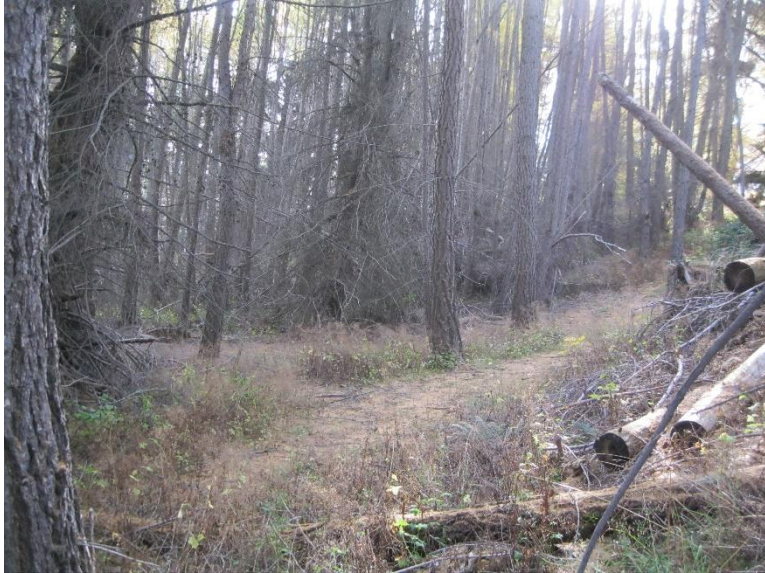
Photo 7: View NW, terrace, partially cleared. Atley Road in centre right (obscured).

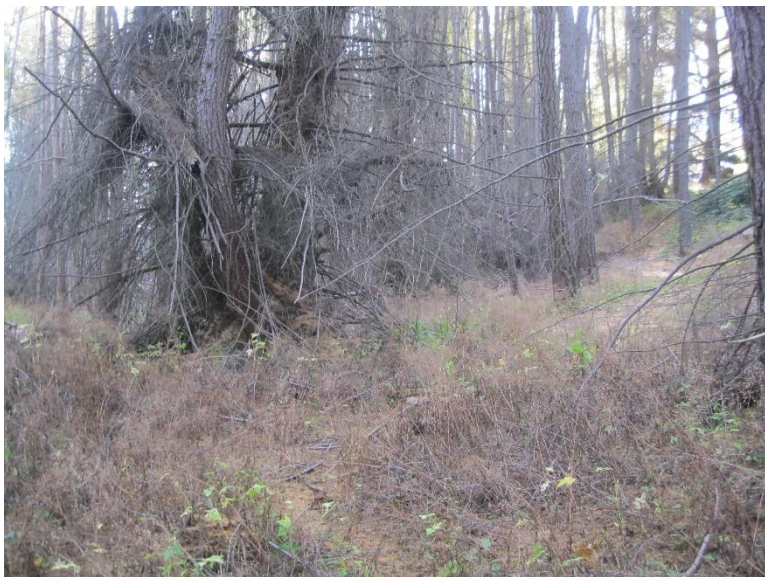
Photo 8: View north, terrace area bordered by gentle slopes. Atley Road in centre right (obscured).

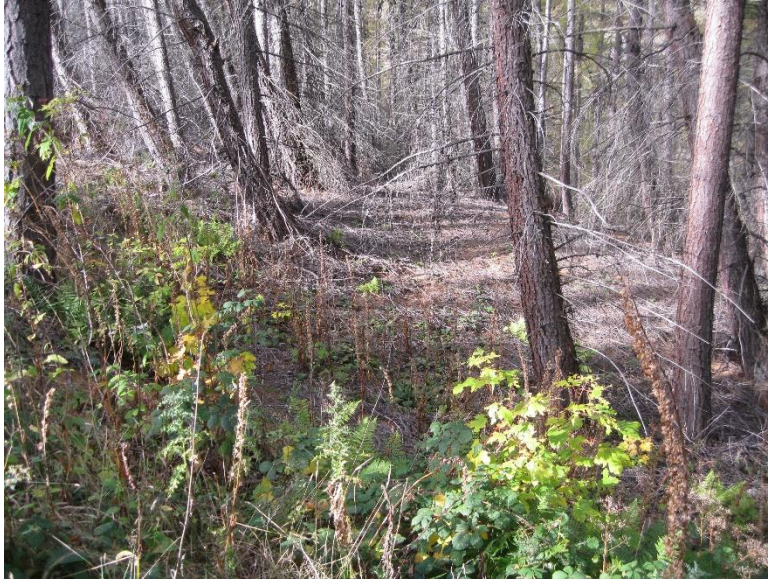
Photo 9: View east, potential buildable, elongate terrace.

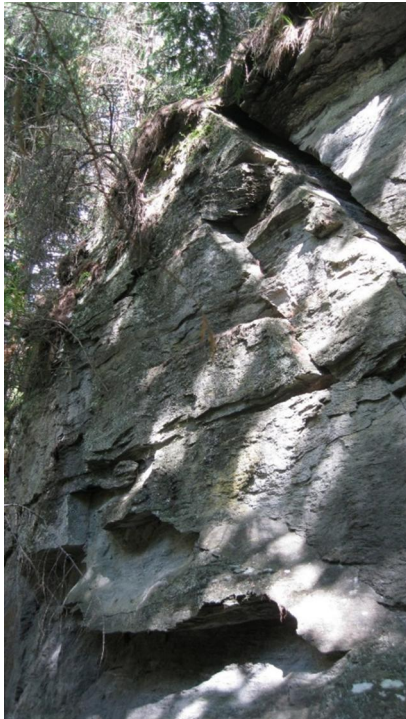
Photo 10: View west, bluffs area, showing joint sets.

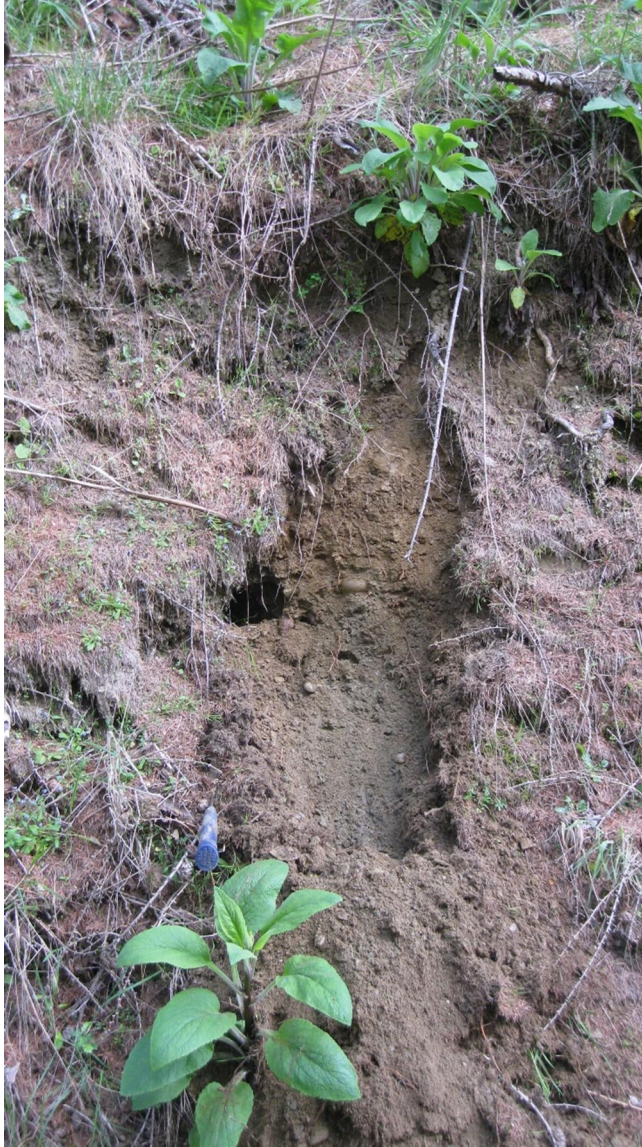
Photo 11: View north, weathered terrace alluvium in bank above road cut. Overlies schist.
