THE HILLS RESORT LIMITED

THE HILLS RESORT ZONE, ARROWTOWN

**ADDENDUM NATURAL HAZARDS ASSESSMENT
HOUSE SITES HS6 TO HS15, SPORTS GARDEN
& ACTIVITY AREA A1**

REF: GL24-113 QT 003 REV 1

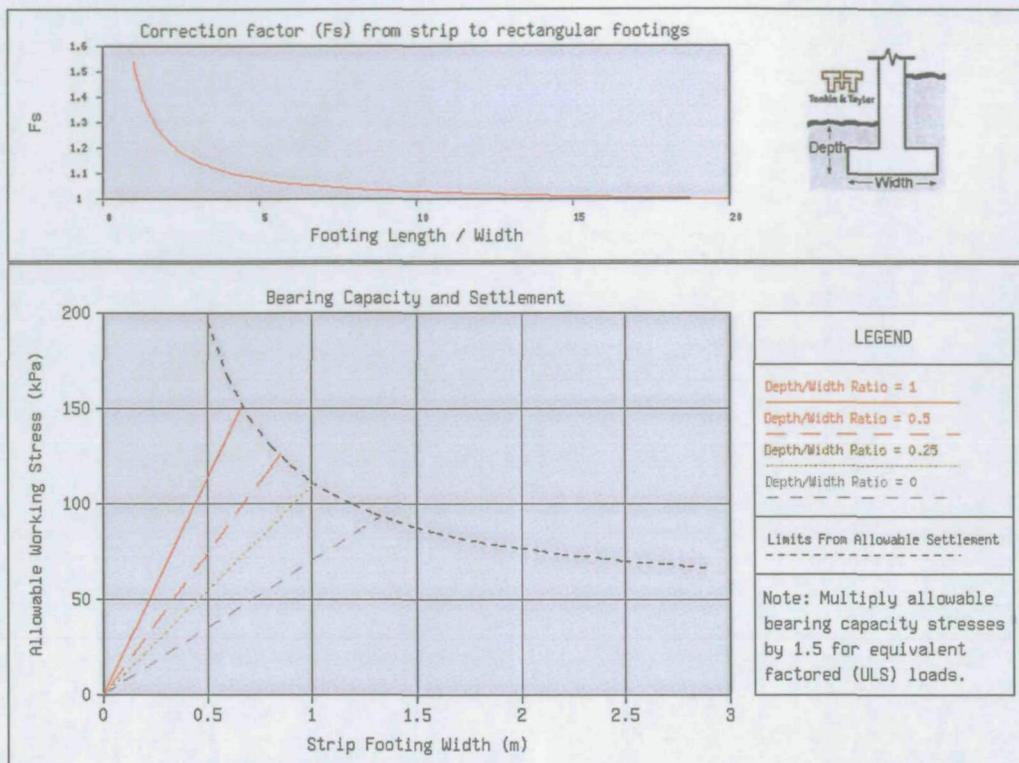
Figure 5.1. Allowable Working Stress for Footings Founded on Medium Dense Glacial Outwash & Glacial Sediments.

From Figure 5.1 it can be seen that a working load bearing stress of 75 kPa is recommended for a 300mm wide by 300mm deep strip footing. This corresponds to a factored (ULS) bearing capacity of approximately 110 kPa and an ultimate bearing capacity of 225 kPa.

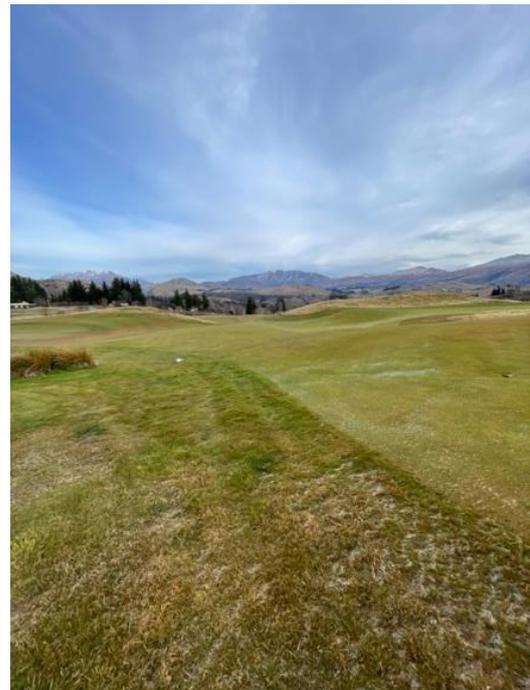
HS9 Looking south west

HS9	Open site of undulating ground with a westerly aspect. Situated within the landscaped Farm golf course	No	No. Race to be considered at design stage.	No definitive surface flow direction, but with a tendency to the west.	Low to Nil risk: Domain A / LIC 1	D	No issues.	UBC 300kPa
HS10	Relatively flat site with slope rising up at 15° to the east and north east. The area to the north east appears to have a small overland flow path and supports long grasses. Drainage noted. Race situated above the site.	No	No. Race to be considered at design stage.	Surface drainage noted to the immediate east of the site. Sheet flow across the site to the south west.	Low to Nil risk: Domain A / LIC 1	B	No issues.	UBC 300kPa
HS11	Open ground situated within a slight depression and undulating ground. No obvious flow paths.	No	No	Seepage to ground.	Low to Nil risk: Domain A / LIC 1	B	No issues.	UBC 300kPa
HS12	Essentially level site within a larger bowl feature. The race is situated to the north east.	No	No. Race to be considered at design stage.	Surface flow to the south west and seepage to ground.	Low to Nil risk: Domain A / LIC 1	B	No issues.	UBC 300kPa

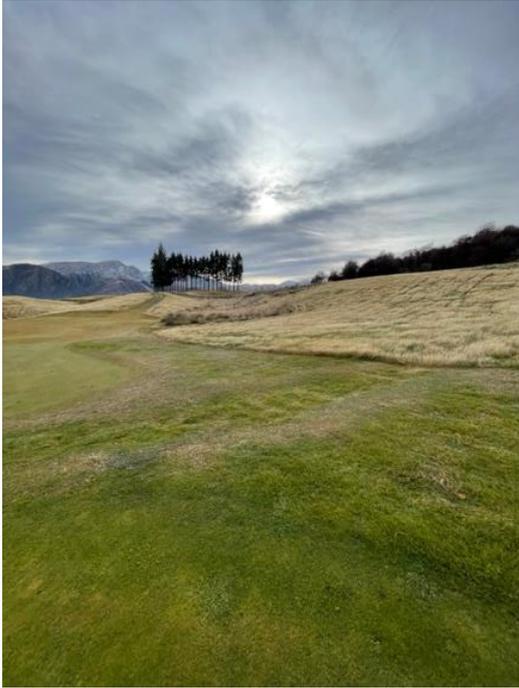
HS10 Looking north

Surface overland flow paths and or ephemeral flow will need to be assessed on a site by site basis with mitigation design being influenced by on the design of the dwelling being proposed. House sites HS10, HS11, HS14 and HS15 are the sites most likely to require drainage measures to ensure the building platform and foundations are suitably protected.

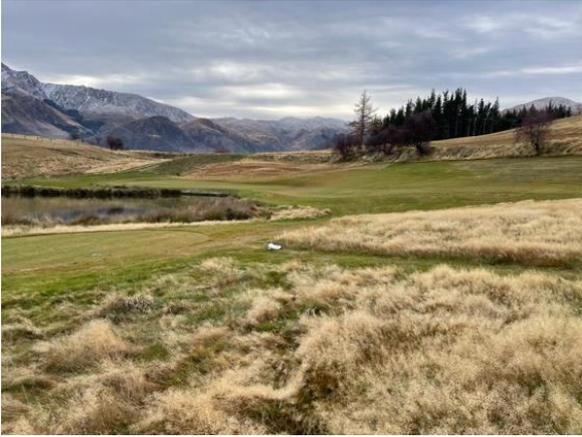
HS14 Looking north east

Sites	Description	Alluvial Fan	Flooding	Surface Drainage	Liquefaction	Soil Class	Slope Stability	Bearing Capacity
HS14	Adjacent to a surface water feature/small lake. North facing aspect. Surface water course to the 50m west of site.	No	No but close to surface water	Surface flow reporting to the lake and water course to the north and west respectively.	Low to Nil risk: Domain A / LIC 1	B/D	No issues.	UBC 300kPa
HS15	Site currently occupied by existing farm shed and yards. The ground to the north and north east of the site slope down towards the site area, with two overland flow paths within the gully systems.	No	No.	Sheet flow to the south, reporting to Hogans Gully Road.	Low to Nil risk: Domain A / LIC 1	D	No issues.	UBC 300kPa
SG	The site occupies level ground adjacent to McDonnell Road.	No	No	Seepage to ground	Low to Nil risk: Domain A / LIC 1	B	No Issues	UBC 300kPa
A1 & A1b	Modified ground with a general slope to the north (current golf course area).	No	No	Surface flow to the north	Low to Nil risk: Domain A / LIC 1	D	No Issues	UBC 200kPa to 300kPa

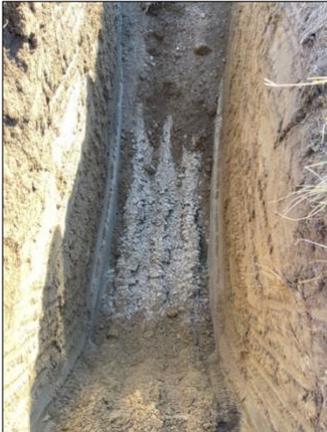
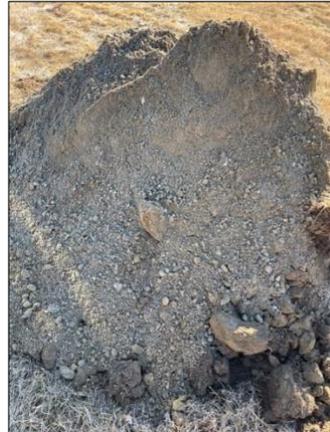
TPSG01

Test Pit	Depth (m)	Description
TP SG01	0 -0.3m	Topsoil. Brown sandy SILT with roots and rootlets
	0.3 – 0.6m	Loess. Sandy SILT, light greenish brown, tightly packed, dry. Sand fine grained.
	0.6 – 1.3m	Glacial Outwash. Sandy GRAVEL with some silt, light orange brown, loosely to tightly packed, dry. Sand fine to coarse grained. Gravels fine to medium coarse subangular to subrounded.
	1.3 to 1.5m	Glacial Outwash. Sand with some gravel, grey, loosely to tightly packed, dry. Sand fine to medium coarse. Gravels fine to medium coarse subangular to subrounded.

Based on the ground conditions encountered, there are no natural hazard or geotechnical constraints associated with this soil profile. The loess soils would typically provide an ultimate bearing capacity of 200-300kPa, which will increase to 300kPa for the sandy gravels of the glacial outwash at depth.

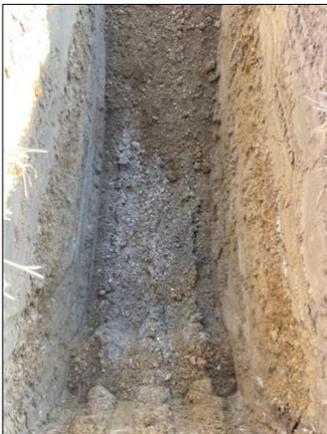
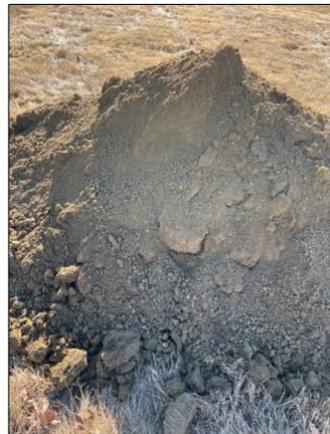
TPSG02

Test Pit	Depth (m)	Description
TP SG02	0 -0.2m	Topsoil. Brown sandy SILT with roots and rootlets
	0.2 – 0.7m	Loess. Sandy SILT, light greenish brown, tightly packed, dry. Sand fine grained.
	0.7 – 1.4m	Glacial Outwash. Sandy GRAVEL with some silt, light orange brown, loosely to tightly packed, dry. Sand fine to coarse grained. Gravels fine to medium coarse subangular to subrounded.
	1.4 to 1.6m	Glacial Outwash. Sand with some gravel, grey, loosely to tightly packed, dry. Sand fine to medium coarse. Gravels fine to medium coarse subangular to subrounded.
