Notes to speak to QLDC DP Hearing 11:10am 29 June 2016

In summary we disagree with the scheduling of Tree 1002 - the Western Red Cedar on the boundary of 5 Berkshire Street and 22 Wiltshire Street for the following reasons:

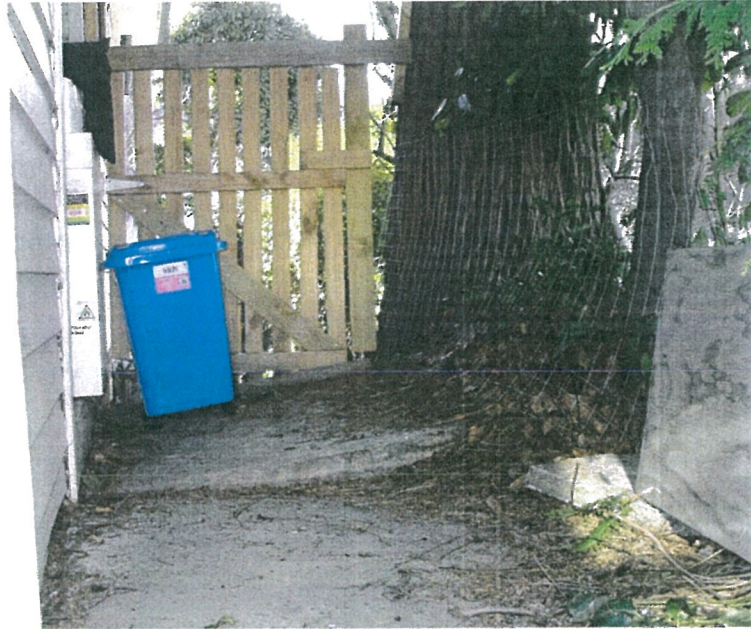
- The tree roots are visibly damaging the footpath, embankment and foundations of the Gents adjoining property. Refer Photo 1 below.

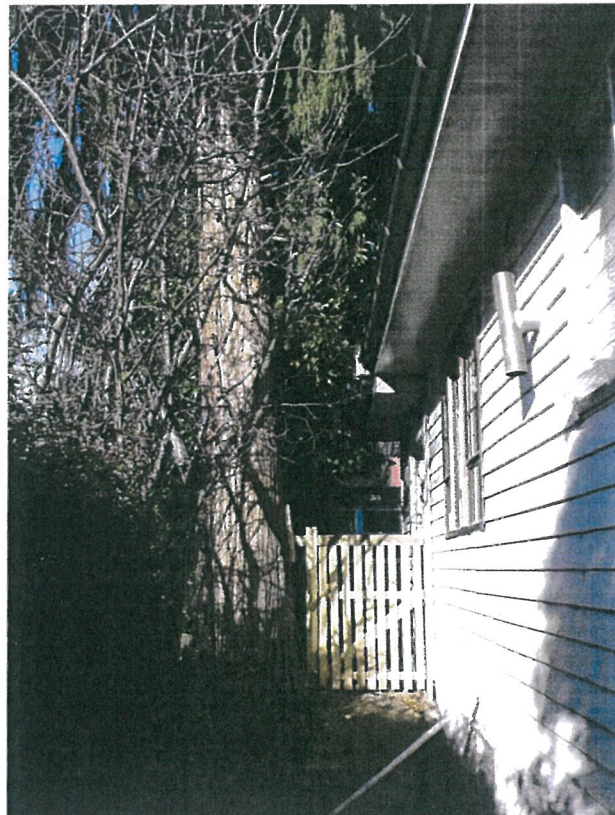
- The close proximity (1m max.) to the neighbouring house means this damage will only increase as the tree grows larger. The girth is listed at 2600mm on the QLDC STEM Report (Appendix 4) and these trees grow in excess of 3000mm in diameter which translates to 9425mm girth. This means the trunk will hit the house in years to come. The branches are already in contact with the house and fill the spouting with leaves. Please refer Photo 2 below.

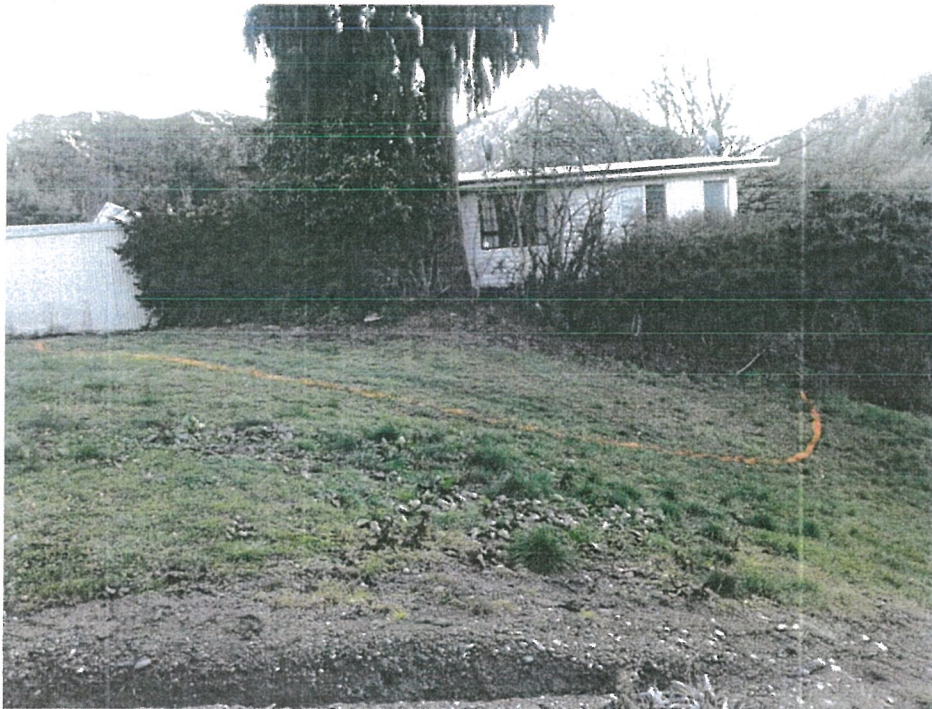
Photo 3

- The tree is seriously impacting the building platform of my section at 22 Wiltshire Street and the 8 metre root protection zone (calculated at half the current height of the columnar tree – refer clarification details in Appendix 5) extends to over half the width of my property. This root protection zone will only increase as the tree grows bigger. Current building standards require a dwelling to be at least 3 metres from any boundary. Given that our section has an approximate 15 metre width that would give us 4 metres (from the root protection zone to the boundary) in the middle of our section on which to build. My partner and I drew an 8 metre half circle with bright orange dazzle from the base of the tree to highlight this fact. Please refer to Photos 3 and 4 below.

(Boundary of neighbours property shown as trench in foreground)

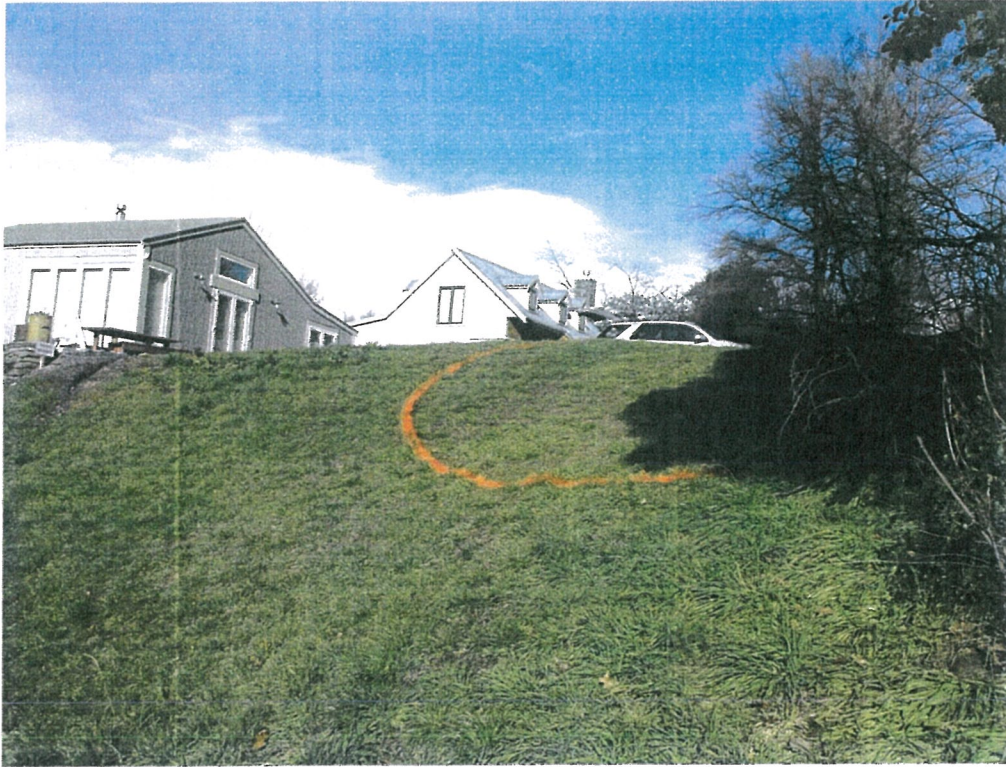
Photo 4

- The fact that the building platform will be significantly decreased will deter potential investors/buyers and greatly devalue our section.
- Because of its size the tree causes significant afternoon shading to both of the neighbouring properties shown in the photo (taken late morning) above and would have an even greater impact on any structure erected on my property.

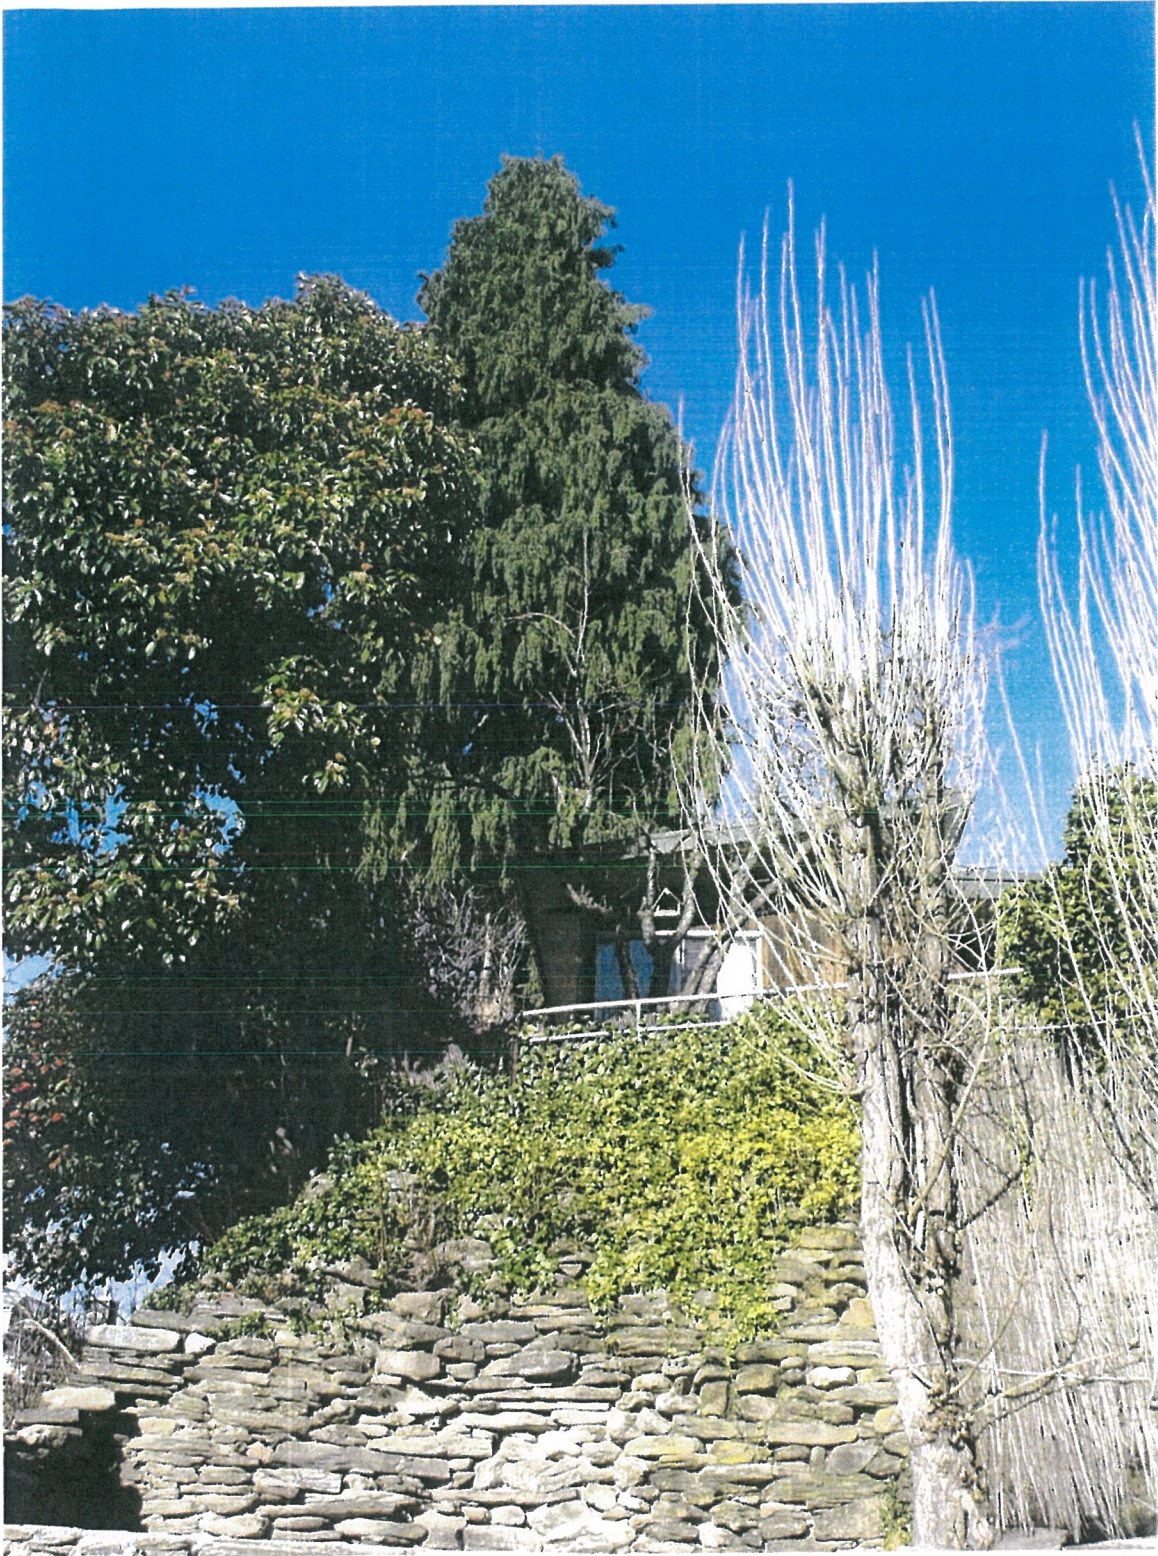
The photo above shows the proximity of the 100yr old wall (in foreground) from the tree (in background)

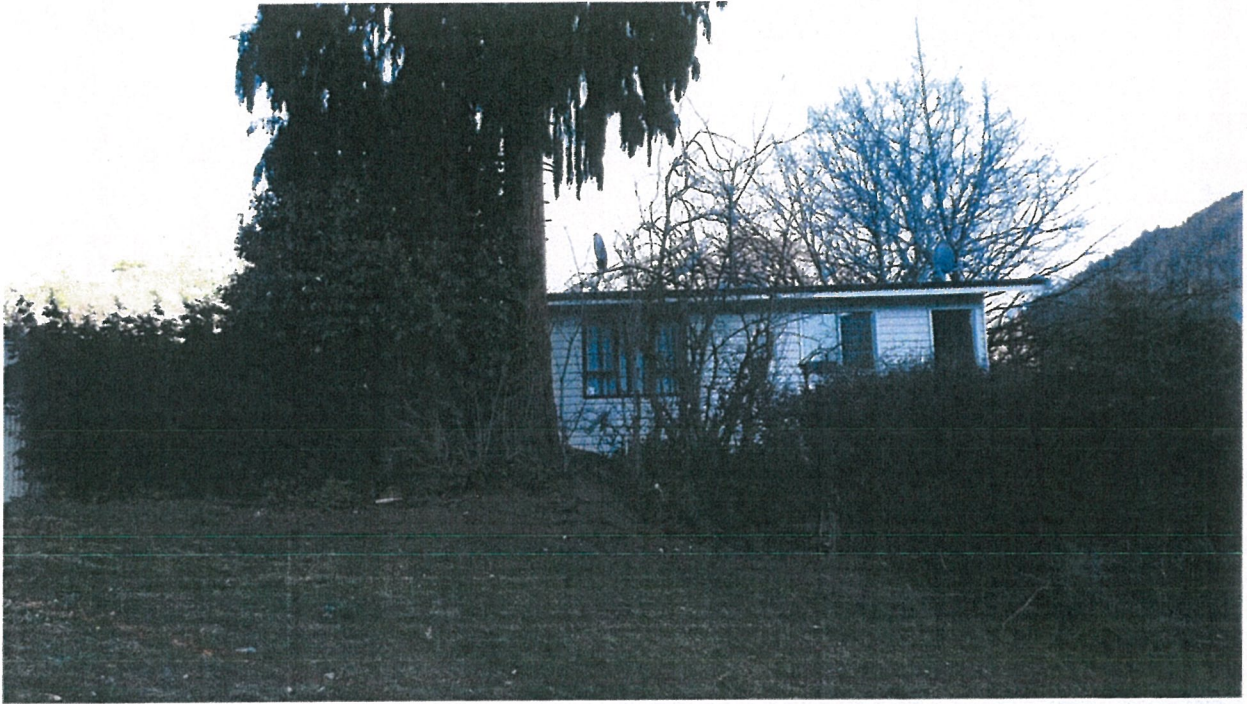
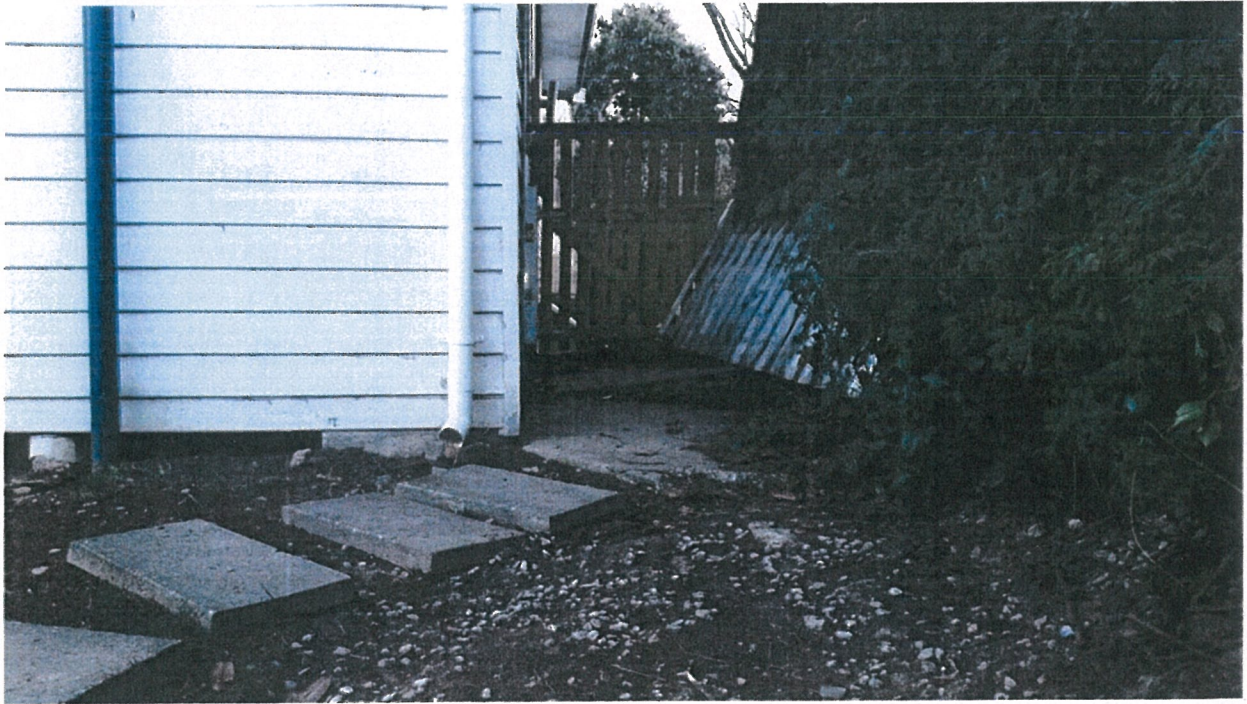
4. There is a concrete footpath adjacent the tree which has been raised and tilted over 150mm as a result of the tree growth. This damage creates a trip hazard on the access route from the backyard and sleepout to the house.

5. There is also damage to the house foundations adjacent the tree. The masonry foundation has cracked opposite the tree and is approximately 2mm wide measured along the masonry. There is also approximately 3mm movement across measured into the masonry. We believe this movement is due to the tree and it's associated root system creating additional pressure onto the side of the masonry foundations. Additional movement across is apparent in the masonry adjacent the crack though this was not feasible to measure without specialist equipment.

6. The remainder of the foundations along the east elevation appear in sound condition.
7. The tree and surrounding uplift on the ground has resulted in a reduced step down from internal floor level to external ground level and fall towards the house, both of these will eventually create long term durability issues.

Currently there is significant damage to the footpath and minor damage to the house foundations which we believe are a direct result of the adjacent Western Red Cedar. We also note due to the current size and the significant expected size the tree could grow to, the damage to the house at 5 Berkshire St will worsen and is expected to become significant both in terms of structure and durability in the long term.
