Gibbston Valley Station Ltd  
C/- Construction Management Services  
96 Atley Road  
RD 1  
Queenstown

**Proposed Gibbston Valley Station Development  
Gibbston Highway/SH6, Gibbston, Otago  
Additional Geotechnical Assessment and Recommendations**

## **Appendix A: Figures**

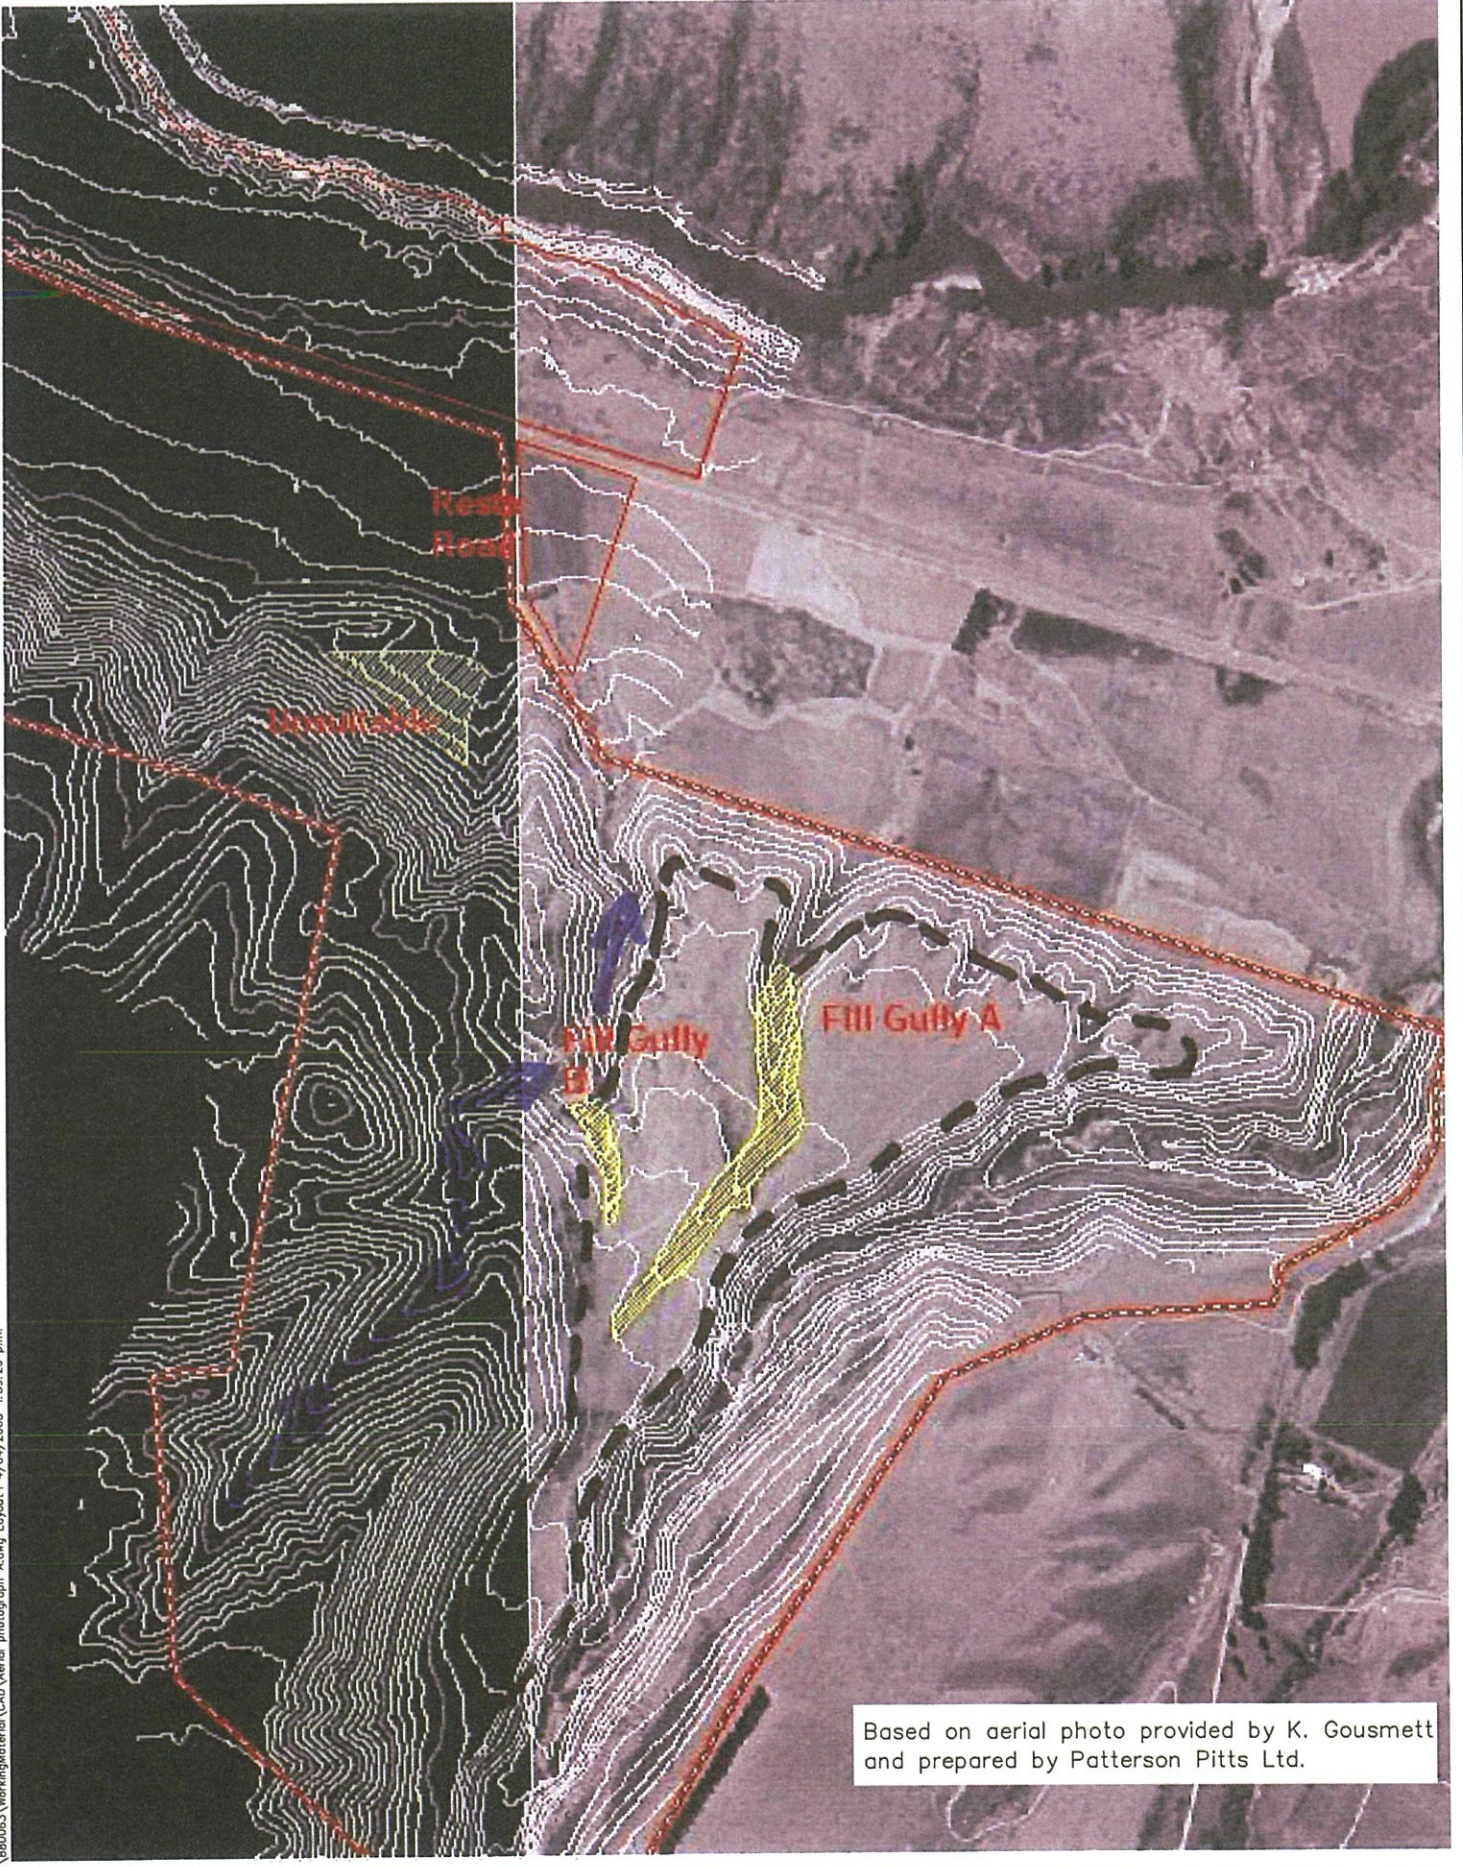
FIG. No.	Aerial photograph A	REV.	0
----------	---------------------	------	---

Aerial Photograph 1, Appendix A, shows the approximate extent of the engineered fill which is to be placed in "Fill Gully A" and "Fill Gully B". These gullies are located on the terrace slopes that lie above the proposed area of building development. Resta Road traverses Fill Gully B at a lower level than the proposed fill area as it climbs to the elevation of the terrace surface from the Gibbston Valley. T&T understands the purpose of filling the gullies is to

**GIBBSTON VALLY STATION Ltd**  
**GIBBSTON VALLY STATION DEVELOPMENT**  
**GIBBSTON VALLY**  
 Proposed Fill Areas

No water flows were observed in either fill gully at the time of the T&T walkover inspection. Site observations indicate the water flows within the subject gullies are not regular and may only occur during periods of high intensity rainfall or during the 'wet' season. A tributary gully joins Fill Gully B down slope from the proposed area of fill. This tributary gully, which is shown as a series of blue arrows on attached Aerial Photograph A, drains a much larger area of land than the short piece of Fill Gully B which is to be infilled.

- The fill in Fill Gully B should not extend down slope of the point where the tributary gully joins Fill Gully B without appropriate design of a storm water collection and distribution system; and;

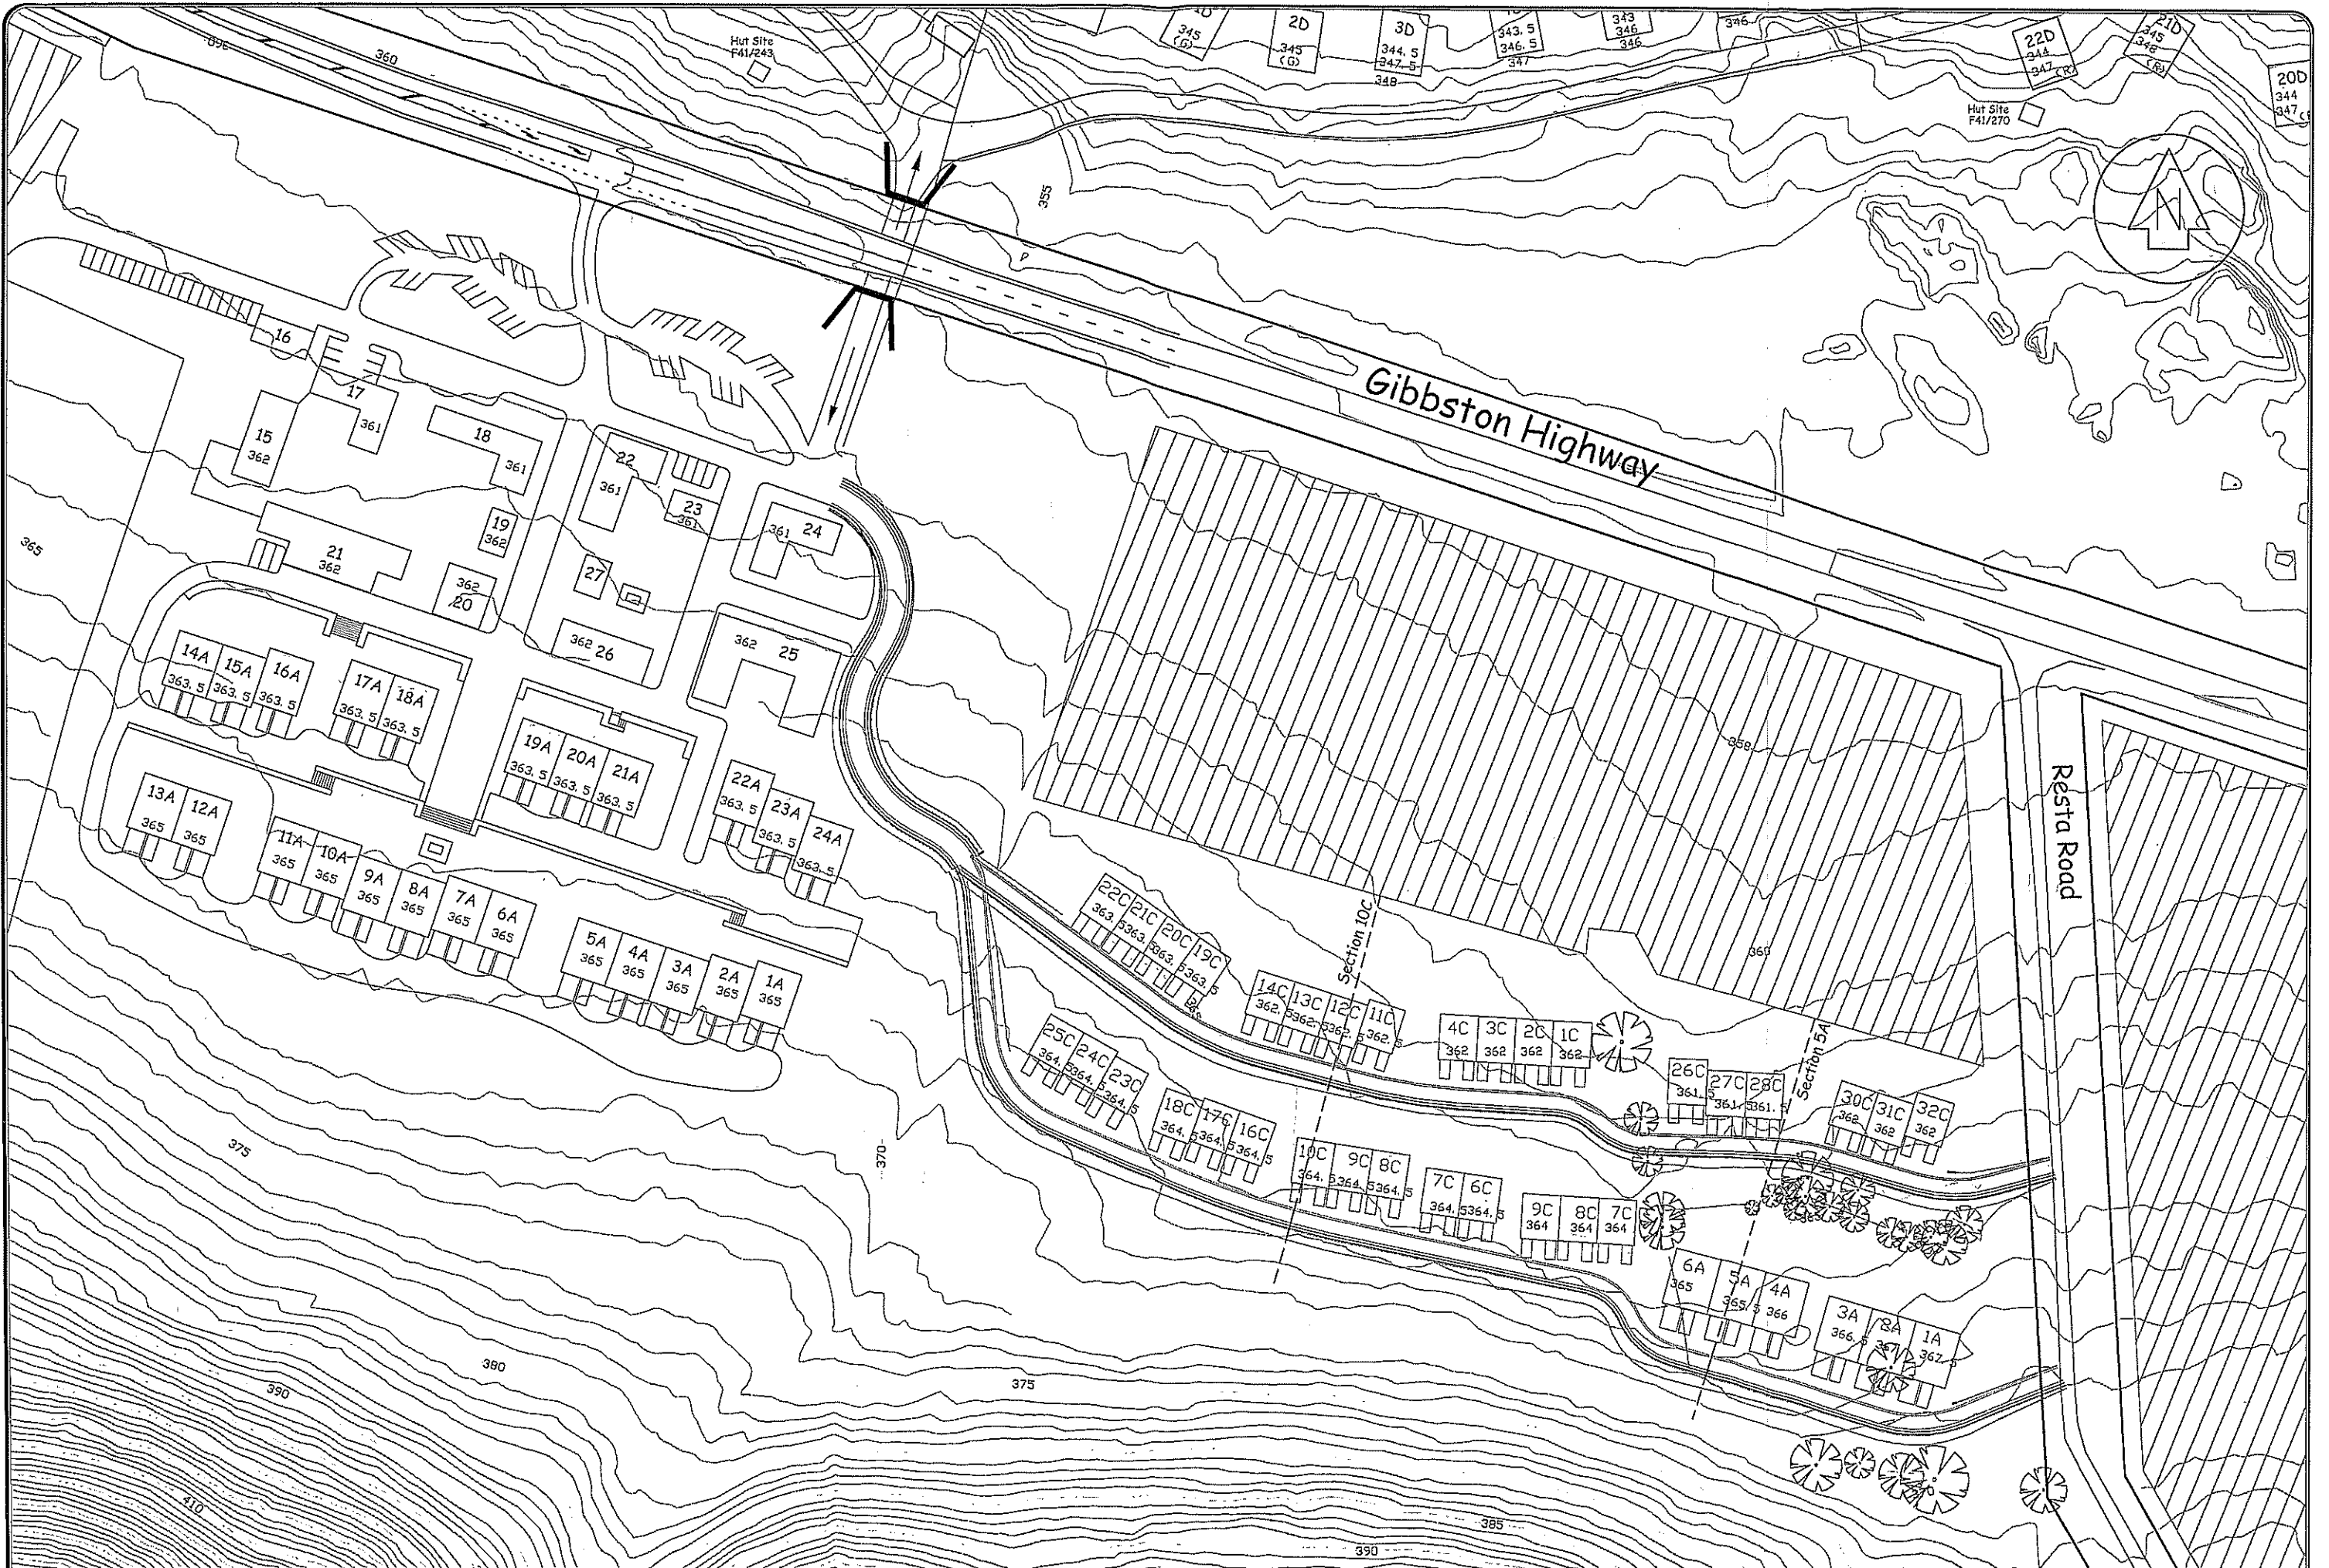
T&T have been provided with updated plans which indicate the location of the proposed residential units immediately west of Resta Road has been moved north to minimise the cuts which are required to form the proposed access roads. A copy of these amended plans, which are entitled 'Gibbston Valley Station, Central Development Area – Village Area" (by Patterson Pitts Ltd, 7 March 2008), is provided in Appendix A.

Topographic contours of the northern slope of Rabbit Ridge are shown on the attached PPL plans (refer to Appendix A), however, the glacial gravel outwash terrace face is located south of the area that is covered by this plan.
