# Preliminary Stormwater Soakage Testing

Ladies Mile Masterplan Area,  
Queenstown

GeoSolve Limited

GeoSolve Ref: 200353.01

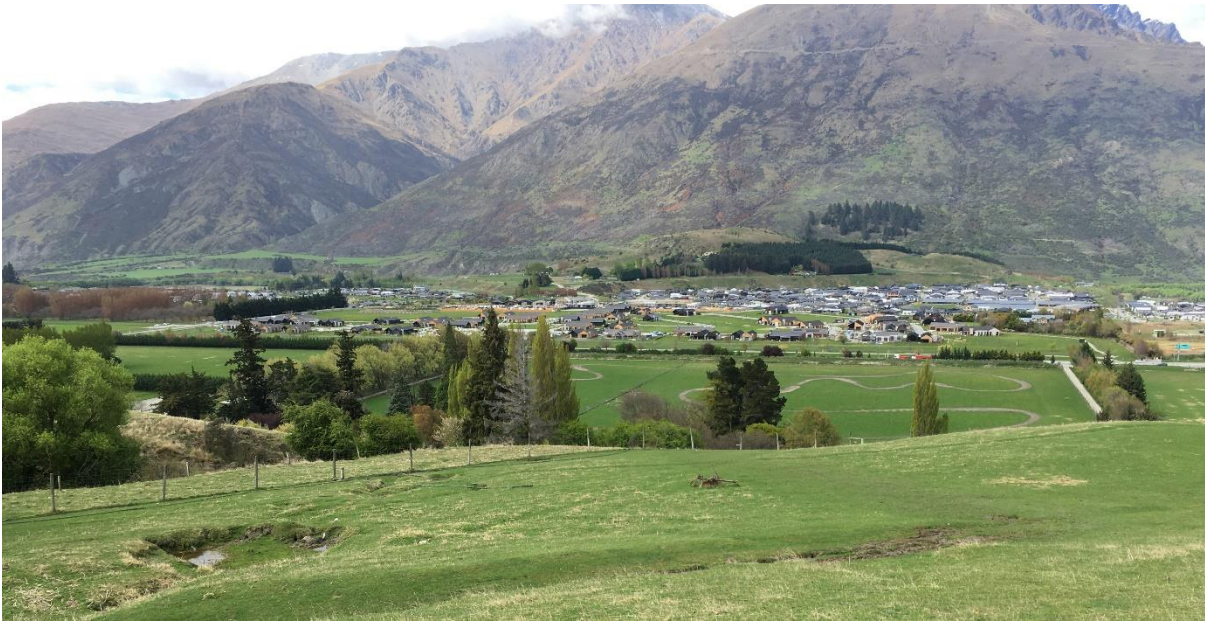
**Photograph 1a – Site photo taken on the hills east of the site, looking south across the masterplan area.**

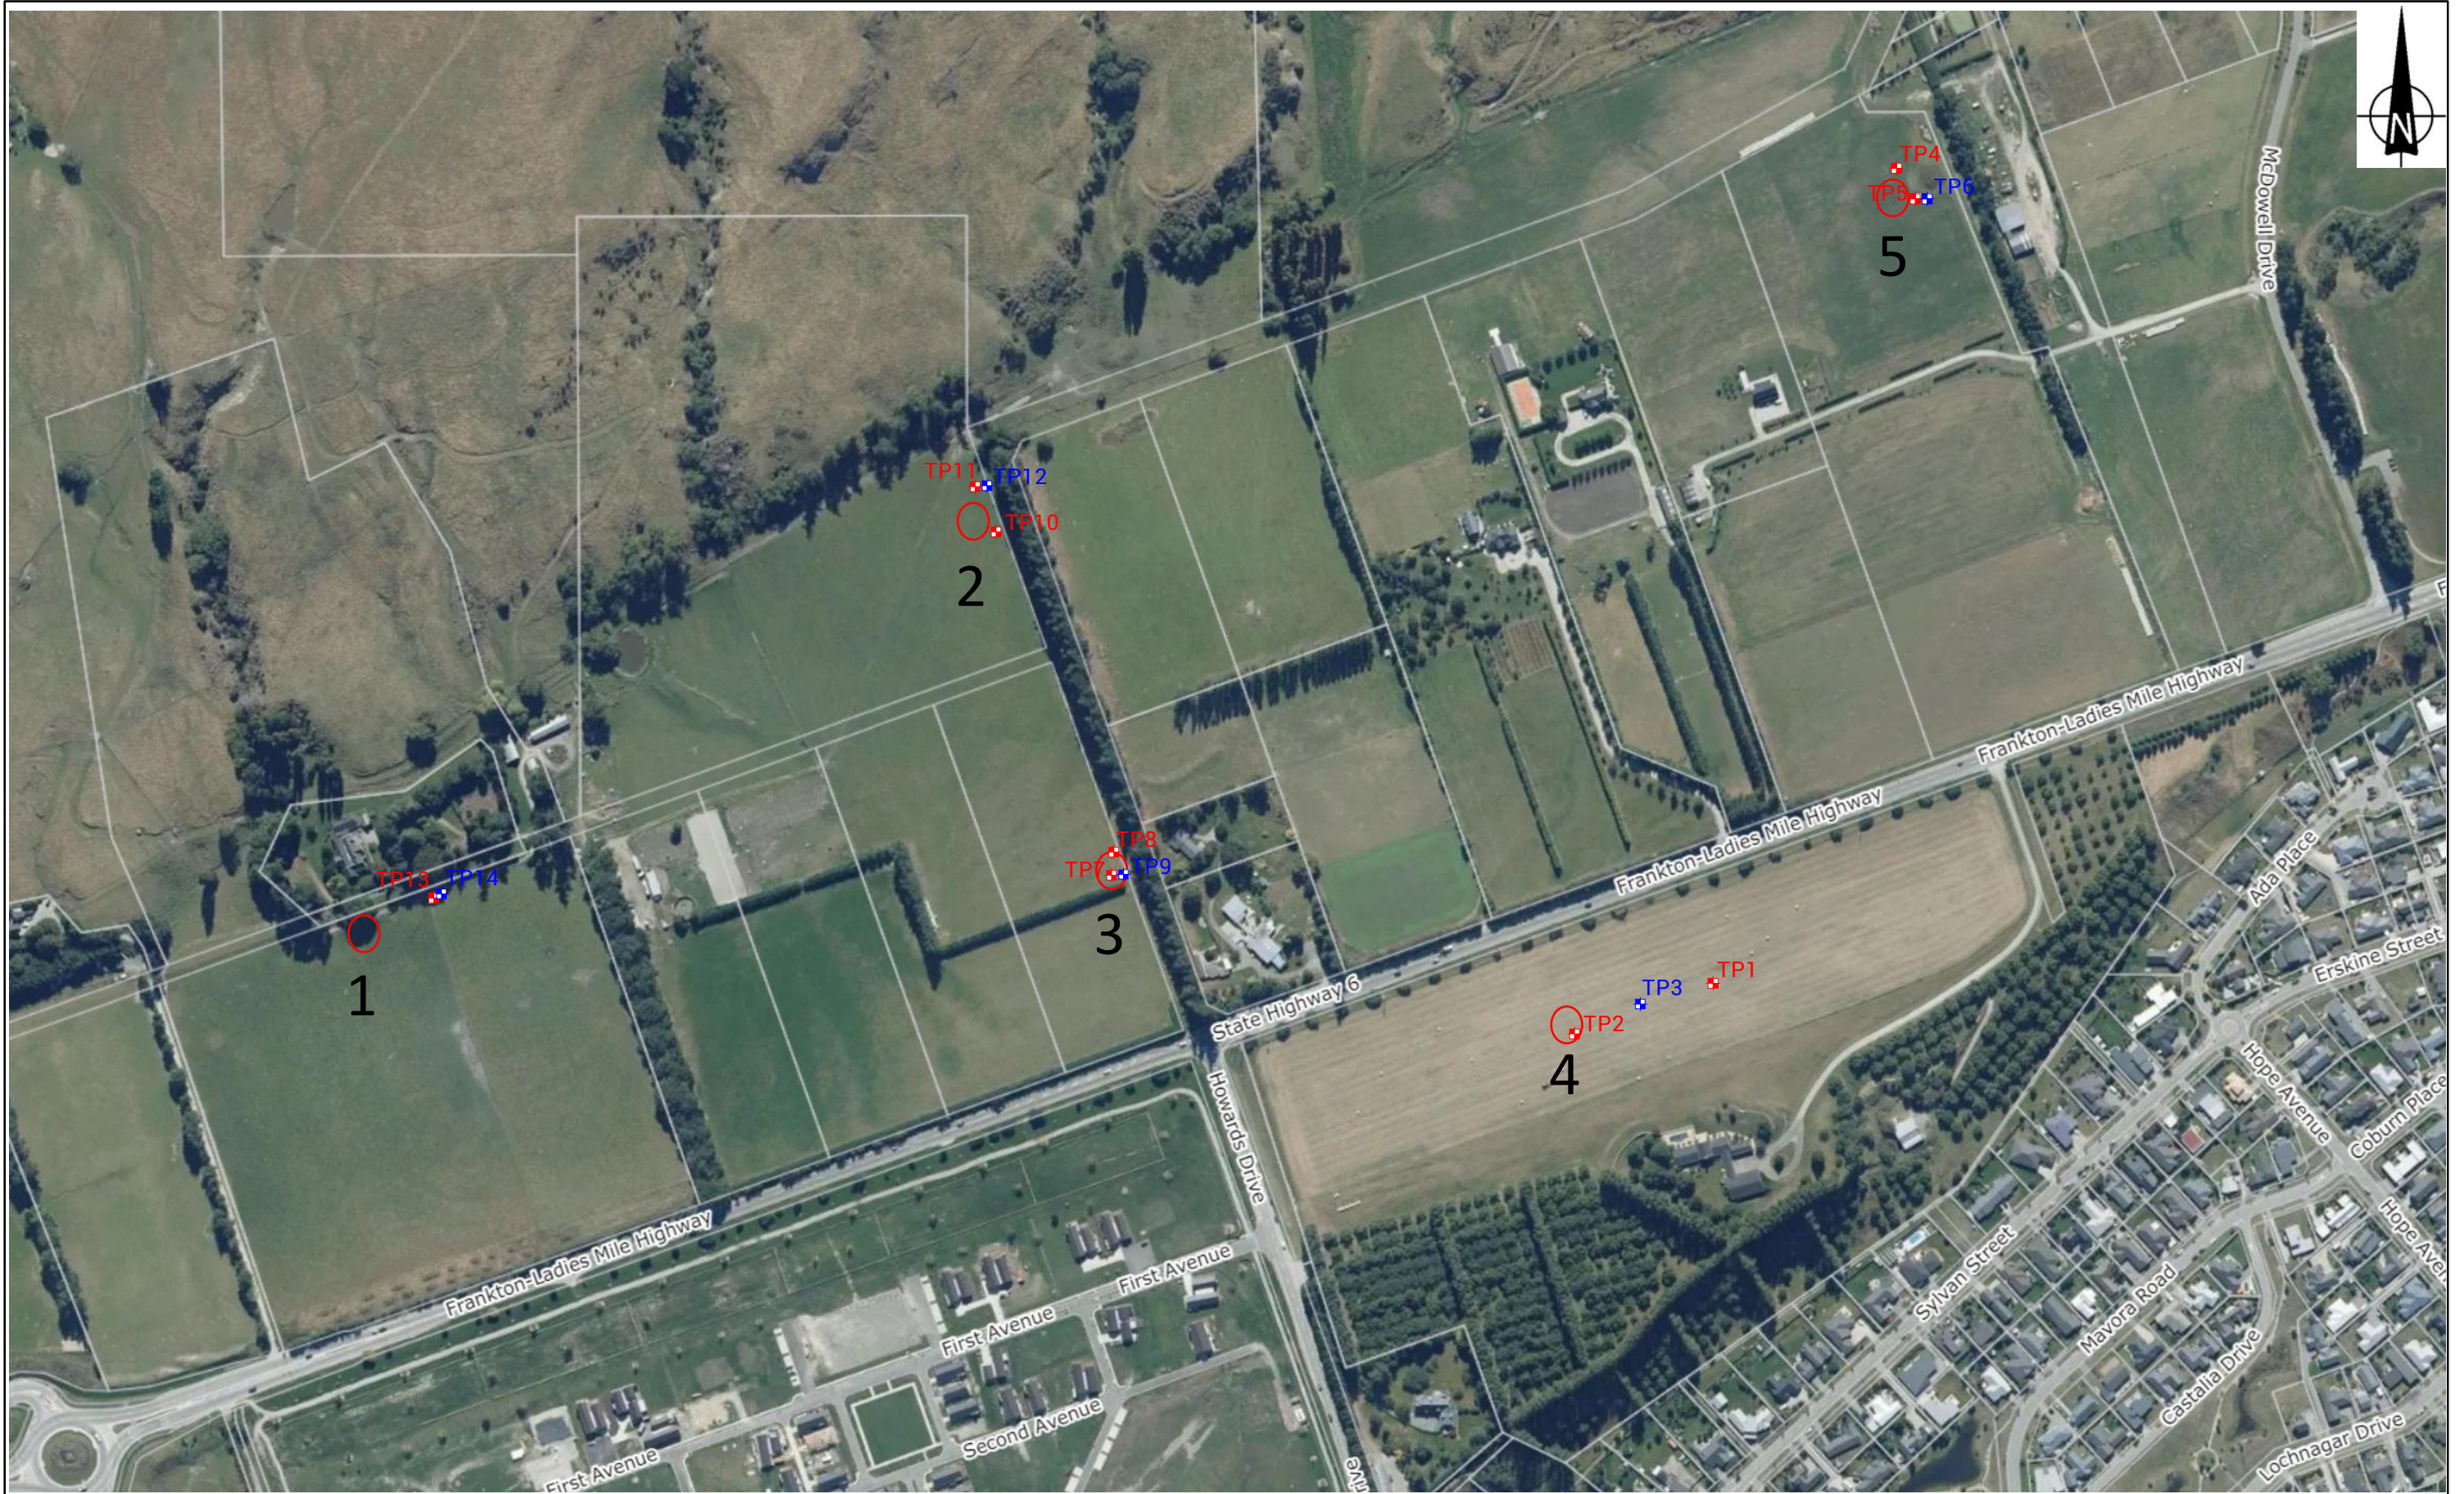
FIG No: FIGURE 1

# **Appendix A: Site Investigation Plan**

TP1 = Test Pit
-

TP3 = Test Pit / Soak Pit
-

= Approximate Location for Soakage Test Pits (provided by Candor3)

Test pit and soakage pit locations were positioned to obtain a representative spread across the proposed stormwater management areas.

TP 13 and 14 was excavated approximately 50 m to the east compared to the location originally provided to GeoSolve as the original location was fenced off with horses grazing, and the landowner did not allow access to this area.

Test pit and soakage pit locations and logs are presented in Appendix A and B. Results from the soakage testing are presented in Appendix C.

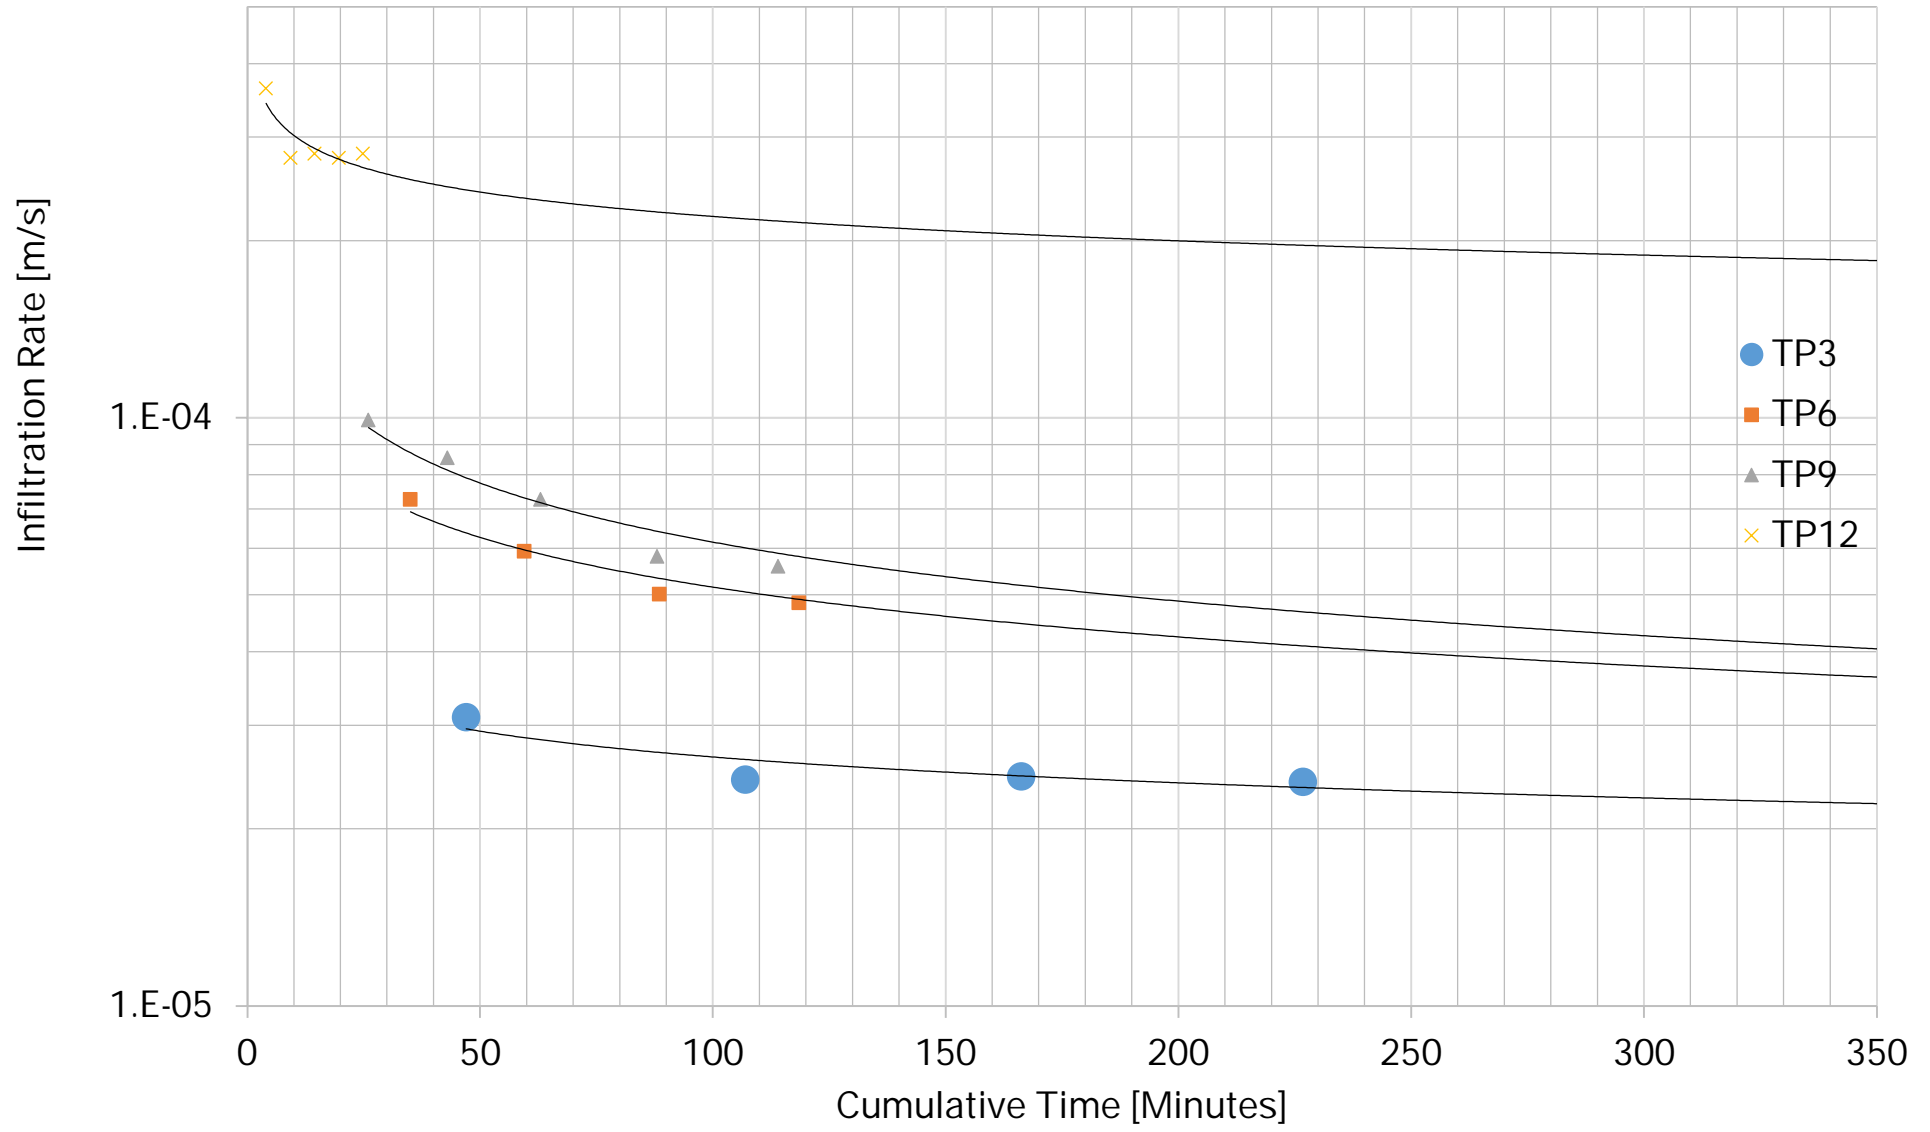
# Soak Test Results - Ladies Mile excl. TP14

- Infiltration rates are provided above in Table 1. Test results within TP 3, 6 and 9 were observed to be relatively consistent. A greater infiltration rate was observed within TP 12, likely due to the 1.1 m thickness of sandy GRAVEL present beneath the base of the soakage pit. A lower infiltration rate was observed in TP 14, which was undertaken within silty SAND (loess);
