Davis Consulting Group Contaminated Land Experience

PROJECT NUMBER: 15063  
SITE NAME: The Hills Area A

Land-use and Site Contamination Request - McDonnell Road / 37 Hogans Gully Road

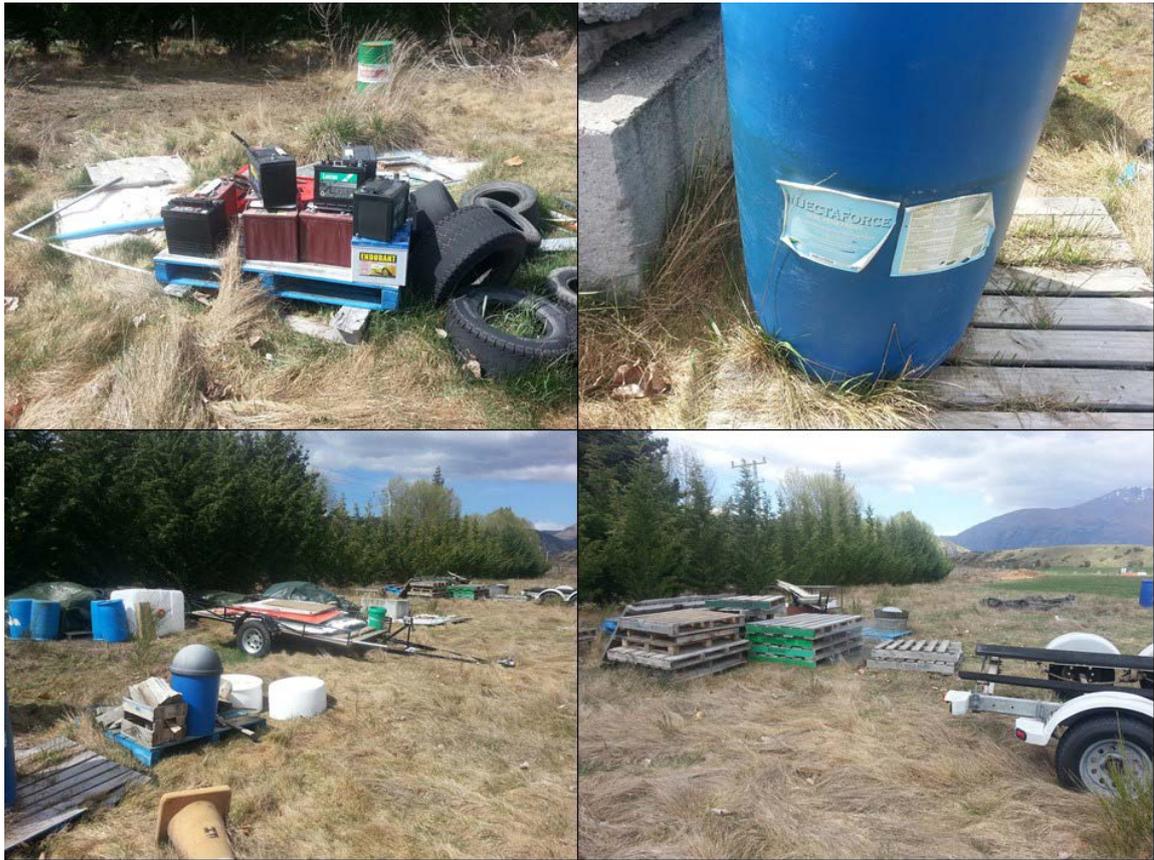
**Plate 1:** Storage Area 'A'

There was no sign of stains across the storage areas however the batteries were being stored inappropriately uncovered, on pellets and grass. The batteries have the potential to contaminate surface soil. The former cattle yard appears to be small in size and most likely only used as a

- Presence of Drums – Empty oil and soil wetting agent drums were found onsite.
- Wastes – In storage area 'A' included wastes such as empty drums, car batteries, pellets and tyres. In storage area 'B' includes tyres, empty containers of 'Turf Gard' oil, pellets and scrap metal (see Figure 2).
