Reavers Catchment Debris Removal Visual Appraisal

Assessment of Ecological Effects for remedial works in Upper Reavers Creek, Queenstown

Skyline – Reavers Slip Repair Works November 2024

| Document Control | |
|---|---|
| Title | Skyline – Reavers slip repair - Environmental Management Plan |

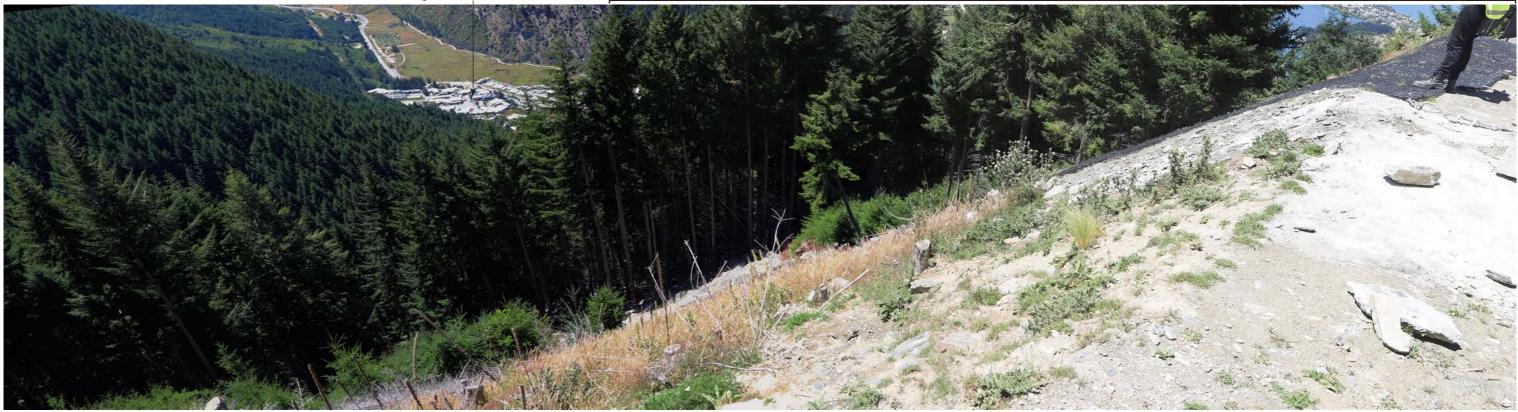
Site Appraisal Photograph A: Photograph taken from southwestern edge of the slip in the Reavers Creek catchment, looking in a northeasterly direction downslope towards the debris flow. The upper slip is located above the existing Douglas fir forest.

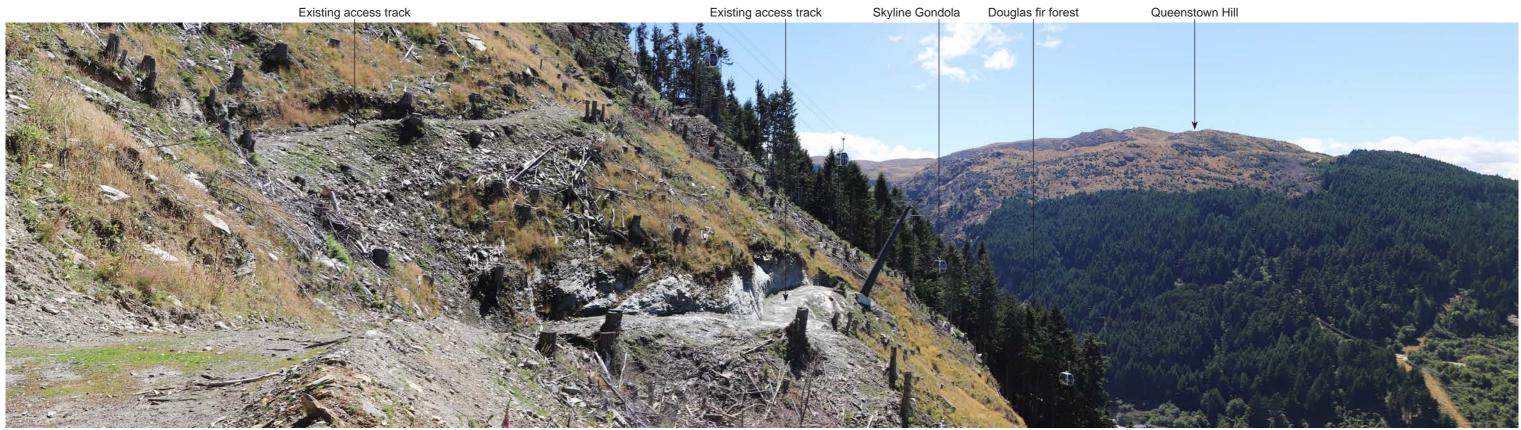
Site Appraisal Photograph B: Photograph taken from a location an existing access track, looking in a northeasterly direction towards the Skyline Gondola and the existing Douglas fir forest.

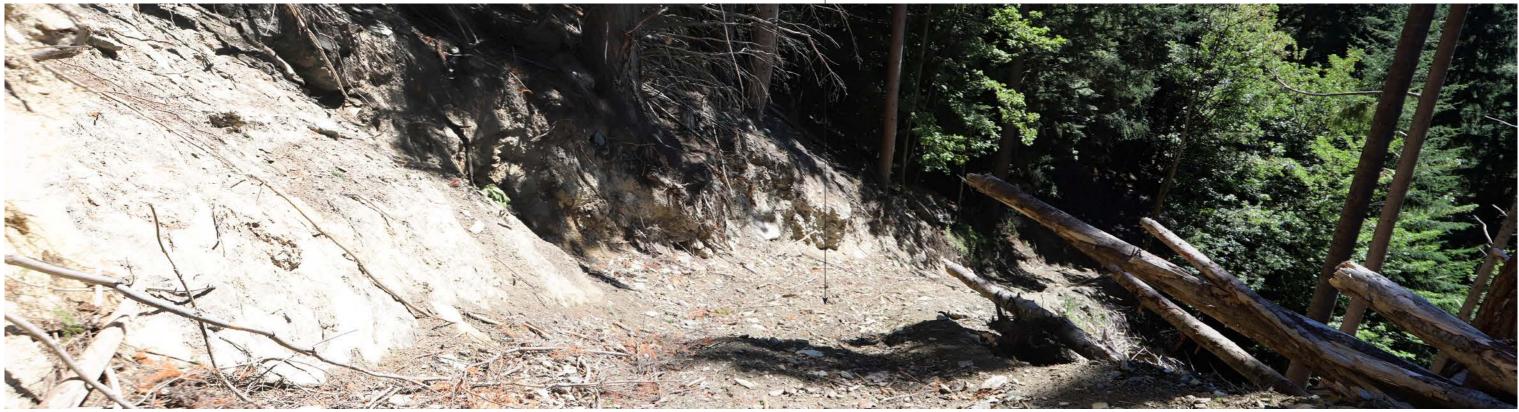
Site Appraisal Photograph C: Photograph taken from a location on an existing upper access track, looking in a northwesterly direction. The track is currently inaccessible due to the September 2023 storm damage.

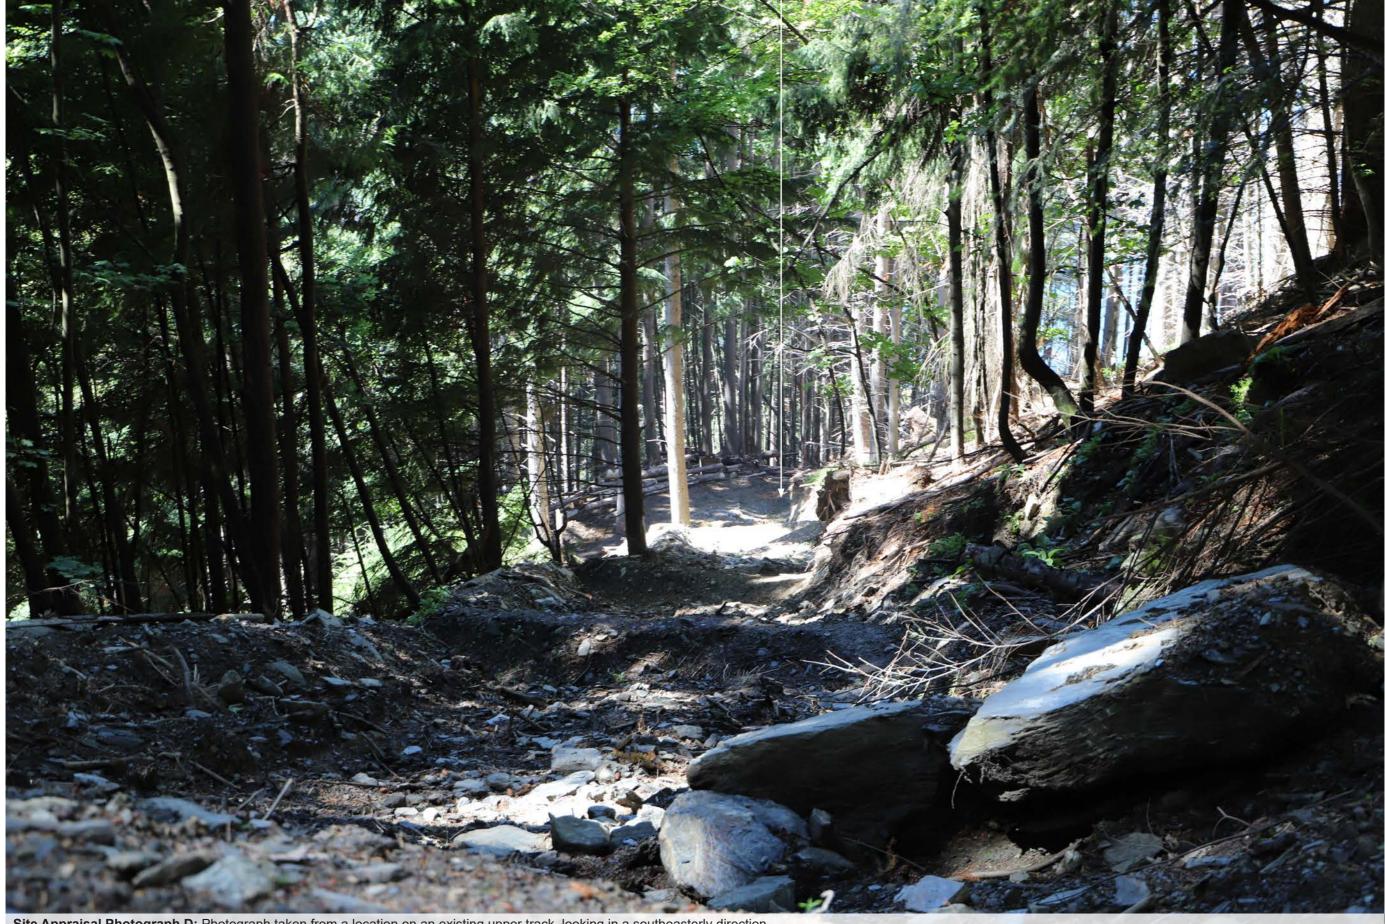
REA ERS CATCHMENT DEBRIS REMO AL Site Appraisal Photograph D

Site Appraisal Photograph D: Photograph taken from a location on an existing upper track, looking in a southeasterly direction.

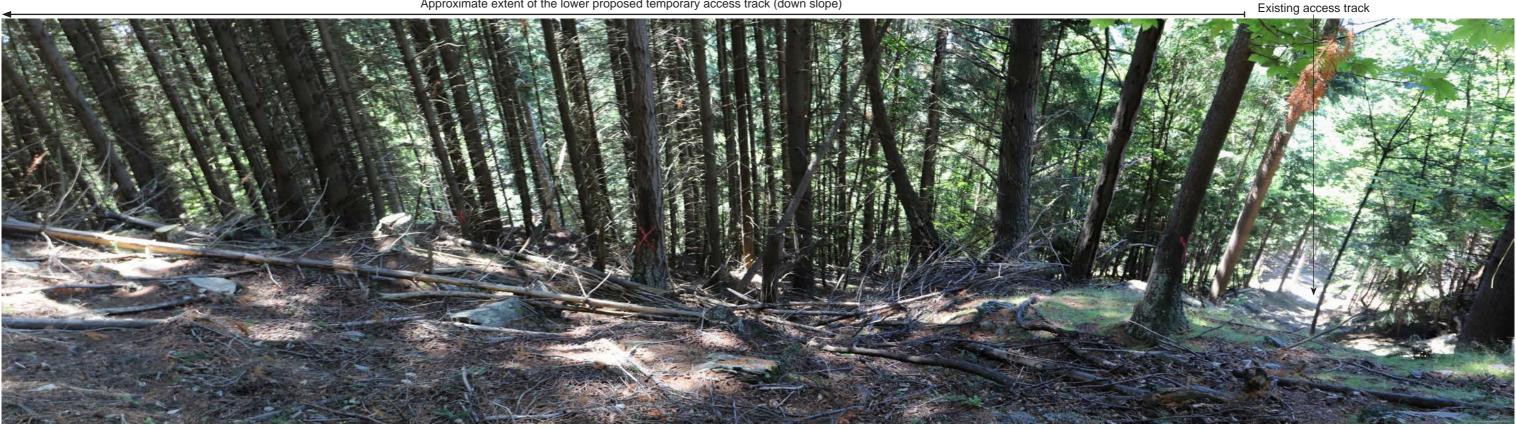
Site Appraisal Photograph E: Photograph taken from a location on the upper proposed temporary access track, looking in a south easterly direction towards the lower proposed temporary access track and existing access track.

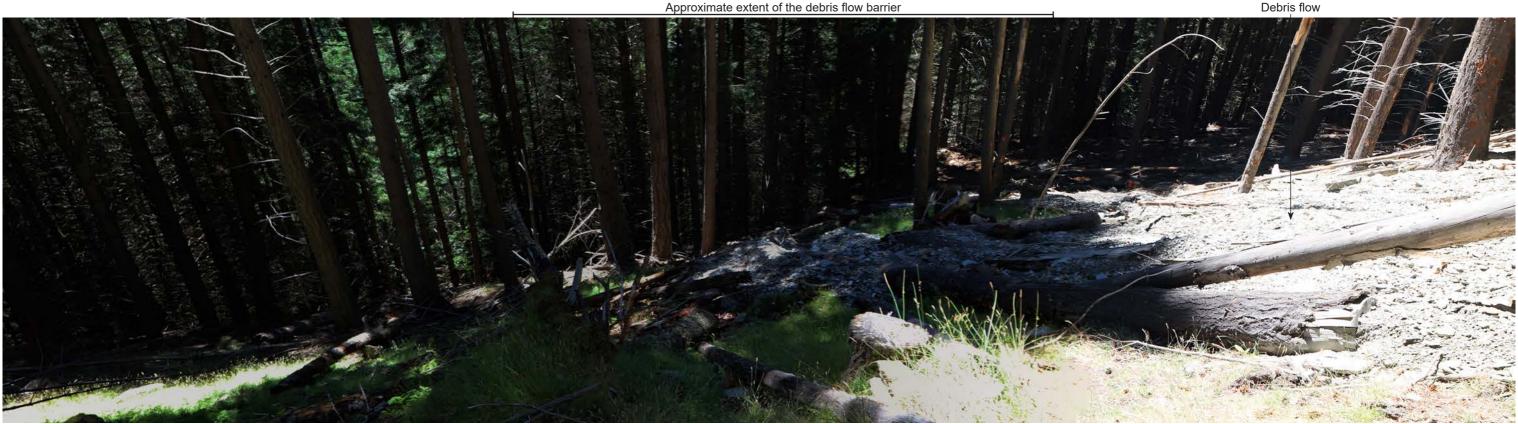
Site Appraisal Photograph F: Photograph taken from the middle of the debris flow, looking in a southeasterly direction towards the location of the proposed debris flow barrier.

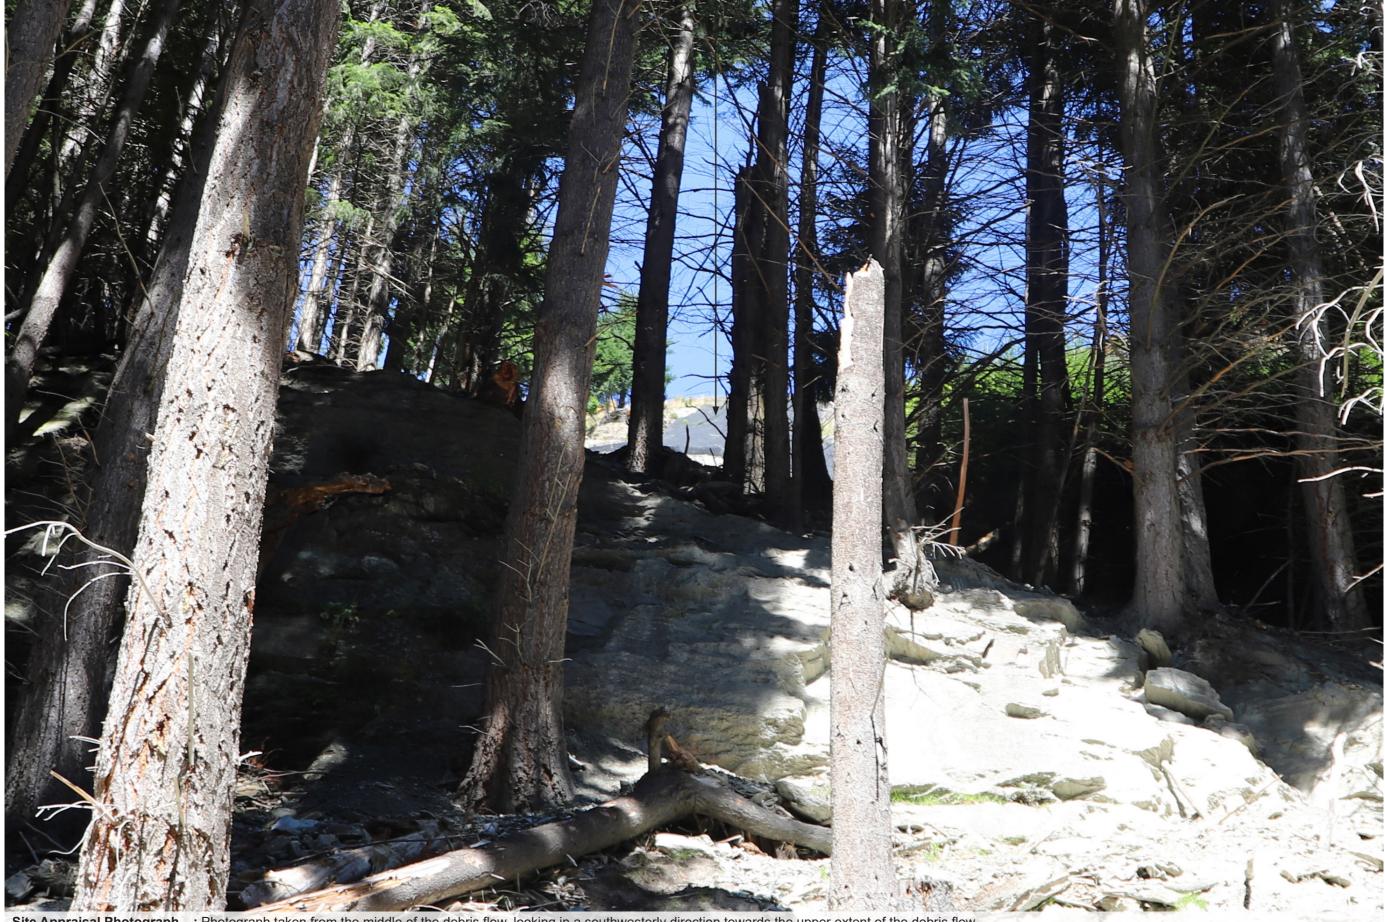
Site Appraisal Photograph : Photograph taken from the middle of the debris flow, looking in a southwesterly direction towards the upper extent of the debris flow.

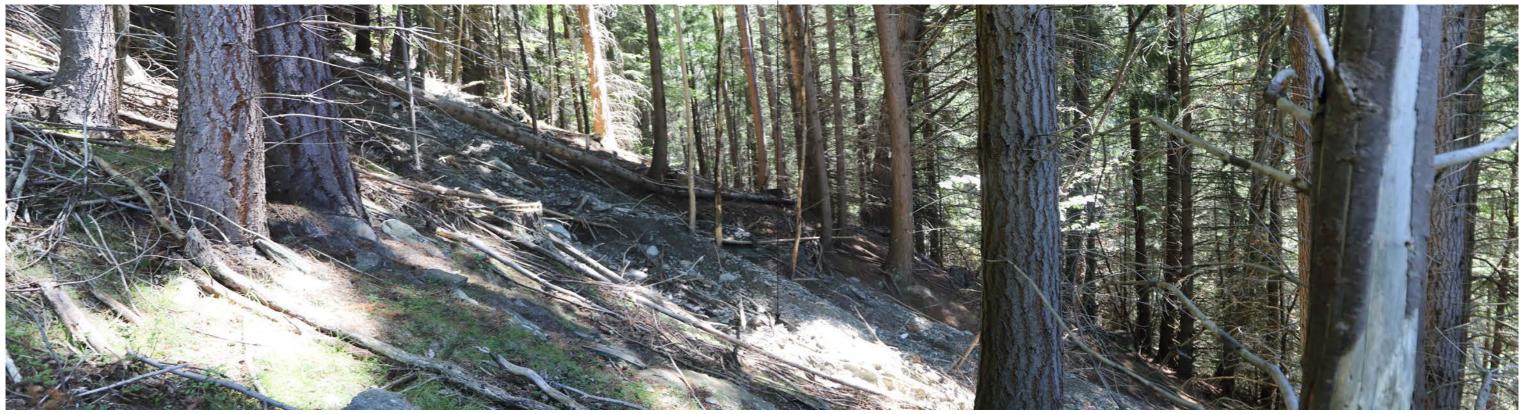
Site Appraisal Photograph H: Photograph taken below the proposed debris flow barrier location, looking in a northwesterly direction towards the lower extent of the debris flow.

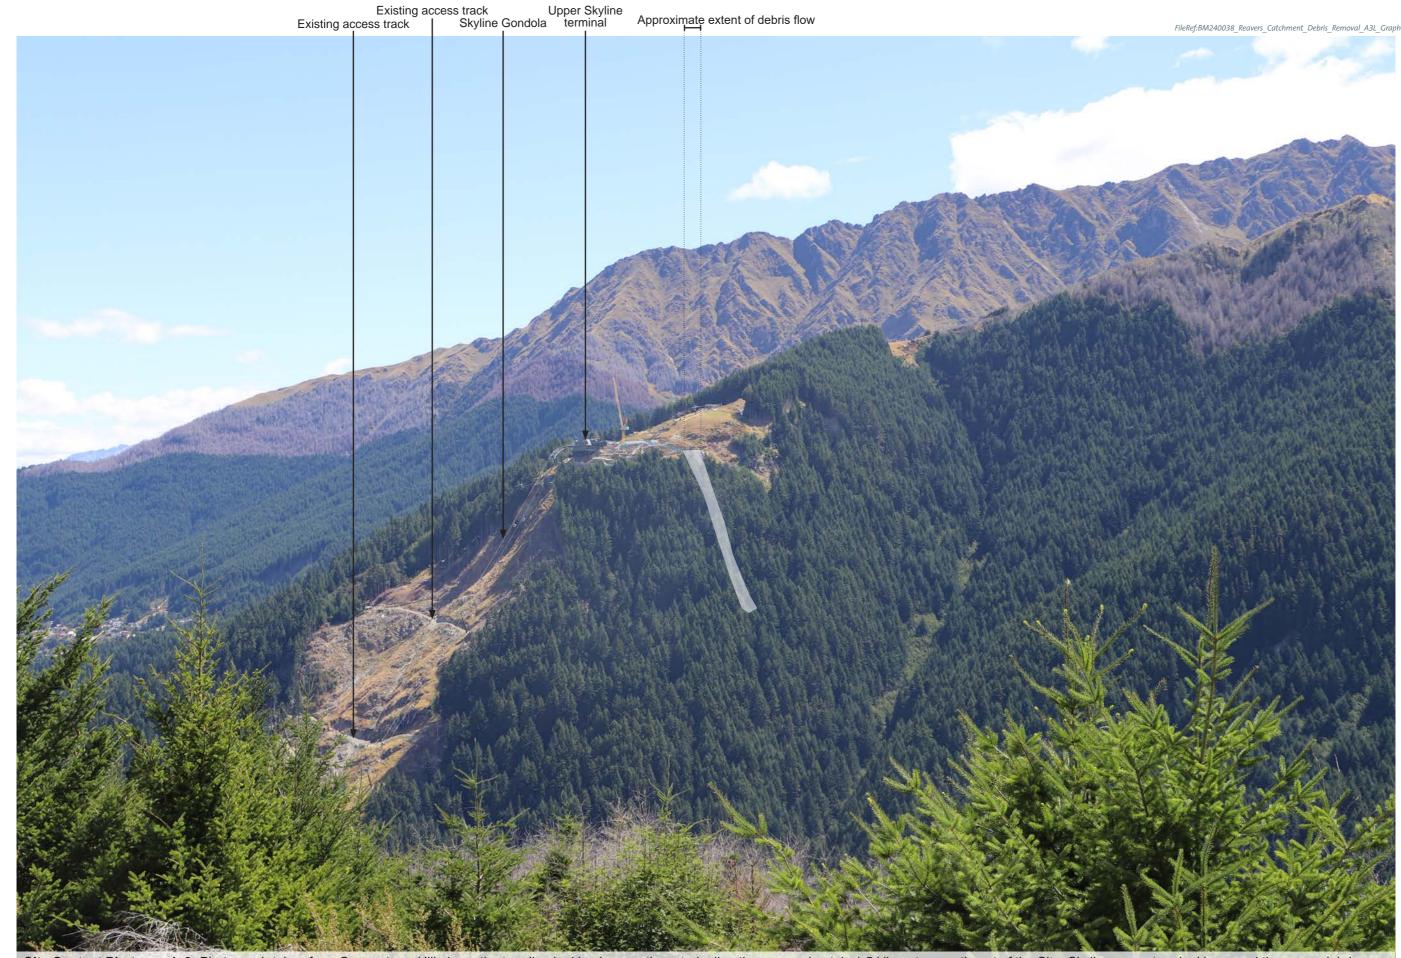
REA ERS CATCHMENT DEBRIS REMO AL Site Context Photograph 9

Site Conte t Photograph 9: Photograph taken from Queenstown Hill above the tree line looking in a southwesterly direction, approximately 1.5 kilometres northeast of the Site. Skyline upper terminal base and the upper debris flow are largely visible from this elevated viewpoint.

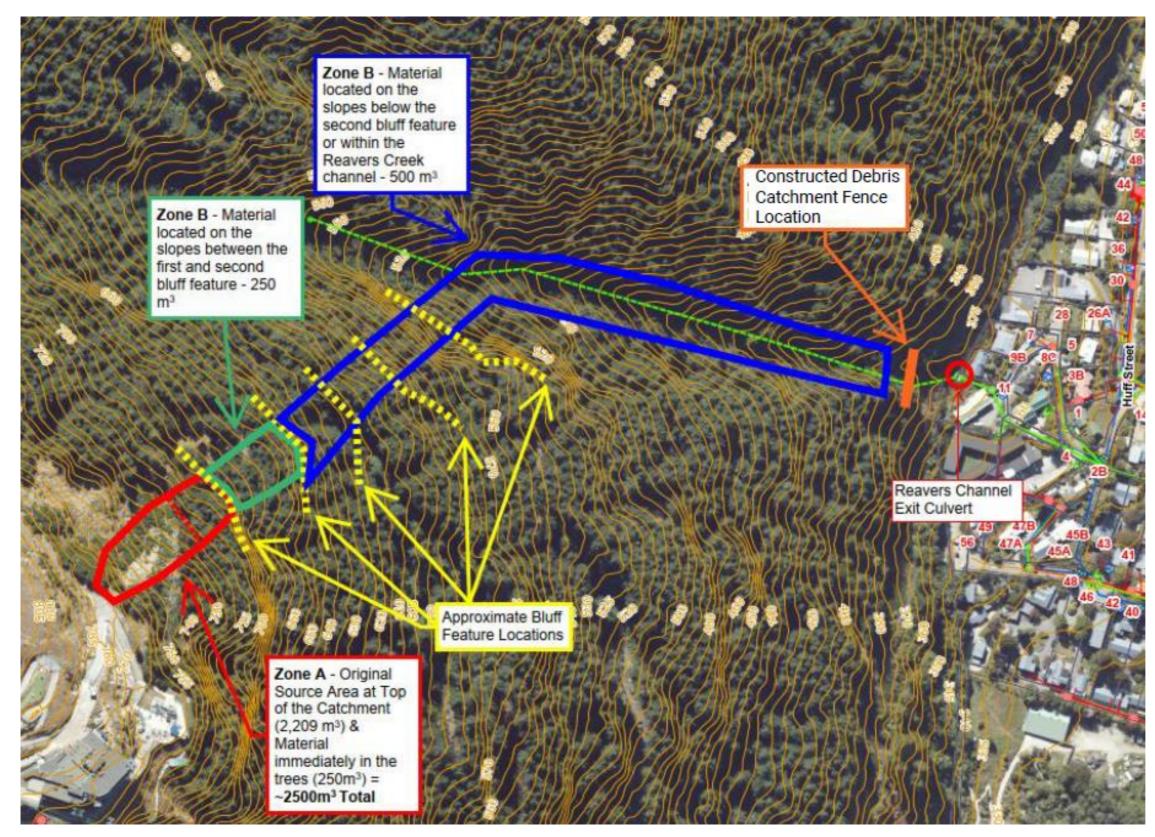
Geosolve report figure of site area and slip material.

Figure A2.1: Location of slip material to be removed. The areas in red and green are above the proposed debris barrier, while the area of blue is below the barrier. The area of blue will have the have the debris removed by hand. (Figure source: Geosolve Report, March 2024).

For the area on the hillside bellow the proposed debris barrier, a small channel has been formed where the debris flow event has scoured the existing ground to the underlying bedrock c. 0.5 meters depth and 1-2 meters width. Small volumes of loose material are still present within this channel that are proposed to be removed with hand tools. The material outside the channel may also be partially removed, if a risk of mobilisation is present (to be assessed during works), however it is anticipated that this will be minimal.

For the debris that will be removed in these two areas, it has been recommended by GeoSolve that helicopter removal of the material within the channel and immediately adjacent areas. Material beyond this can remain on slope without posing a risk, this material is to be dictated by Geotech on site during works.

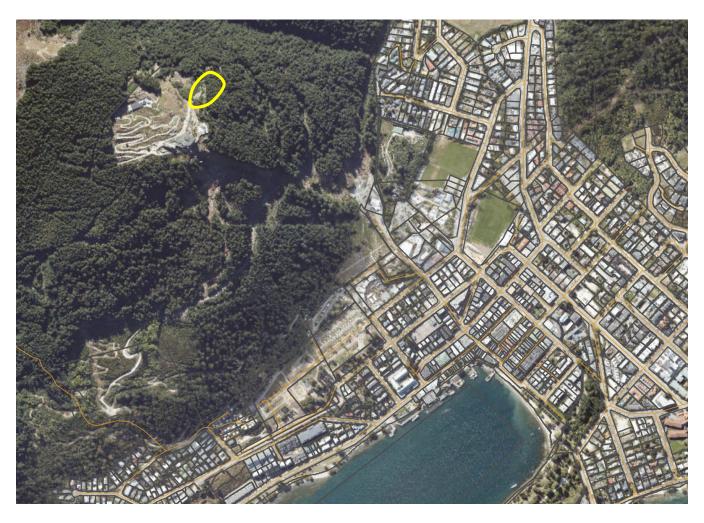
The slip is accessed by existing forestry tracks, of which require upgrading to allow temporary access to access the slip. The surrounding land uses are forestry, recreational use of Skyline's facilities, the gondola passing overhead to the west and residential dwellings to the east of the downslope portion of the site adjacent Reavers Lane.

Figure 1: General location of the slip in yellow (Source: QLDC GIS)

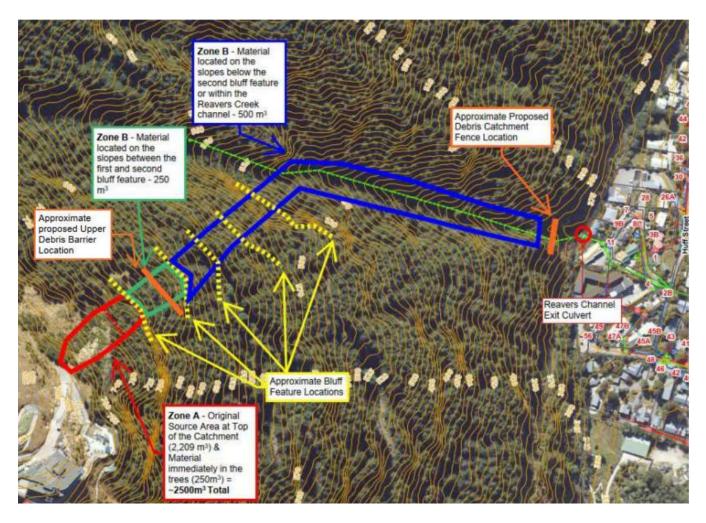
Figure 2: Slip material to be removed (Source: Geosolve Report, March 2024)

A total of approximately 2,500 m³ of slip material will be removed from the debris bulb at the upper portion of the Reavers Catchment (Zone A depicted in **Figure 2**). A further $500 - 750 \text{ m}^3$ of soil will be removed from the Reavers Channel and the slopes between the top source area and Reavers Creek Culvert (Zone B depicted in **Figure 2**).

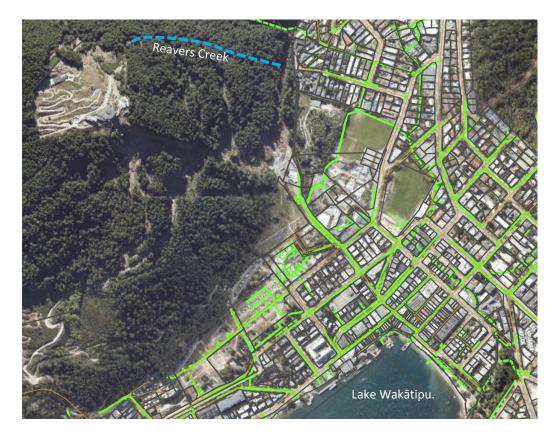
Figure 3: Waterways within and in proximity to the site

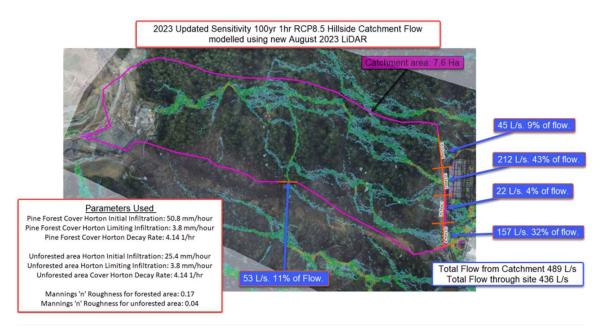
Figure 4: Hydraulic modelling results focusing on the Brecon Street catchment (Fluent Report, 2023)

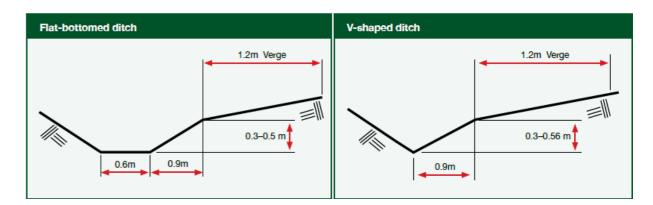
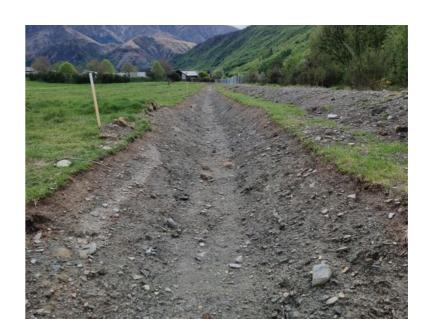
| Base Width | Top Width | Flow Depth | Freeboard Height | Batter ratio | Channel slope | Buffer |

- This has been designed to convey upto a 5% AEP design event.
- Check dams required.
- Rock armouring required.
- Flat bottomed shape as per schematic provided.
- Note ditches have been designed as per GDO5 specifications as per the schematic above. This deviates from the ditch design specifications recommended by the New Zealand Forest Owners Association as shown in the schematic to the right.
- Full calculations for both GDO5 dirty water diversion channel and NZFOA ditch are included in Appendix 2.

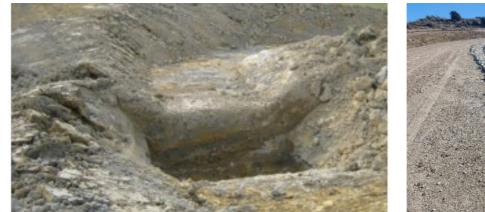
SEDIMENT TRAPS

- Sediment traps should be 1 m deep by 1.5 m long. A good length to width ratio is 3:1.
- Spacings of Sediment traps will vary throughout the site with differing gradients. However, generally the sediment traps are placed every 10-20 m.
- As a contingency measure, sediment traps can be increased in size and lined to prevent any scour of the pit.

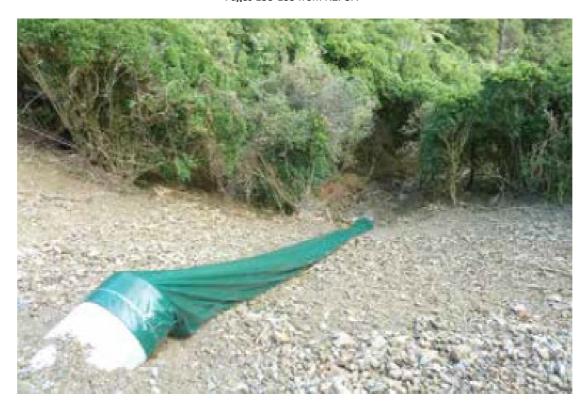
SOCKS Pages 133-135 from NZFOA

- Culvert socks are to be installed on the outlet of culverts to protect earthworks from erosion, particularly areas of fill.
- Culvert socks will also be utilised to manipulate the culvert discharge location to reduce erosion of sensitive areas and keep flows within the same natural catchment as required.
- Culvert socks are to be clamped to the outlet of the culvert and secured to the approved location by anchoring the sock eyelets to the ground.
- Ensure the sock is installed on a slope with a minimum gradient of 5%.

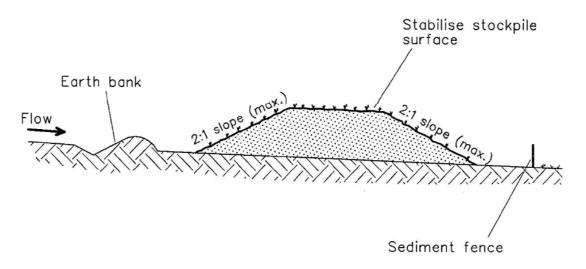
TEMPORARY STOCKPILES

- Temporary stockpiles should be a maximum height of two metres to mitigate wind effects and to preserve the quality of the topsoil as future planting media for revegetation.
- If the stockpile is to be left insitu for a period of 6 weeks or more it shall be seeded with grass or erosion control matting to provide erosion and dust protection.
- A silt fence should be installed on the downslope of the stockpile.

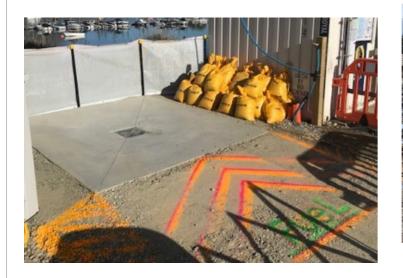
REFUELING BAY

- Where possible construct a hardstand as far as practicably possible from waterways and concentrated flows.
- Ensure spill kit is located nearby.

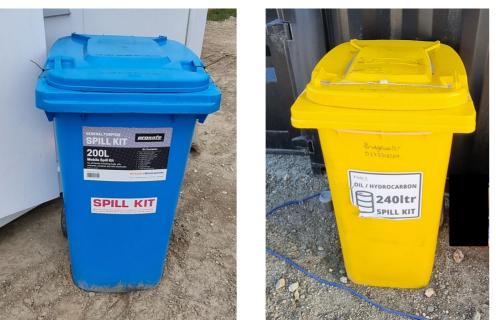
• One 240 L Oil and Hydrocarbon spill kit and one 240 L Chemical spill kit will be located in close proximity to the location of liquid hazardous materials storage and refuelling areas.

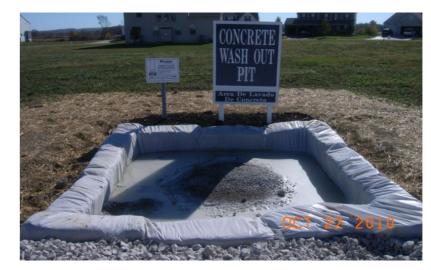
- The concrete wash out pit consists of a plastic-lined bunded pit constructed with fill or straw bales.
- After concrete washout any water shall be left to evaporate. •
- Cured concrete is to be disposed of within the plastic sheet to a licensed facility.
