Environmental Management Plan (Rev B)

832 Malaghans Road

Document Control	
Title	832 Malaghans Road - Environmental Management Plan
Address	832 Malaghans Road
Consent Number	TBC
Client	I & R MacRae
Our Reference	24017
Prepared by	  Tom Grandiek (BAppSc, CEnvP) Senior Environmental Consultant

832 MALAGHANS ROAD, QUEENSTOWN
PRELIMINARY/DETAILED SITE INVESTIGATION

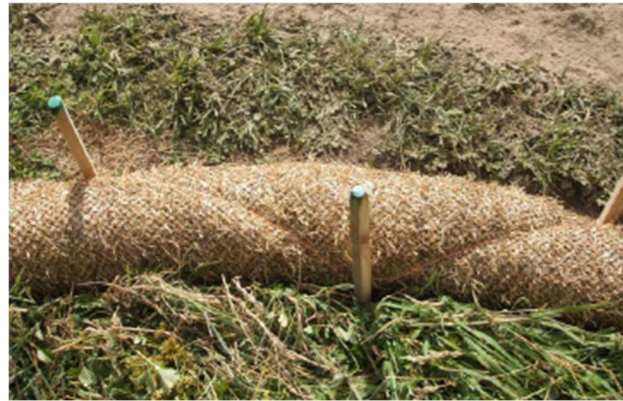
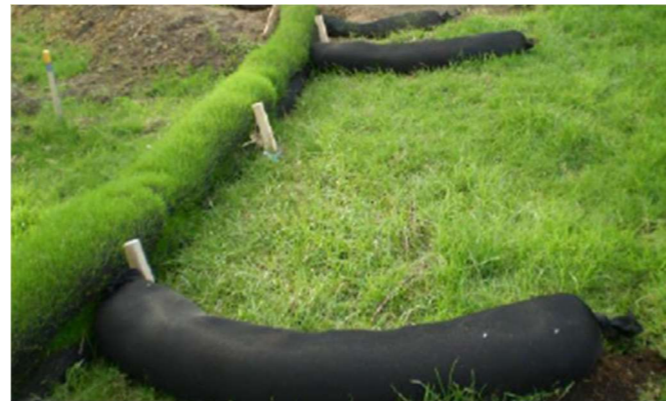
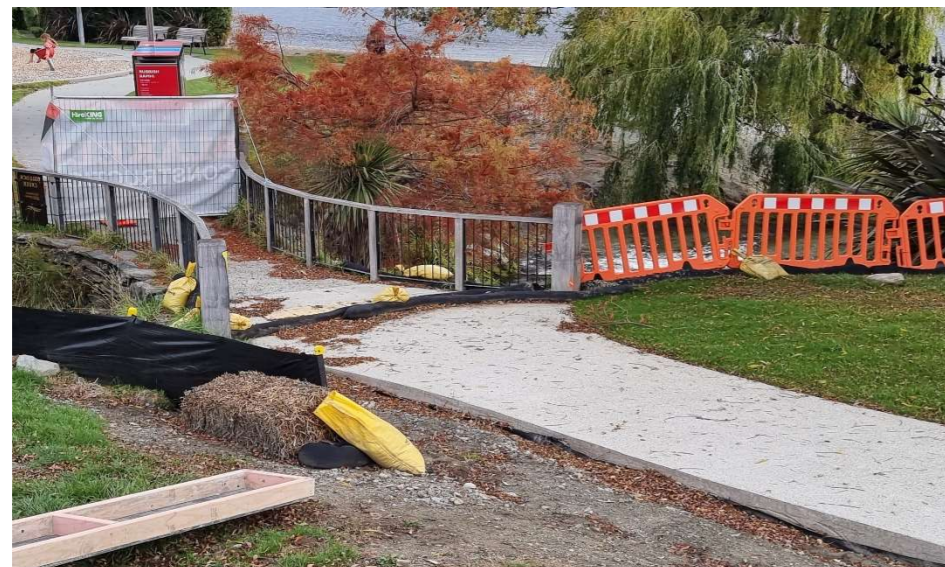
SILT SOCK

Slope steepness (%)	Slope length (m) (maximum)	Spacing of returns (m)
Less than 2%	100	N/A
2- 10%	40	30
10- 20%	30	25
20- 33%	10	10
33- 50%	5	10
Greater than 50%	2	5

- The silt sock should run the length of the bridge footings.
- It is important that the silt socks are secured flush with the ground to prevent sediment from undercutting the sock.
- Ensure silt socks are placed along the contour and secured with pegs.

Silt sock locations are provided in ESCP-002 **Appendix 1**. It should be noted that that number of silt socks indicated on ESCP-001 & 002 are approximated and may be increased if required. These devices are essentially mesh or fabric tubes filled with sand and or compost.

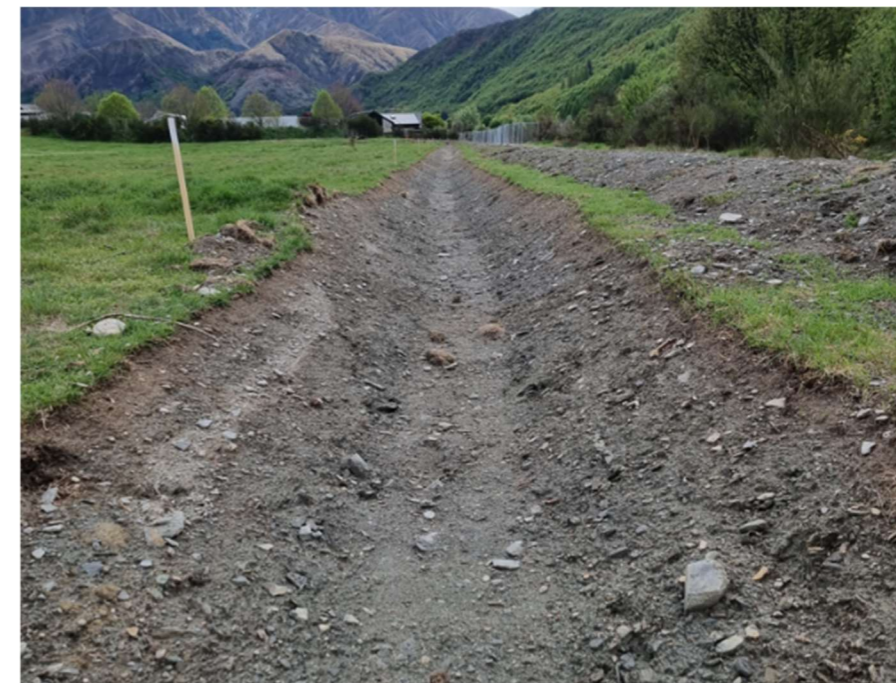
(Pages 43-46 from GD05)

- This has been designed to convey up to a 5% AEP design event.
- Trapezoidal shape
- Full calculations are included in [Appendix 2](#).

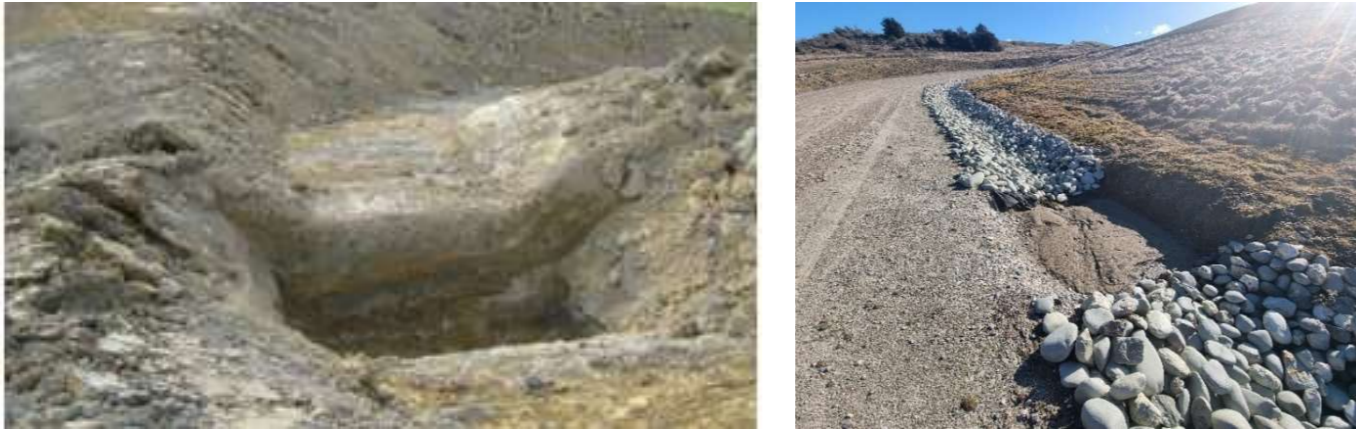
DROP-OUT PIT

- Drop out pits should be one metre deep by one-metre-wide cube.
- As a contingency measure, drop out pits can be increased in size and lined to prevent any scour of the pit.

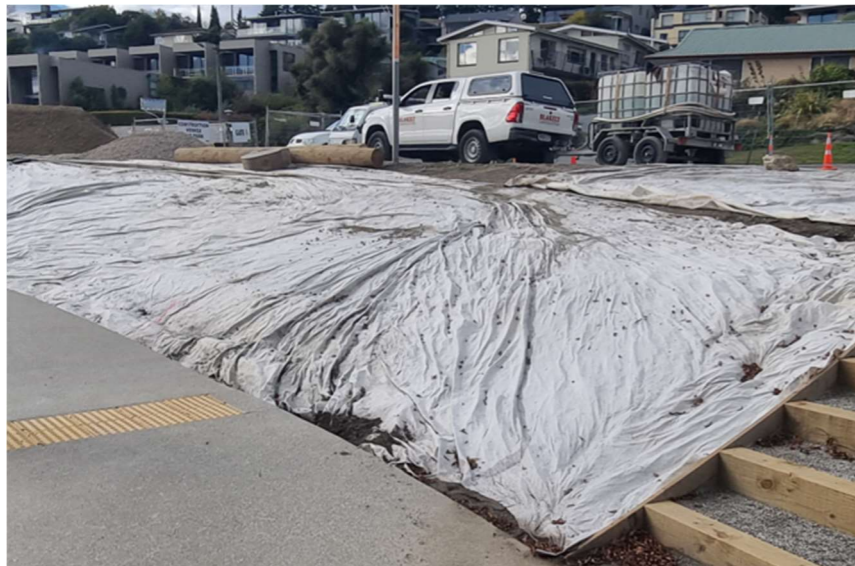
GEOTEXTILE EROSION MATTING

- For the bridge works within direct proximity of Mill Creek, geotextile erosion matting should be placed over exposed surfaces prior to rain events and at the end of the working day.

During construction of the access bridge, erosion matting should be used to cover all exposed surfaces surrounding footings at the end of the day’s work and or prior to any forecast rainfall events. These exposed areas are small in nature and due to the proximity of Mill Creek, actively covering the exposed areas will significantly reduce potential erosion and sedimentation. Geotextile matting should be pinned into the bank to ensure they are robustly secured and are not subject to damage from fluctuating Creek levels. A woven geotextile matting should be employed for this purpose. The geofabric should be secured and pinned in place. The geotextile erosion matting will be installed in accordance with the schematic diagram in ESCP-005, **Appendix 1**.

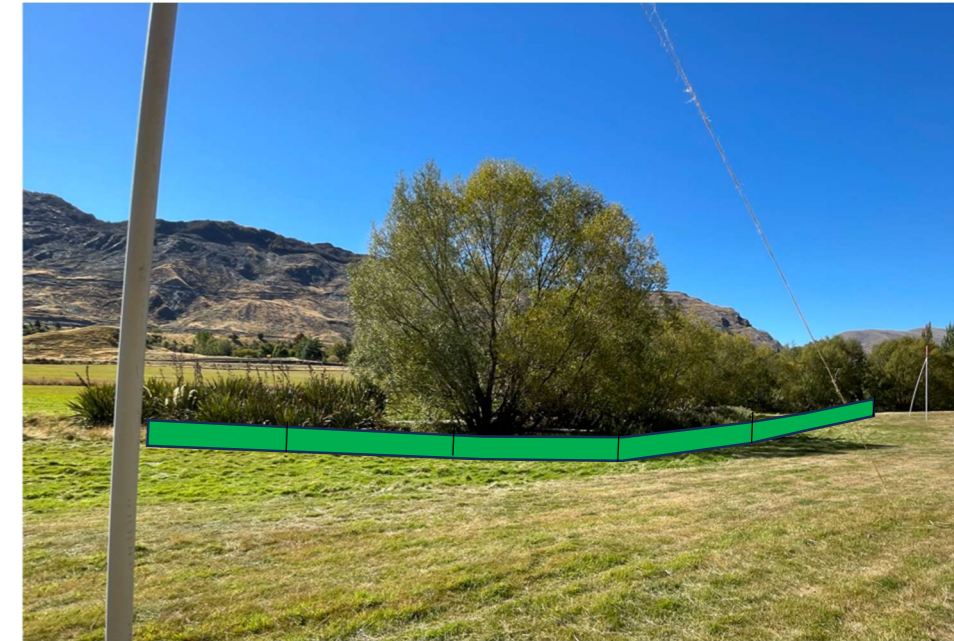
SUPER SILT FENCE
(Page 120-125 from GD05)

- The super silt fence should be 800 mm above ground level and a minimum of 200 mm below ground level.
- The anchoring of the silt fence should ensure stability and the double layered geotextile should provide for drop-out prior to any water filtering through the upper portions of the fabric.
- It is imperative that the front face of the fence follows the contour as close as possible to ensure the designed holding capacity is achieved and to avoid creating pressure points on the fence.
- Supporting waratahs should be placed at 2-4 m intervals.
- Returns will be installed very ten metres along the silt fence.
- Stays to be installed with silt fence to provide additional structural support.

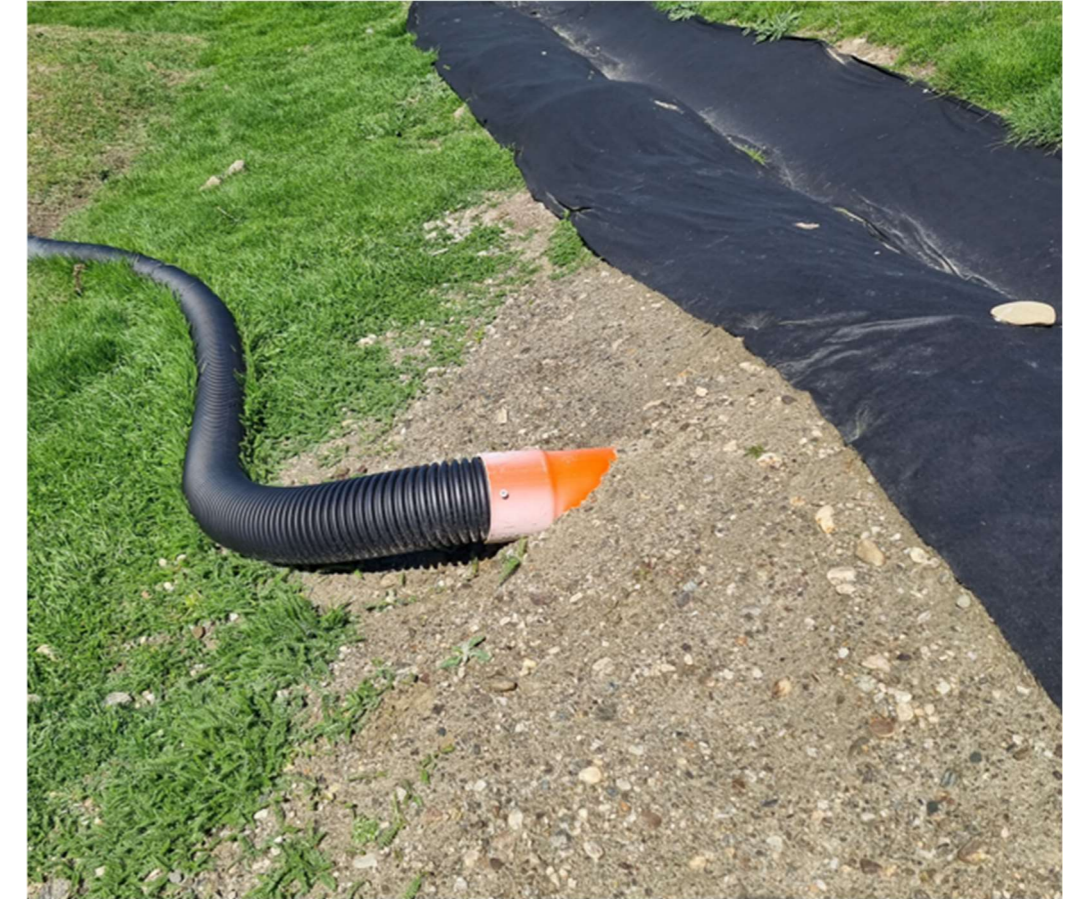
Page 55-60 from GD05

- Ensure the height of the bund is 2x the pipe diameter).
- Attach a 250 mm pipe into the bund.
- The drainage coil will be unpunched and ensure all connections are water tight.
- The pipe will be pinned every four metres to anchor it. There will be no less than two anchors equally spaced along the length of the pipe.
- Ensure the flume or pipe extends beyond the toe of the slope and the outlet is stabilised with geofabric or rock rip rap to avoid downslope scouring.
- The pipe drop structure will be monitored and maintained regularly to ensure it operates effectively.
- See **Appendix 2** for full calculations.

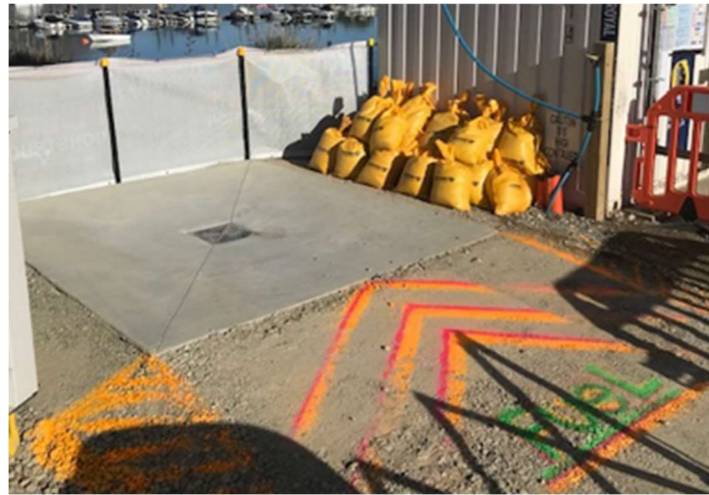
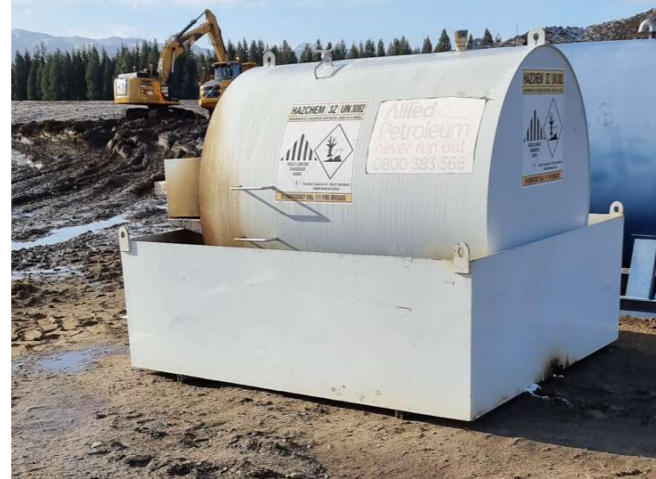
REFUELING BAY

- Locate the hardstand as far as practicably possible from waterways and concentrated flows.
- Ensure spill kit is located nearby.

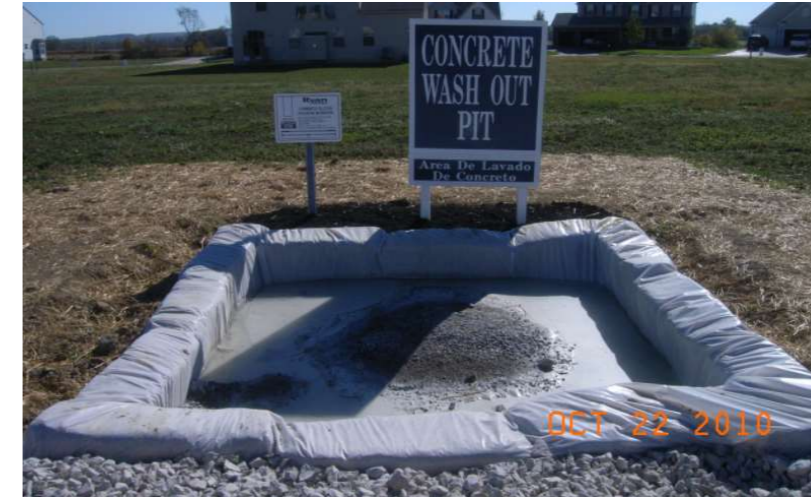
CONCRETE WASHOUT PIT

- The concrete wash out pit consists of a plastic-lined banded pit constructed with fill or straw bales.
- After concrete washout any water shall be left to evaporate.
- Cured concrete is to be disposed of within the plastic sheet to a licensed facility.

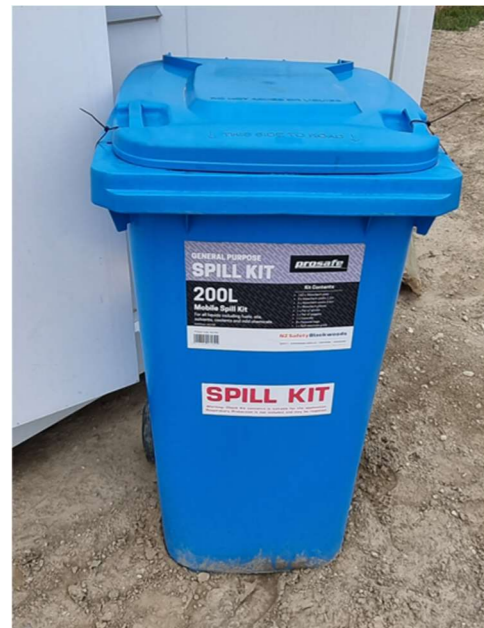
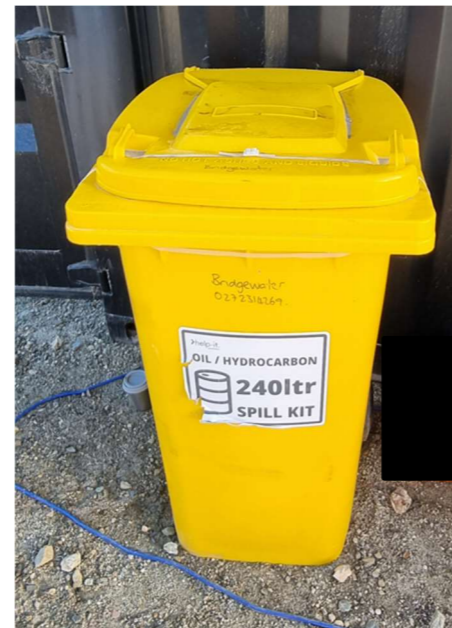
SPILL KITS

- One 40 L Oil and Hydrocarbon spill kit and one 40 L Chemical spill kit will be located in close proximity to the location of liquid hazardous materials storage and refuelling areas.

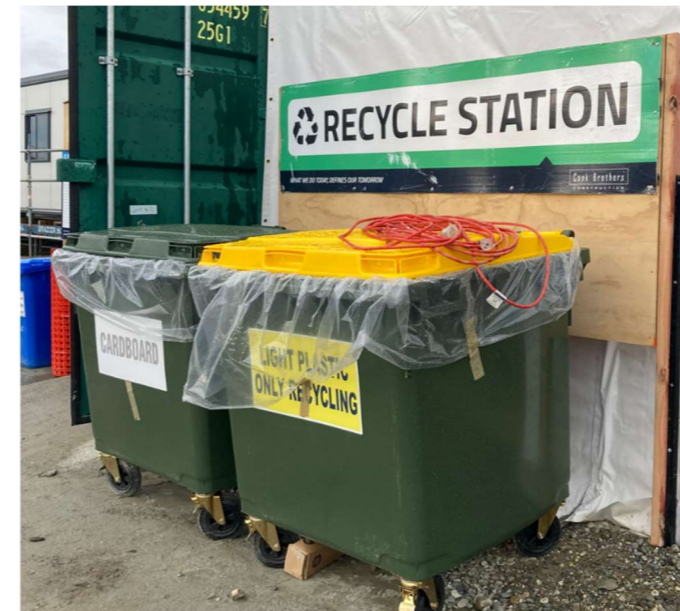
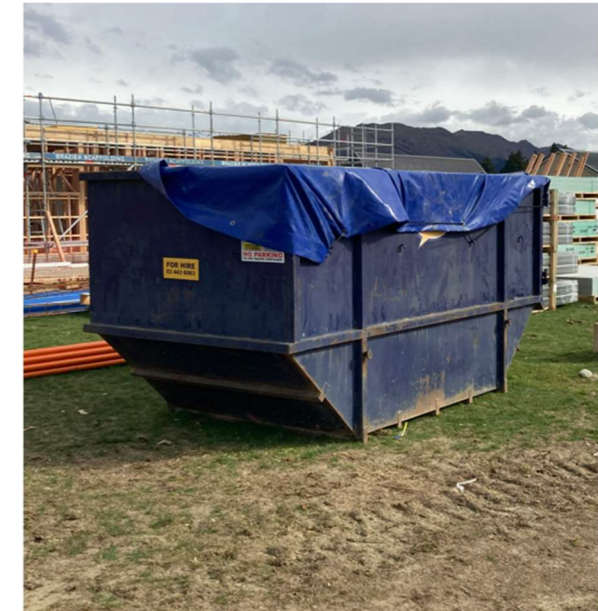
WASTE

- Where possible, waste shall be segregated into labelled bins.
- Wastes on site will be suitably contained and prevented from escaping off site. This may include covering skip bins during high winds.
- Waste storage is not permitted in or near drainage paths.
- Wastes will be removed from site when bin is full.

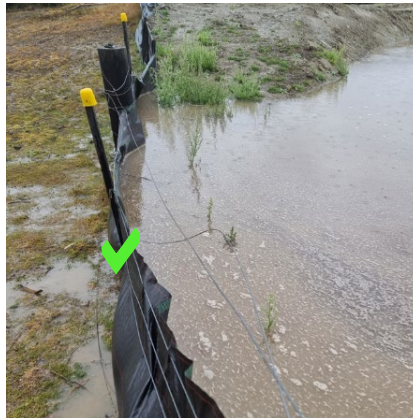
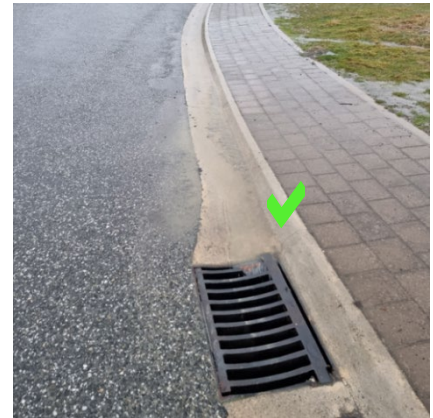
Sampling a discharge

Collect sample where water crosses the site boundary or enters a sensitive receptor from a retention device. Always photograph the location you sample from.

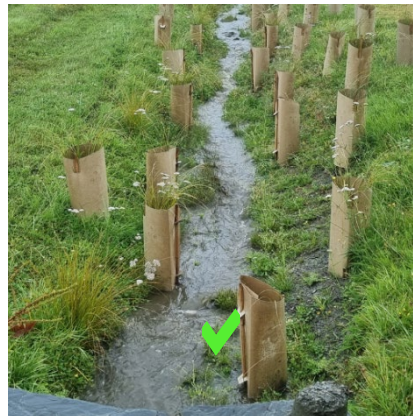
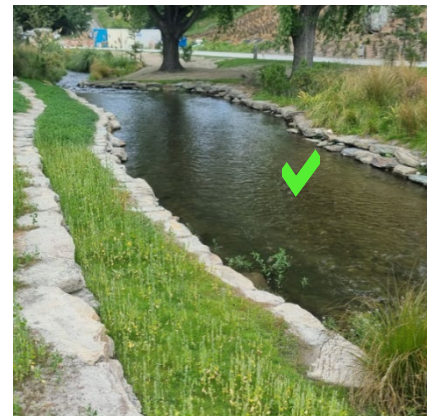
Sampling a waterway

Collect sample from the centre of the flow and the top third of the water column where possible.

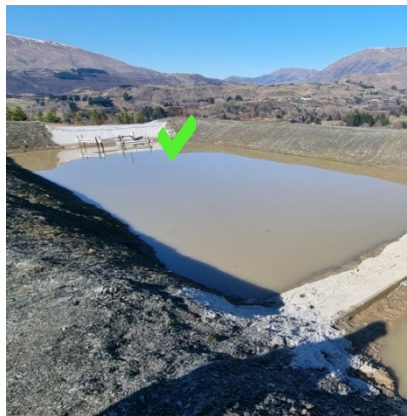
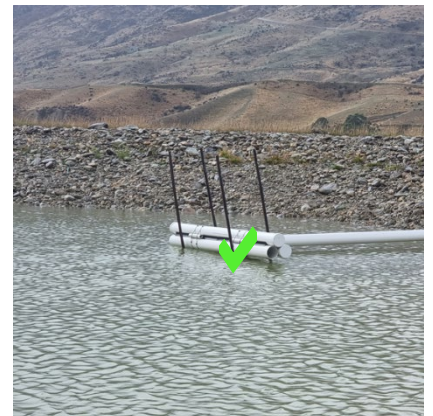
Sampling a from a Sediment Retention Device

Collect sample from the discharge location, this is either near the decanting arms, spillway, hose or the outlet pipe.

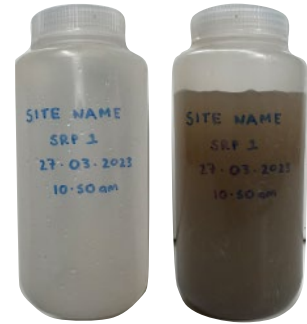
If you wade into the water to collect the sample, always collect the sample 'upstream' of where you're standing to avoid contamination by disturbed sediment.

Always ensure your meters are calibrated regularly to ensure accurate sampling results.

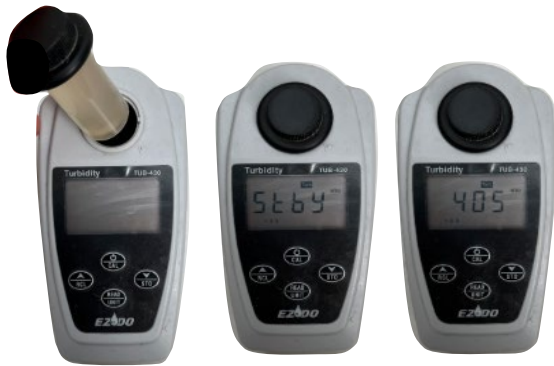
Measuring Turbidity using a Turbidity Meter

- Fill the turbidity pottle with the sampled water. Wipe away any moisture on the outside of the pottle and insert it into the meter. Turn the meter on and once the standby value appears press read. Record the turbidity value.

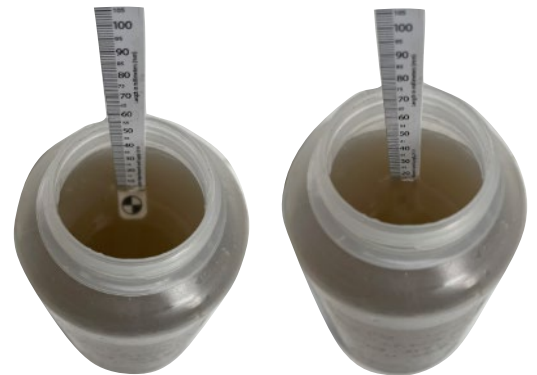
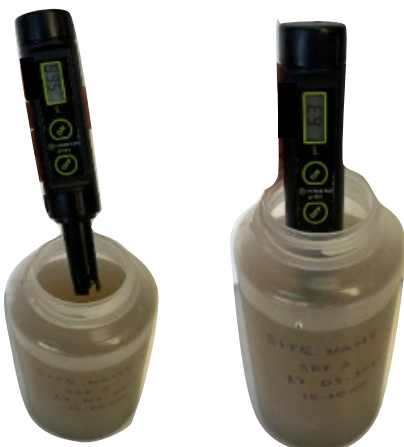
Measuring Clarity using a field testing seechi disc

- Lower the seechi disc into the water sample until you can no longer see the disc. Then lift the seechi disc back up until the disc is just visible. Record the number where the water level sits.

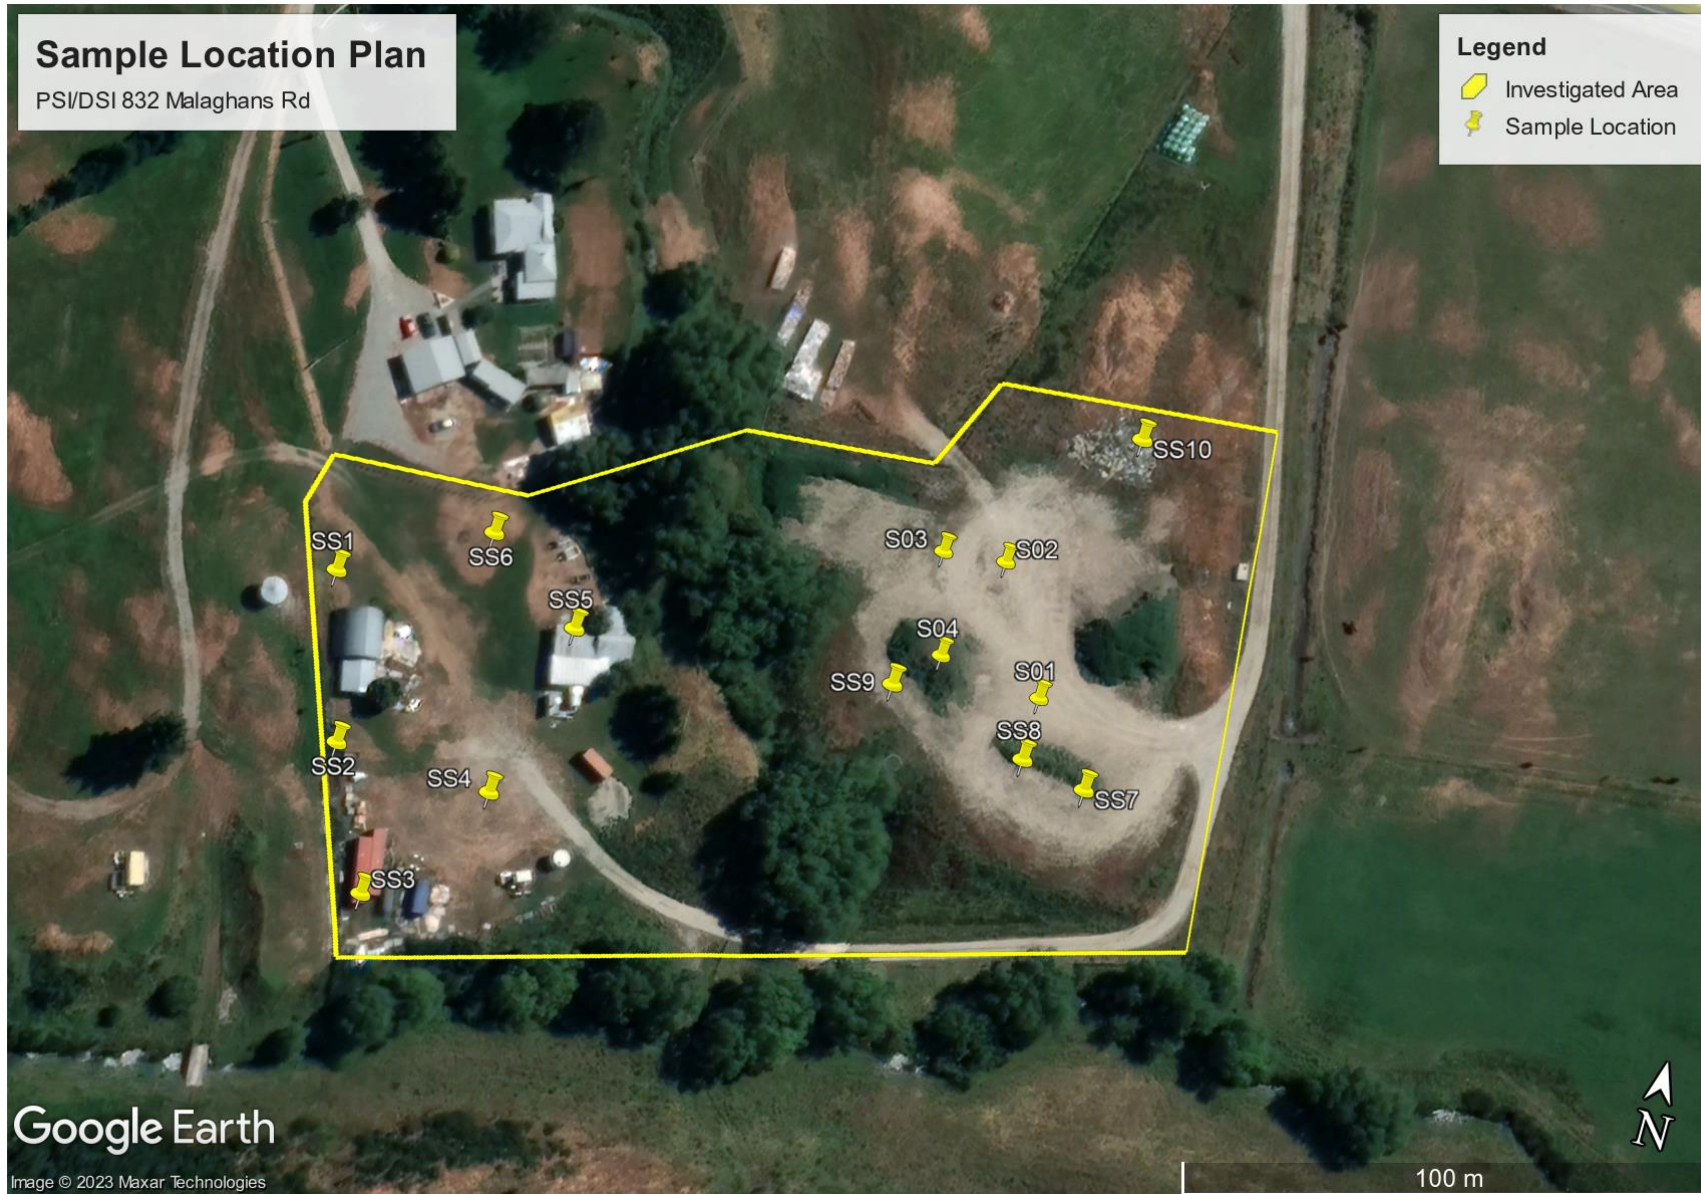
Figure 9-1: Sample Location Plan.

The June soil samples were submitted to Analytica Laboratories and the July samples to Eurofins for analysis of determined contaminants of concern. Both laboratories are accredited by International Accreditation New Zealand (IANZ) for the analytical suites requested.

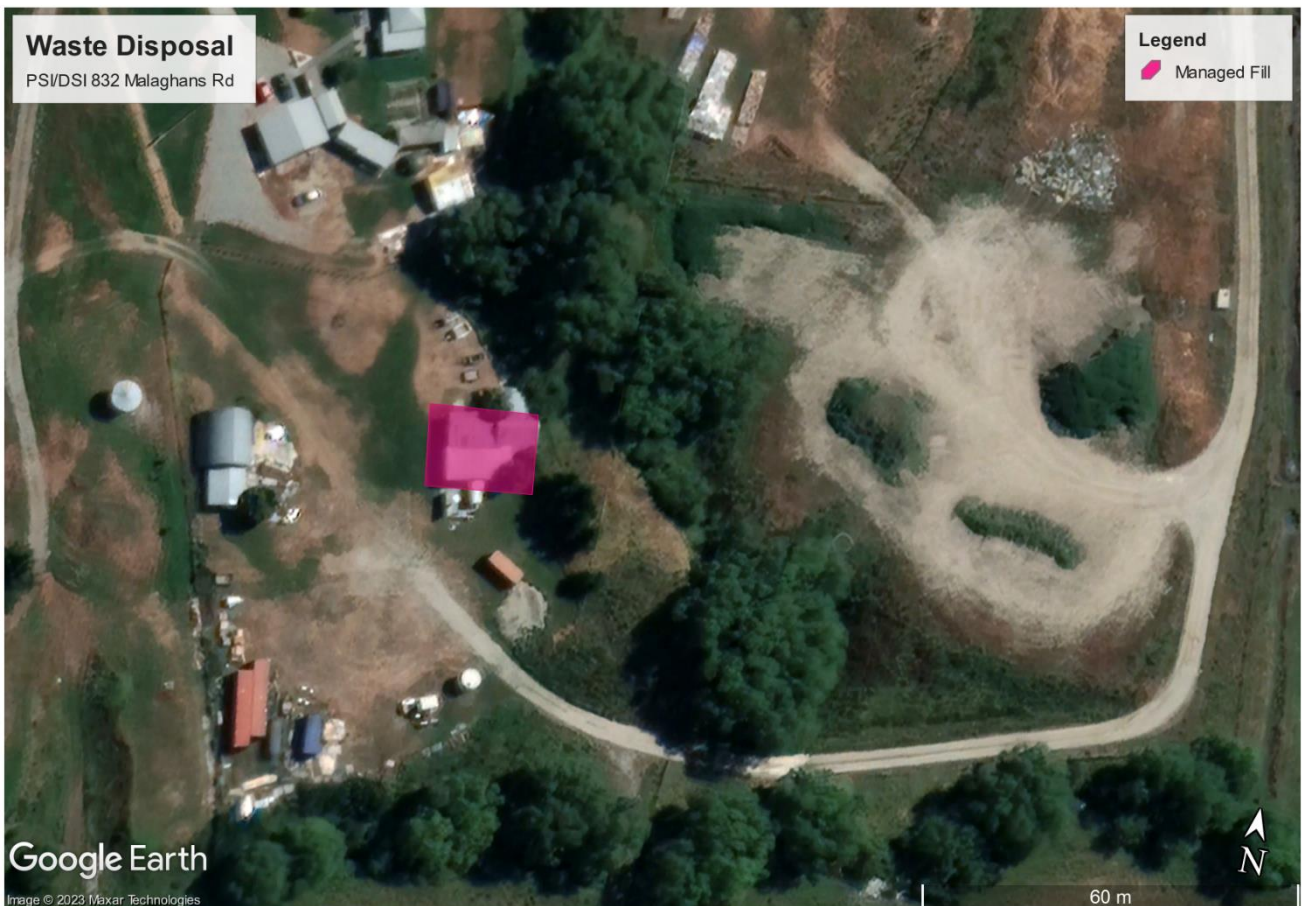
Figure 14-1: Summary of waste disposal recommendations.

Prior acceptance of the landfill should be sought prior to disposal of soils, and the appended laboratory results (referencing SS5) may need to be presented prior to acceptance.

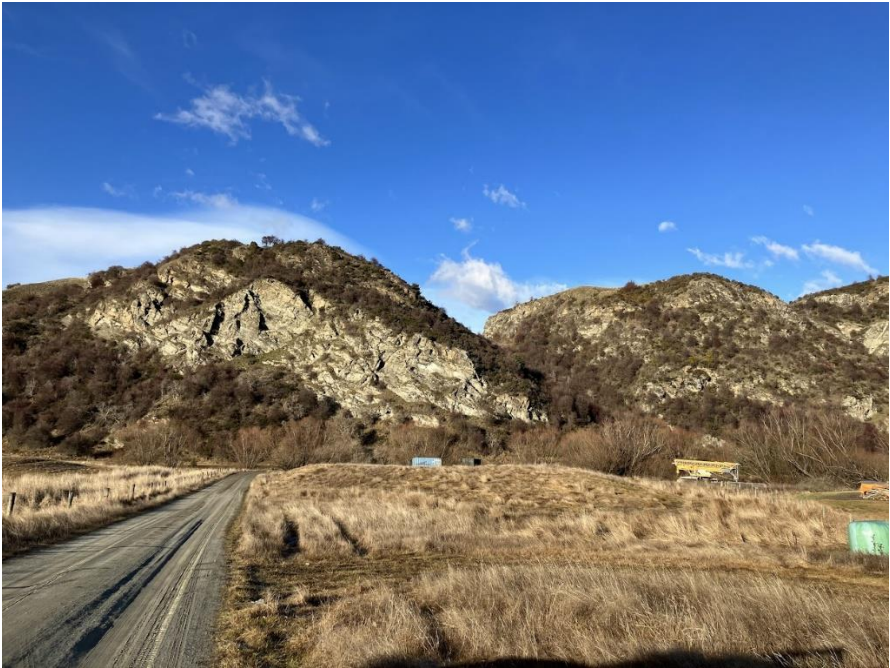
Photo No.	Date	
1	19/07/2023

Description The site investigations took place on 15 June 2023 and 19 July 2023 by a WSP Environmental Engineer. The site is accessed via a gravel driveway off Malaghans Road. Some hills with rocky outcrops can be seen south of the site.

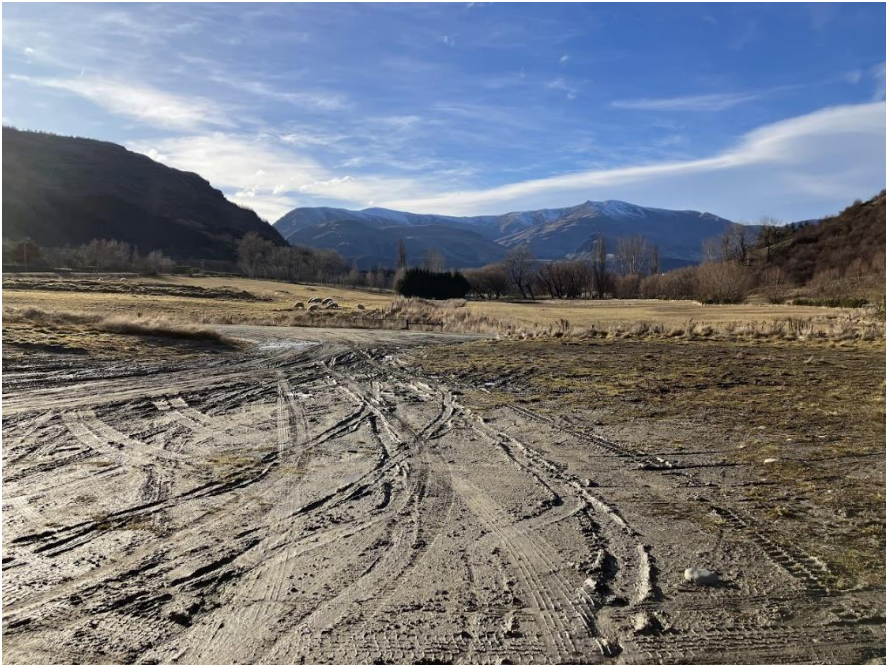
Photo No.	Date	
2	19/07/2023

Description The eastern part of the site comprises vacant land, currently used for sheep grazing.

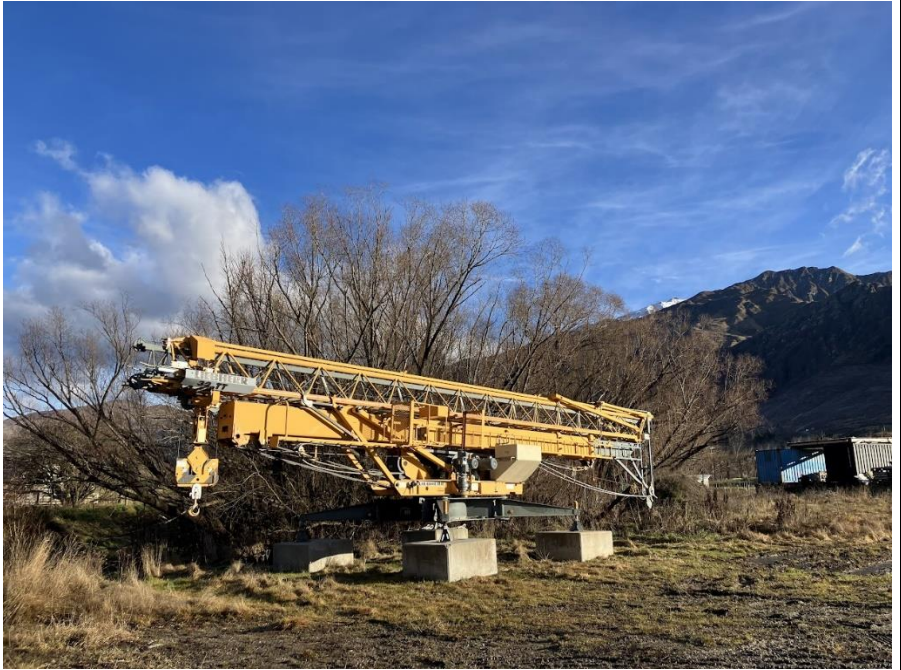
Photo No.	Date	
3	19/07/2023

Description Picture shows the location of where the soil screening formerly took place. A soil screening machine is noted on the ungrassed area south of the access road. No stockpiles or imported soils were noted at the time of the site visit.

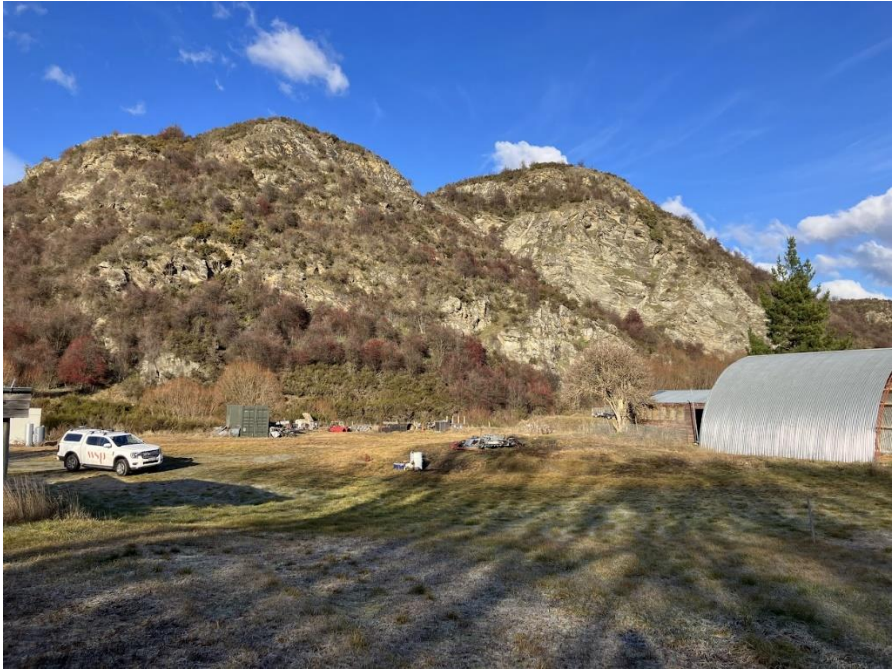
Photo No.	Date	
5	19/07/2023

Description The western part of the site has some general storage of material goods, such as shipping containers, a prefabricated coolstore, and construction material.

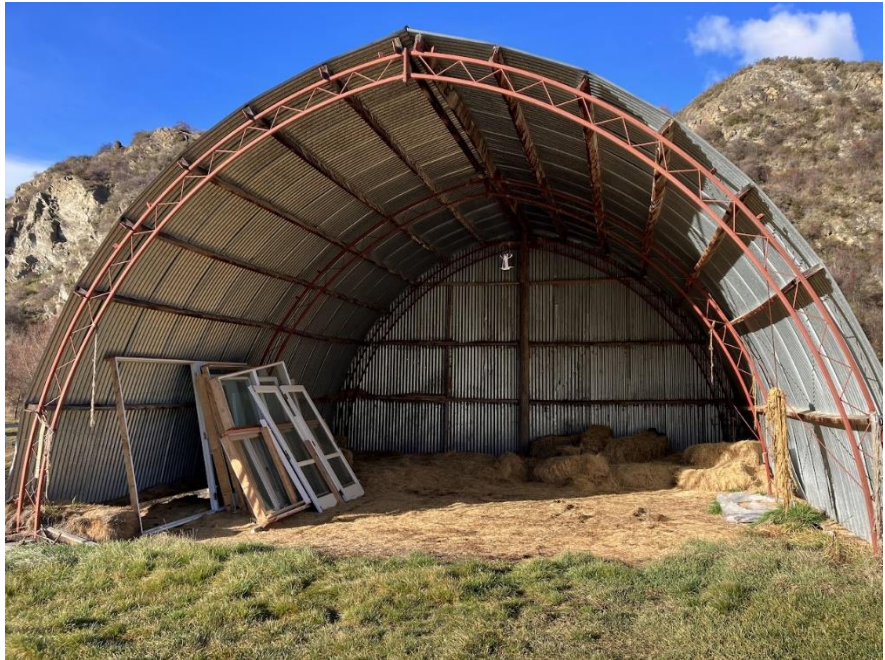
Photo No.	Date	
6	19/07/2023

Description A domed shed is noted with some old windows and hay bales stored inside.

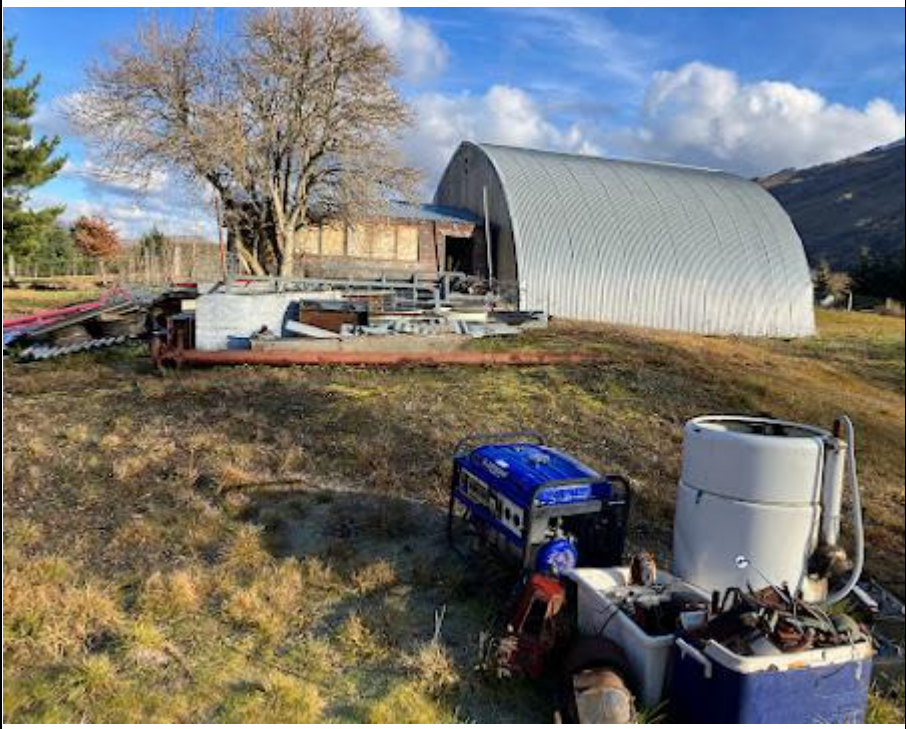
Photo No.	Date	
8	19/07/2023

Description Some scrap metal is stored alongside the shed with some construction materials and a generator.

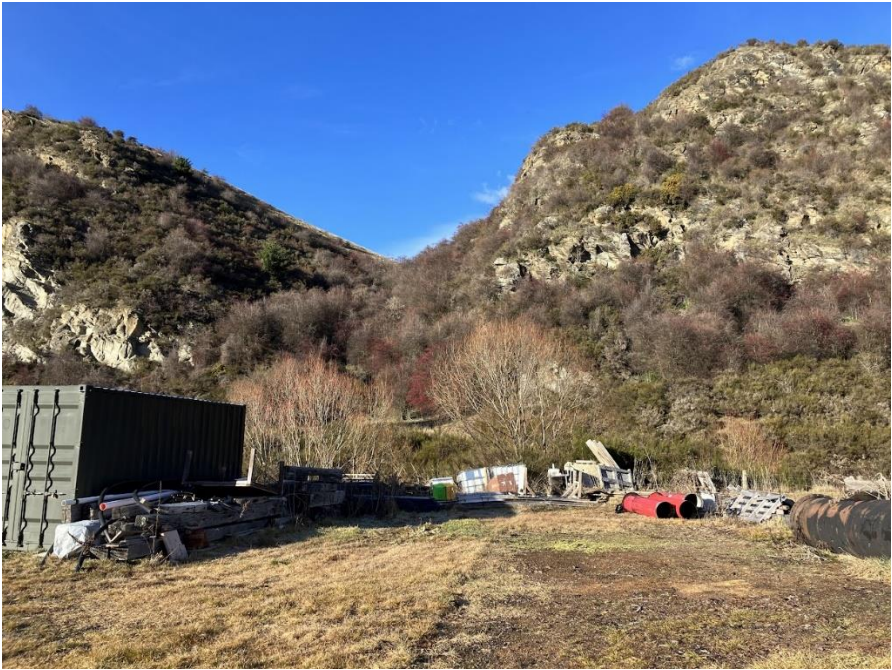
Photo No.	Date	
9	19/07/2023

Description Several storage containers, construction material, water tanks, wooden pallets, etc can be seen along the southern part of the site.

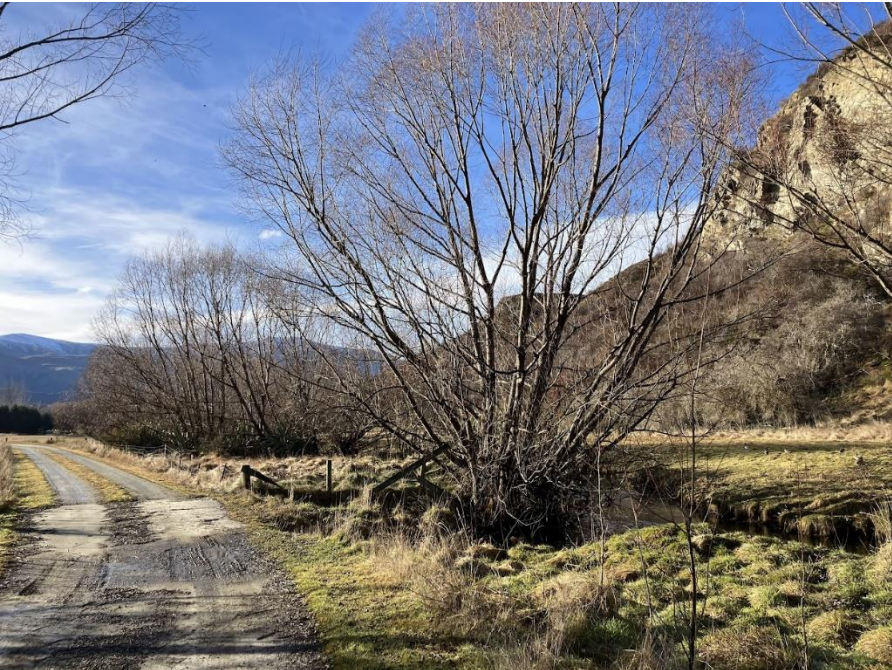
Photo No.	Date	
10	19/07/2023

Description A creek runs along the gravel driveway, through the center of the site.

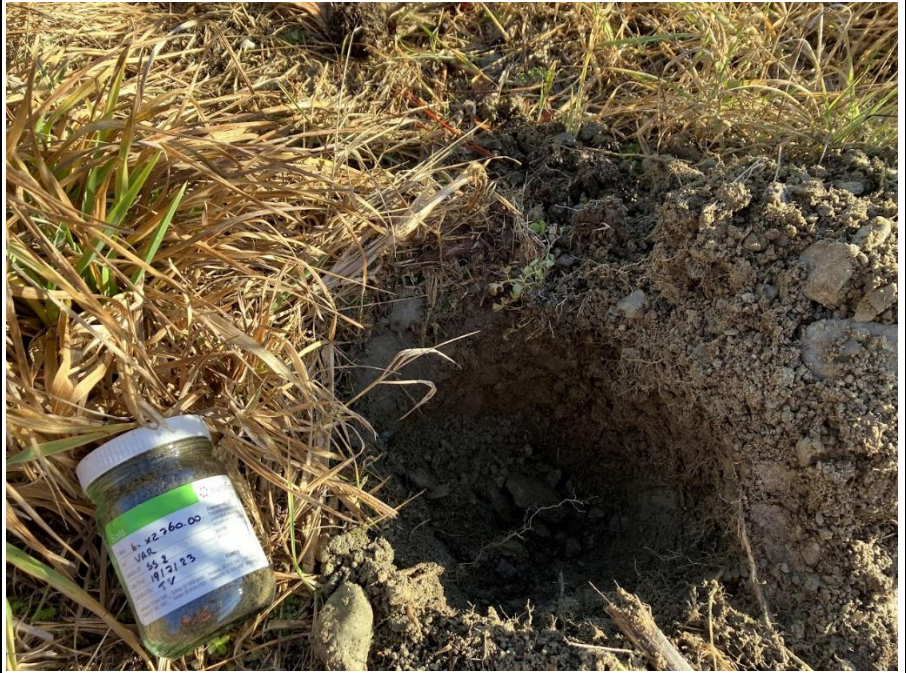
12

Samples were taken from near surface soils using a hand trowel. Samples were placed directly into laboratory supplied glass jars and sent to the laboratory under chain of custody for selected analysis. Soils were logged concurrently.

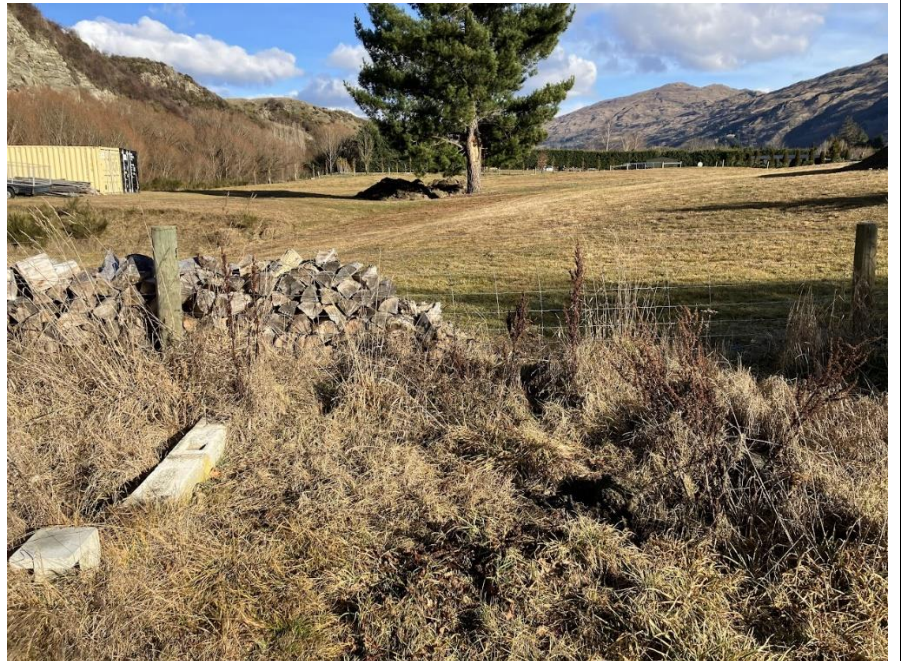
Location of sample SS2 between two concrete beams along the western boundary.

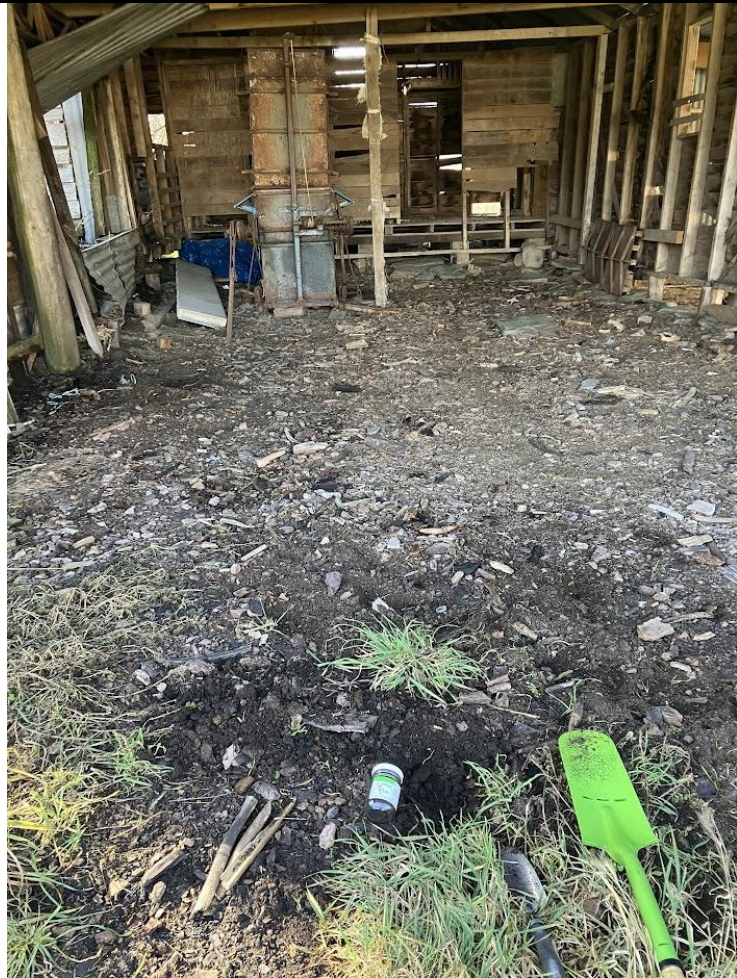
Location of sample SS5 near the entrance of the pole shed in the western corner of the site.
