*Geotechnical Report No. 1184*  
*Mitchell Partnerships*

**Geotechnical/Natural Hazard  
Assessment  
Three Parks Land, Wanaka**

**March 2007**

Date: March 2007  
Reference: 6CWM03.46 006DD  
Status: FINAL

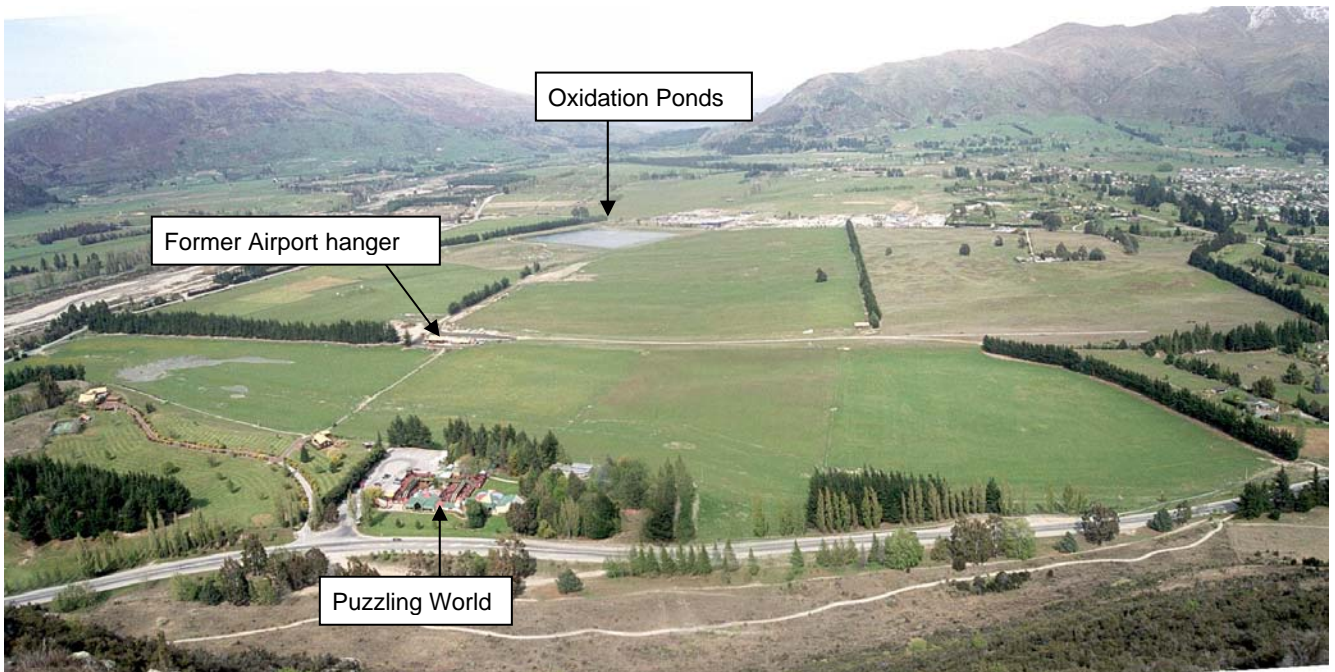
The site is located on an old alluvial landscape formed during the Last Glacial Advance (15-23ka); an overview of the site is shown in Photo 1. As indicated by the topographical map for the region (NZMG, Sheet F40), as well as a survey of the oxidation pond area, average elevation across the site is roughly 320 m above sea level. The topography across the site is gently rolling between old river channels with slopes generally ranging between 0 - 5°. The Cardrona River is located 150 – 200 m east of the eastern property boundary while land to the west is slightly higher in elevation with similar rolling plains topography. The site is bounded at the north by State Highway 84 and Mt. Iron.

Photo 1 - Overview of site from Mount Iron (October 2006).

The airstrip once served as the main airport for Wanaka with a hanger constructed for the airport in the late 1970's – early 1980's at the southeast end of the airstrip (Figure 3 and Photo 1). This building is still present today and is currently used as an operations base for Capell Construction Ltd and Nichols Landscaping. These businesses use the area for storage, maintenance, and servicing of vehicles and machinery. The former hanger also contains two 9000L tanks that had historically been used to store diesel and fuel for airplanes and airport vehicles. The tanks are owned by Mobil and presently contain diesel for the business at the site.

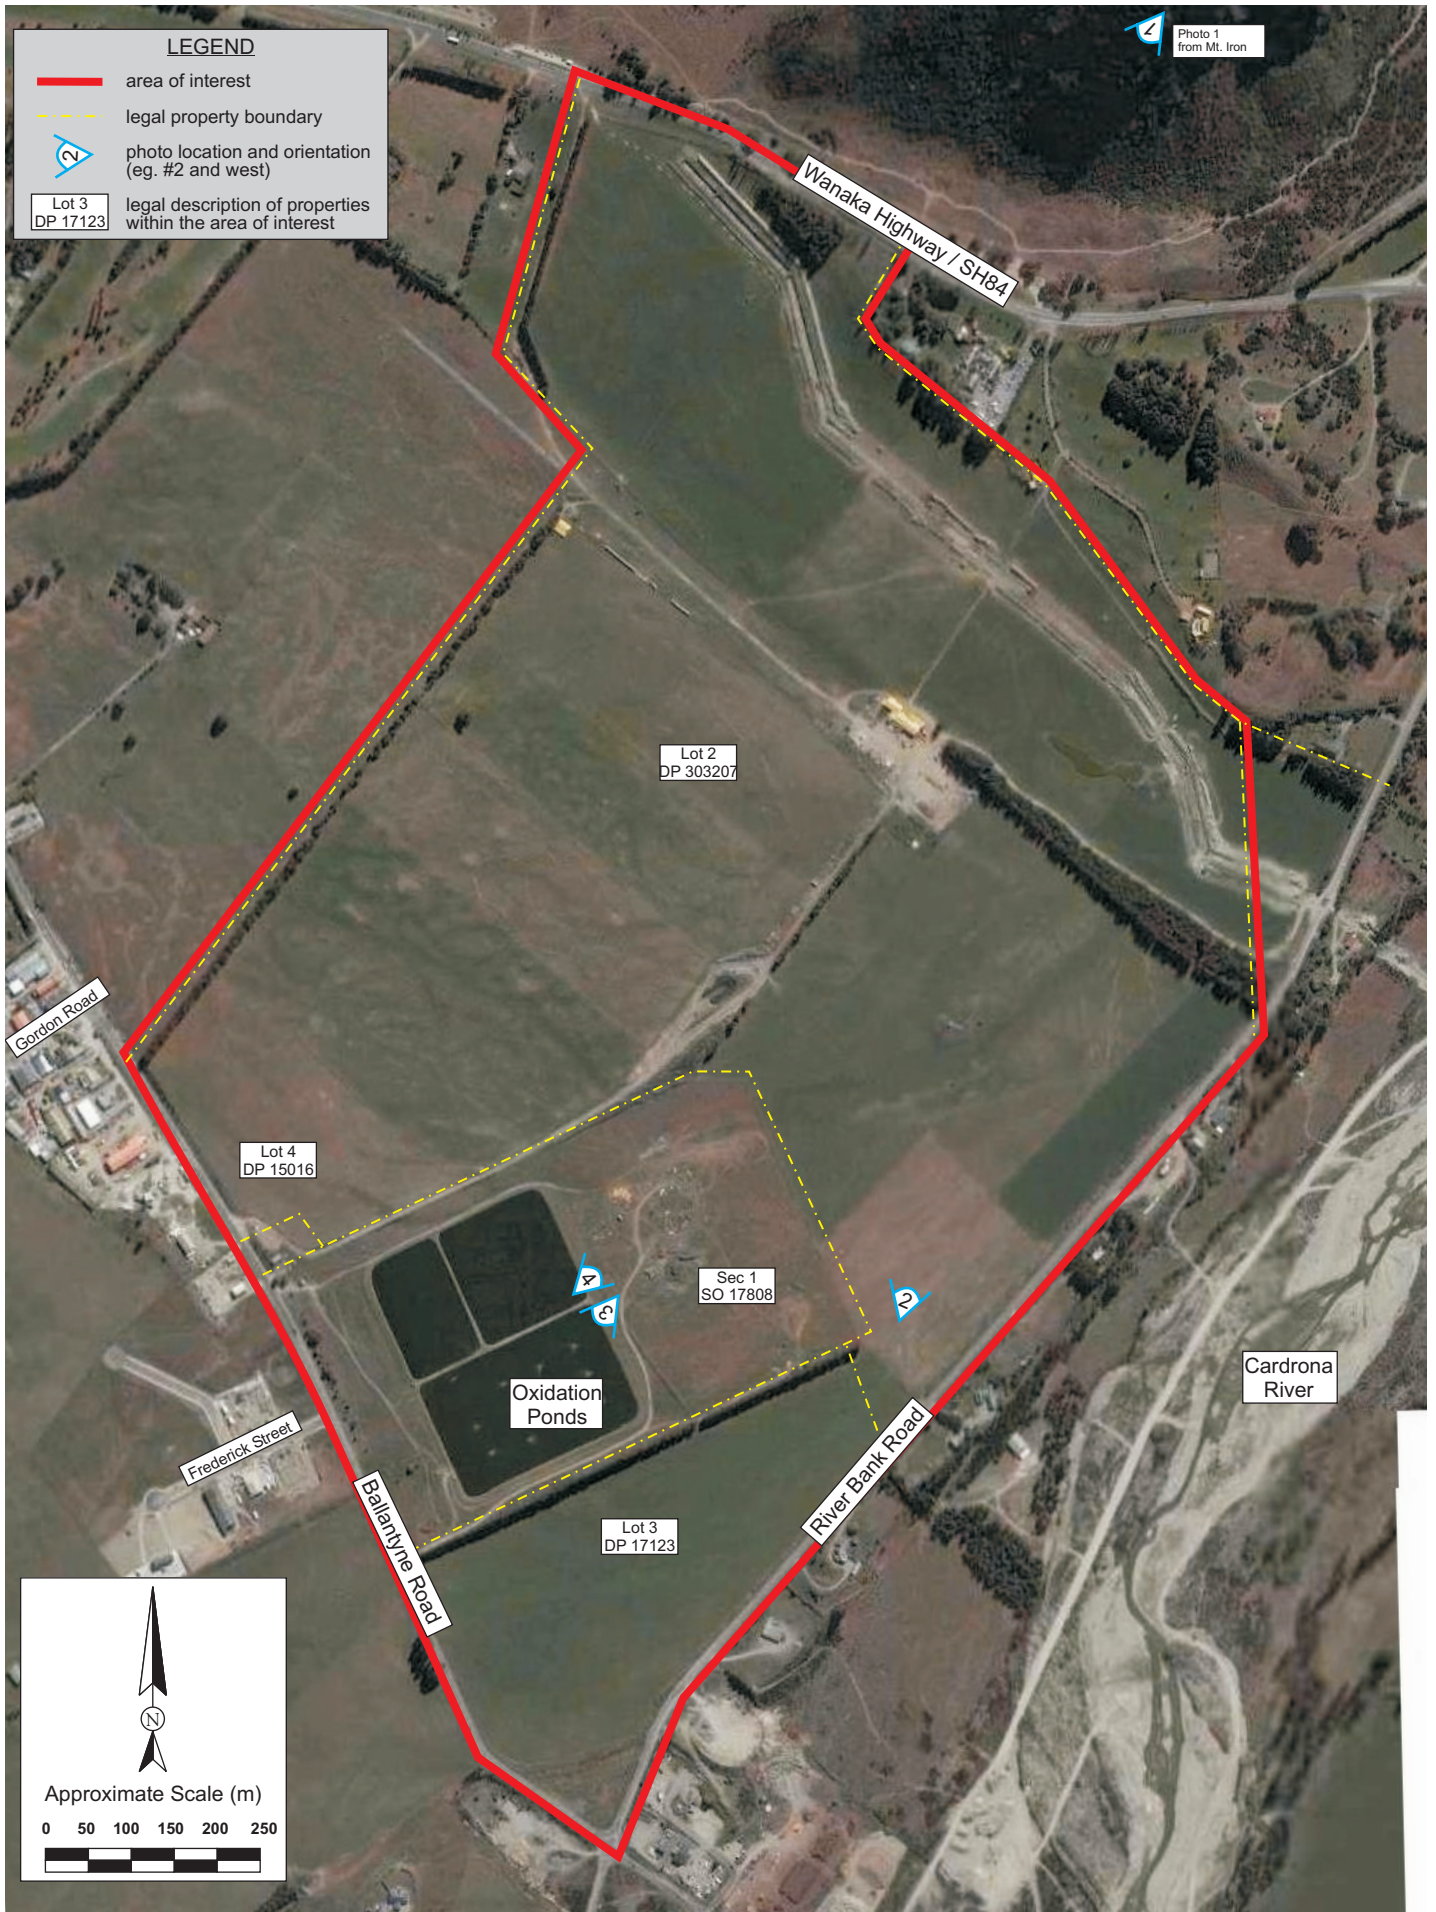
Figure 2 - Aerial Photography (2006) and photographic map with the site enclosed within the red boundary (2006 aerial photo modified from image obtained from Google Earth)  
 Three Parks Land Development

The site history described below is based on the compilation of data obtained from aerial photography, interviews with regional and local councils/authorities and a review of available documentation relating to the site (eg. LIM reports). Locations referred to below are indicated on Figure 3 and photograph locations and orientation provided in Figure 2.

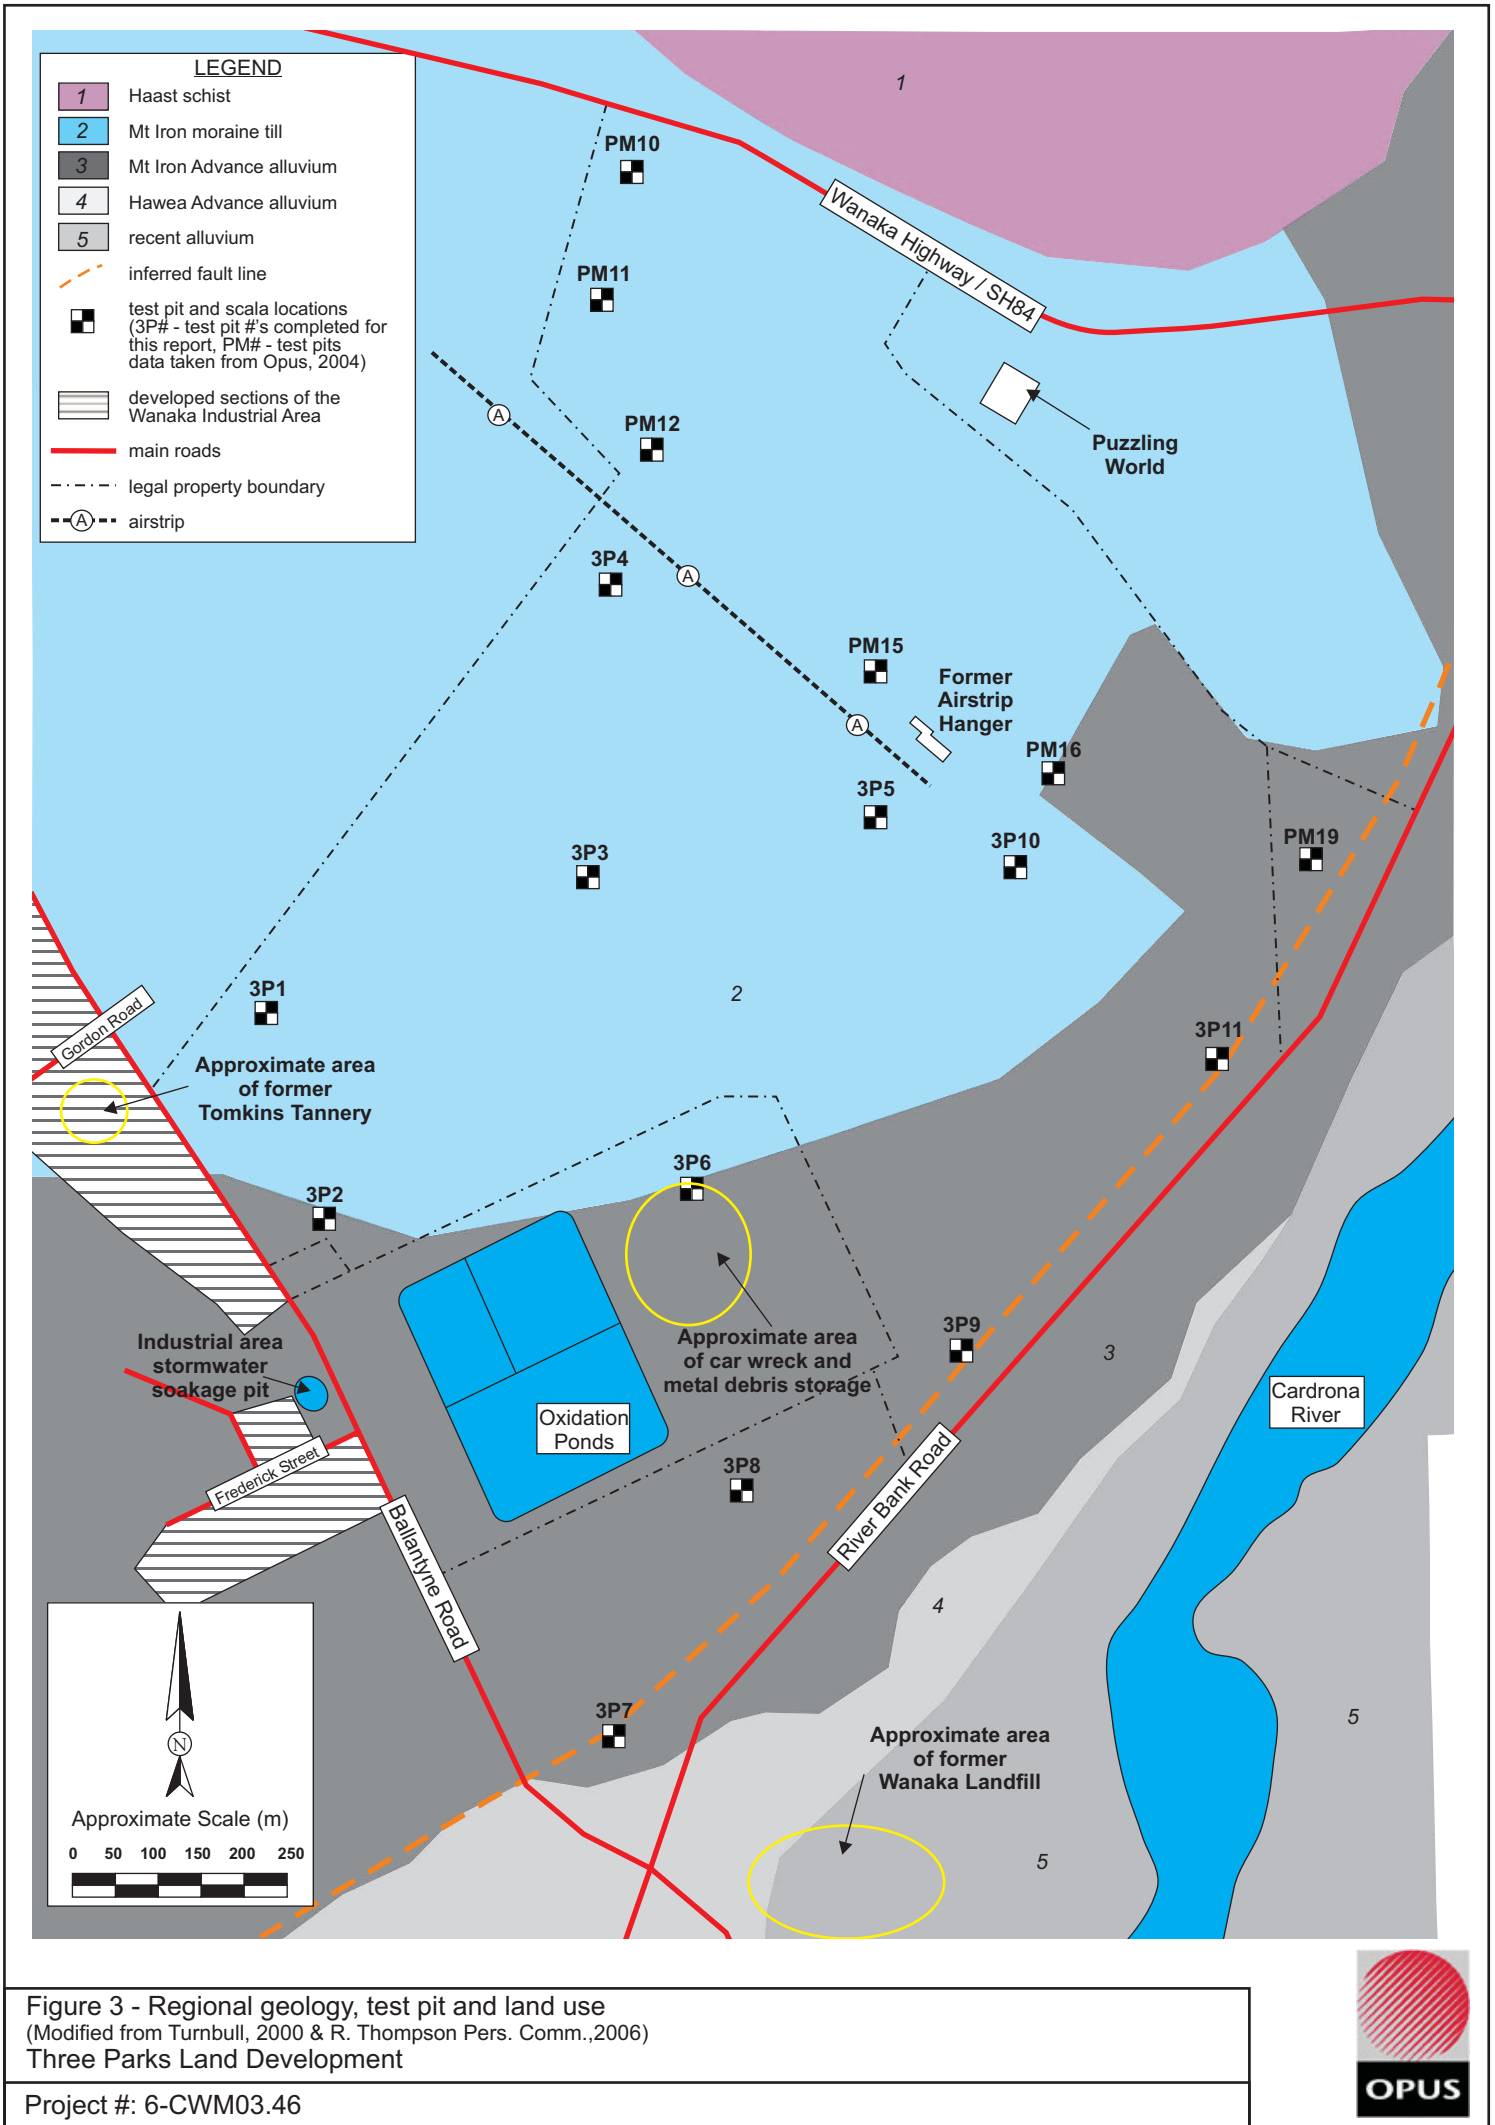
The majority of the site comprises tills and outwash gravels from the Mount Iron moraine deposit (refer to Figure 3). There is a small area along the eastern margin of the site where deposits represent alluvial deposits associated with the Mt. Iron moraine and glacial advance. The Mt. Iron moraine deposit and related Mt. Iron alluvial deposits are assumed to be approximately 23,000 yrs old (R. Thompson, Pers Comm.). A small slither of land to the south east of the site comprises of alluvial deposits of the Hawea Glacial Advance (~15ka).

Figure 3 - Regional geology, test pit and land use  
 (Modified from Turnbull, 2000 & R. Thompson Pers. Comm., 2006)  
 Three Parks Land Development

Subsurface investigations consisting of test pits and scala penetrometer tests were undertaken at 11 locations on the site as shown in Figure 3 (test pit logs are presented in Appendix A). The test pits were excavated with a 6 tonne digger to depths of 3 m. In addition, 6 test pits to depths up to 5 m were excavated at the northern end of the site during the Geotechnical investigations into the Queenstown Lakes District Council Cardrona Stormwater Bypass (Opus, 2004).

The close proximity of the Wanaka Industrial Area to the western extent of the site presents a risk for contamination migration. A possible source of contamination is stormwater drainage transported from the industrial activities along Ballantyne road to a small soaking pit ~ 20 – 30 meters from the western property boundary (Figure 3). However, the likelihood of significant contamination from the Wanaka Industrial Area is unlikely.

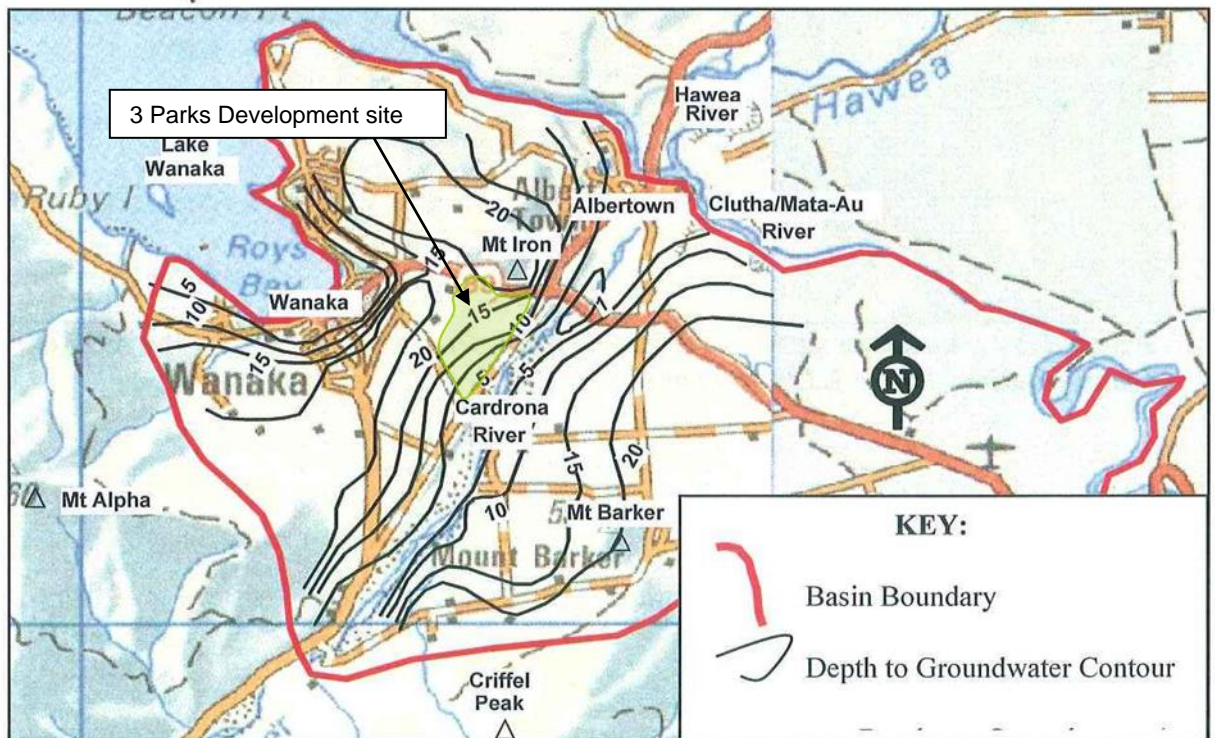
The water table varies considerably across the site and is highest, ~ 5 mBGS (meters Below Ground Surface), adjacent to the Cardrona River. At the northern end of the site groundwater is much deeper, ~ 20 mBGS, as shown in Figure 4. There are 198 wells located within the Wanaka Basin Aquifer that are currently being used for drinking water supply, irrigation, commercial, scheme water supply and stockwater uses. There are a number of wells (> 5) located within the site with known uses including irrigation and drinking water supply.

Figure 4 – Depth to water table for the Wanaka Basin in metres below ground level (m BGL) during July 1999. The Three Parks Development Area is highlighted in green. Scale approximately 1:120,000 (ORC, 2003).

As discussed in section 3.3 and 4.2, no groundwater or perched water were observed in any test pits excavated on site. Information gathered from the Wanaka Basin Groundwater Modelling Report (ORC, 2003) show that the groundwater table on site varies from between 5 and 20 m below ground level (Figure 4). Liquefaction is unlikely to occur in sediments where the groundwater table is at depths >12m

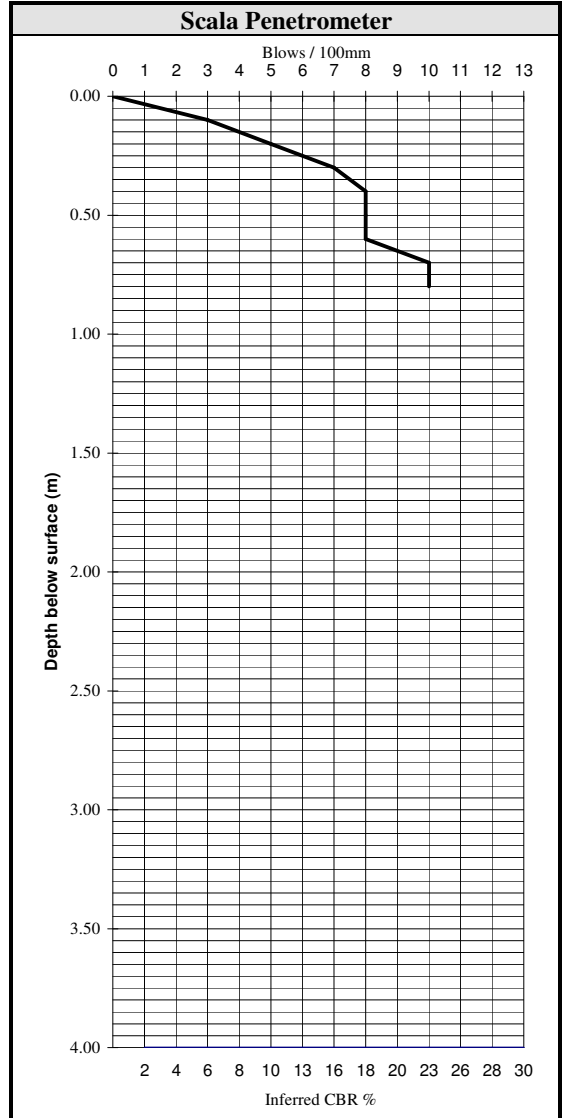
Depth (mm)	Geological Description
0-100	Topsoil; dark brown.
100	Very coarse SAND; yellow/white. Bedding, wavy, 2-5mm thick.
100-600	Coarse GRAVEL with some brown silt. Densely packed; rounded to sub-rounded schist gravels.
600-1200	Fine to medium GRAVEL; grey. Moderately packed; rounded to sub-rounded schist gravels.
1200-2100	Medium to coarse GRAVEL, grey. Moderately packed; sub-rounded to angular schist gravels with some 300mm sub-rounded to angular schist.
2100	fine to medium SILT; grey; with some medium, rounded to sub-rounded gravel.
	end of test pit No groundwater observed, hole damp
Sample recovered at :	
Depth at which scala penetrometer started : 0 metres

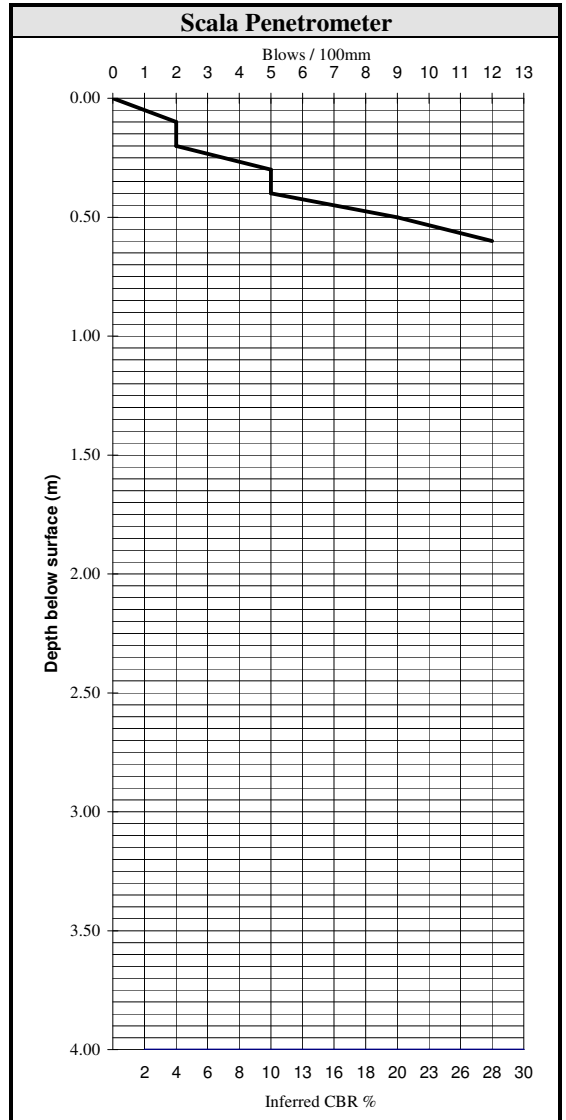
Depth (mm)	Geological Description
0-200	Sandy, silty topsoil; dark brown with some schist derived gravel
200-700	Sandy coarse GRAVEL; grey. Moderately packed; rounded..
700-2800	Fine to coarse GRAVEL; grey. Moderately packed, rounded with some 200-300mm sub-rounded schist boulders, some up to 800mm
	End of test pit - hole collapsing No groundwater observed, hole damp
Sample recovered at :	
Depth at which scala penetrometer started : 0 metres
