**EVIDENCE OF PETER NICOLSON FOR**

Gertrude's Saddlery Limited (494) and Larchmont Developments Limited (527 and  
1281)

## 111 Atley Road, Arthurs Point, Queenstown Geotechnical Assessment for Proposed Plan Change

160771. SITE PLAN. 8/11/16. REVISED 7/5/17  
 111 ATLEY ROAD, ARTHURS POINT, QUEENSTOWN

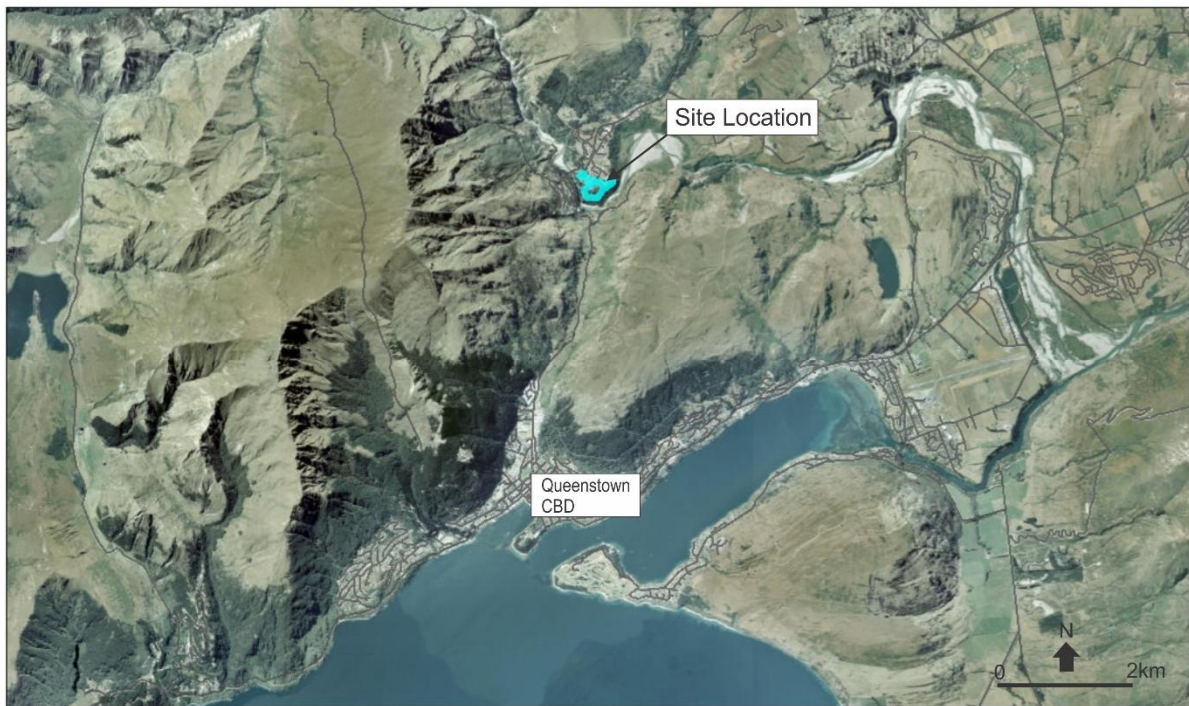
Figure 1. Aerial view of proposed development site location.

The site is located on the northern side of the Shotover River at the southern end of Atley Road, Arthurs Point, Queenstown, see Figure 1 below.
