## Attachment A - Option Study

Stantec | Butlers Green Retaining Wall - Option Study | 23/02/2018

### Butlers Green Retaining Wall - Option Study

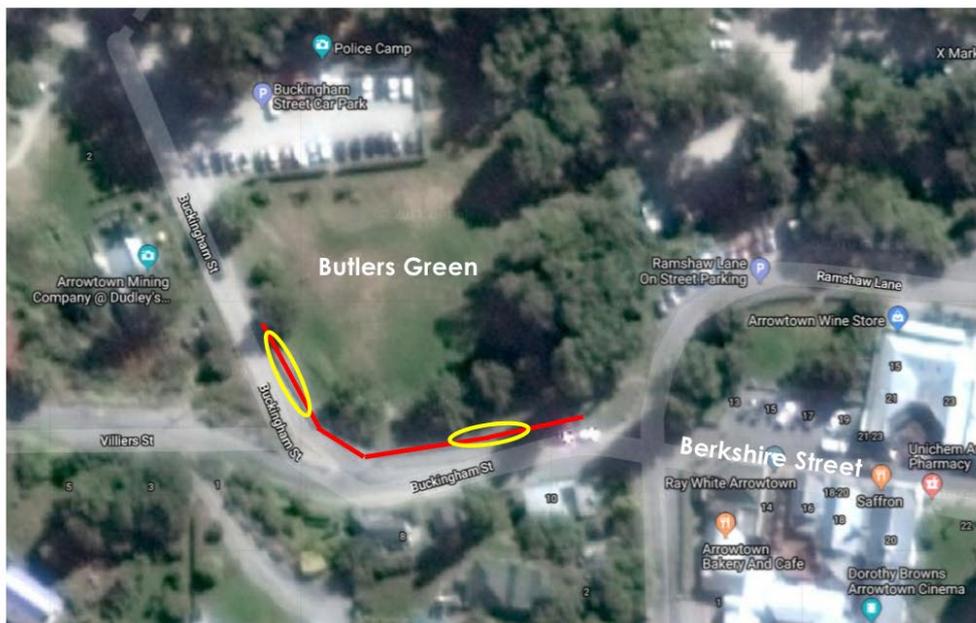
Figure 1 – Location Plan (wall marked in red, bulging areas marked in yellow)

Two notable sections of the wall are bulging outward significantly with a deflection of approximately 600 mm. This deflection has resulted in cracking of some stones and loss of stones in some areas.

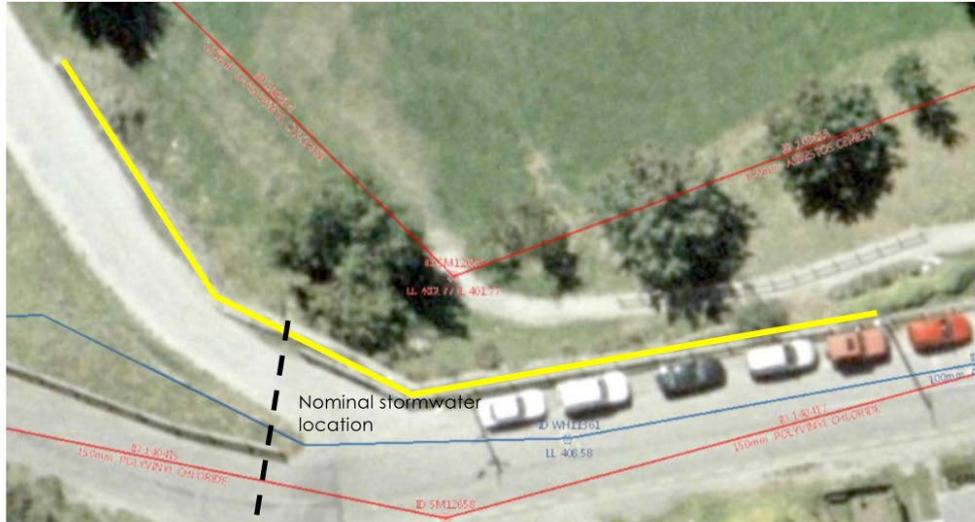
Figure 10 – Water and Wastewater Service Location

Both sewer and water bulk mains exist within the road alignment adjacent to the wall and a sewer main within Butlers Green runs parallel with the base of the wall. Figure 10 indicates the general location of these services.

It is possible that other underground services exist within the road reserve. Appropriate service location including both 'before you dig' and potholing using a vacuum truck are considered necessary.

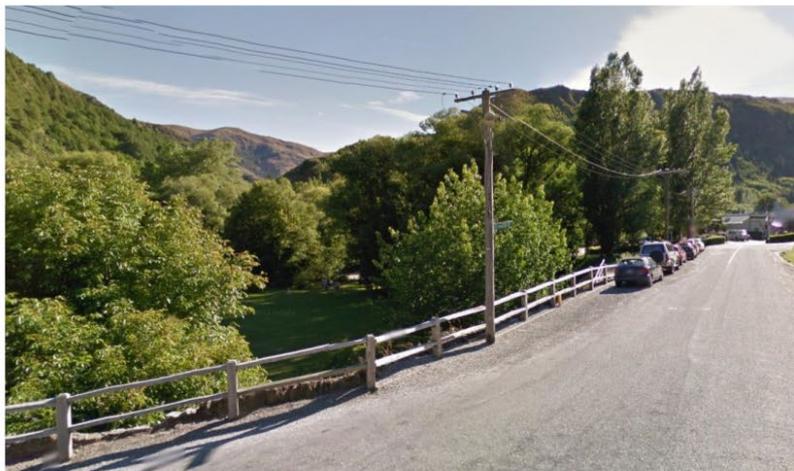
Figure 11 - Power Location

Overhead power is located directly adjacent to and above the wall and will restrict the use of excavators from above. The service must be managed during construction by isolation, temporary relocation or permanent relocated for some options, especially for the implementation of bored piles. Figure 11 shows the locations of above ground power services.

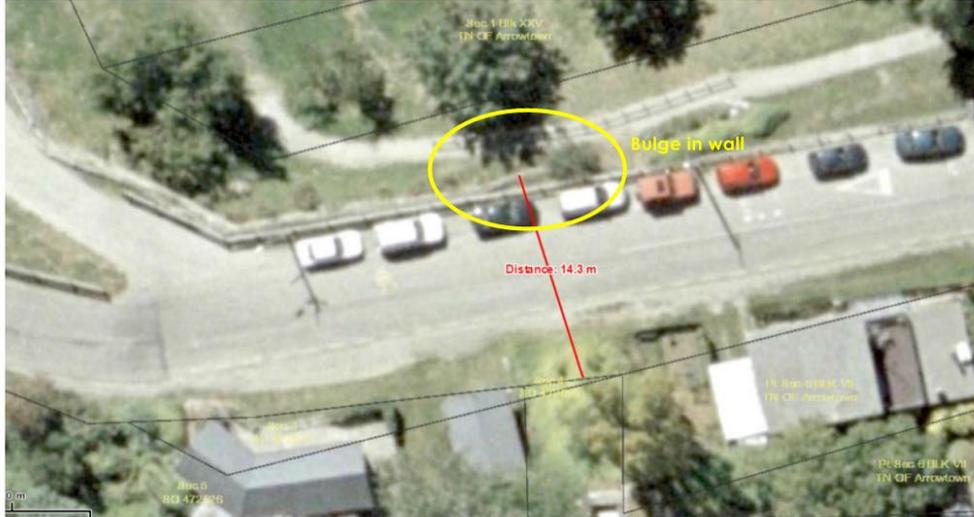
Figure 12 - Property Boundaries

There is approximately 14 metres of road reserve between the wall and the nearest property boundary. Property boundaries were a potential risk for the remediation option involving anchors however we do not expect that 14m anchors will be necessary and 15m is the maximum practical length that self-drilling anchors can be used.
