E. coli monitoring

Shotover & Kawarau Rivers

Water quality sampling locations

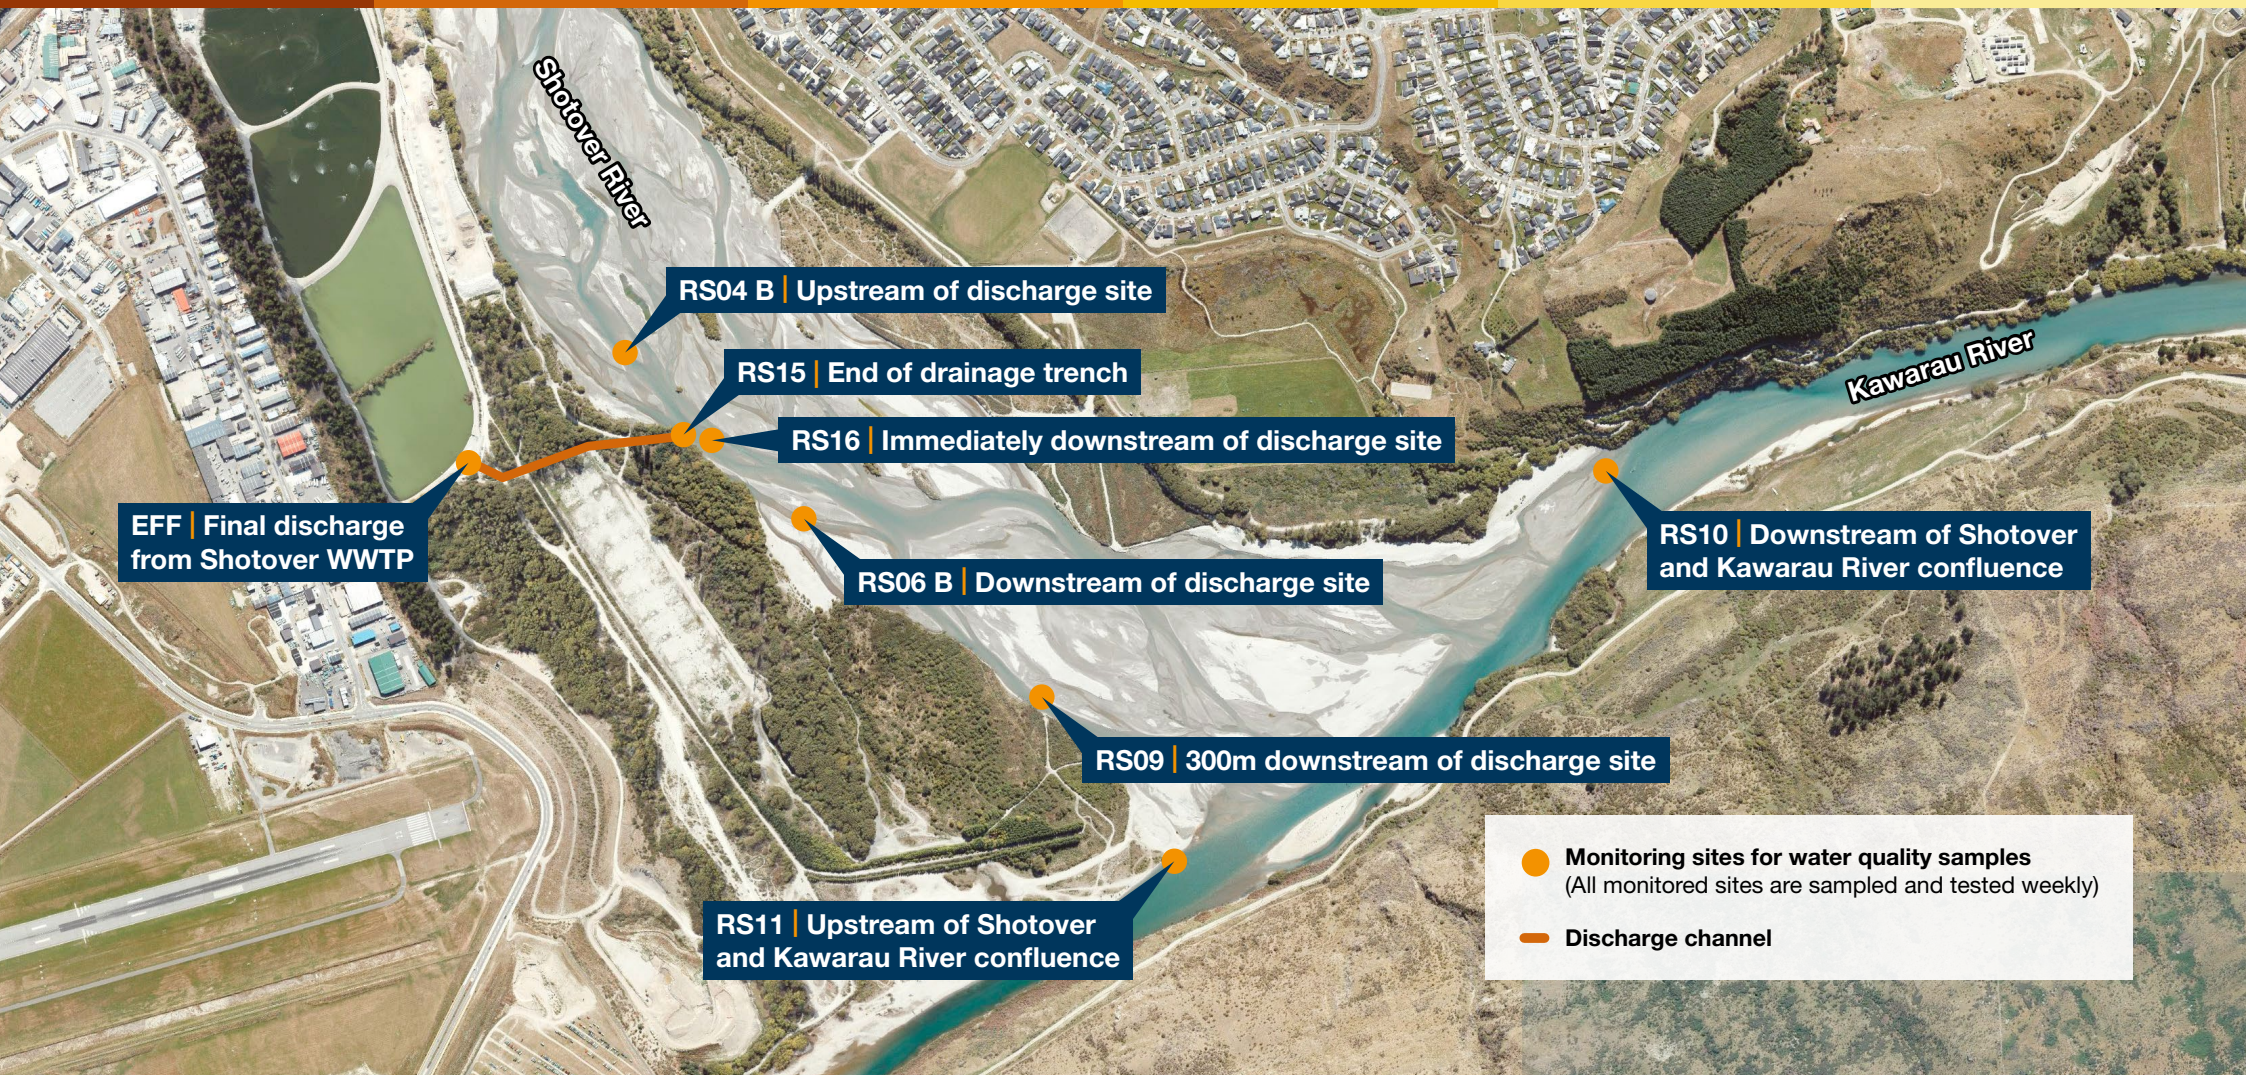
Shotover & Kawarau Rivers

Shotover WWTP E. coli results									
Parameter		E. coli							
Unit		CFU/100mL							
Location		EFF Final discharge from Shotover WWTP	RS15 End of drainage trench	RS04 B Shotover River upstream of discharge to provide baseline water quality	RS16 Shotover River immediately downstream from discharge channel	RS06 B Shotover River 50m downstream of discharge	RS09 Shotover River 300m downstream of discharge site	RS11 Kawarau River upstream of confluence	RS10 Kawarau River downstream of confluence
Date	3 June 2025	<10	28	1	3	2	3	5	1
	12 June 2025	<10	33	15	190	13	12	9	7
	18 June 2025	10	16	1	40	1	1	6	<1
	26 June 2025	<10	8	*	*	*	*	*	240
